NATIONAL TRANSPORTATION SAFETY BOARD

SAFER SEAS Digest

Lessons Learned from
Marine Investigations

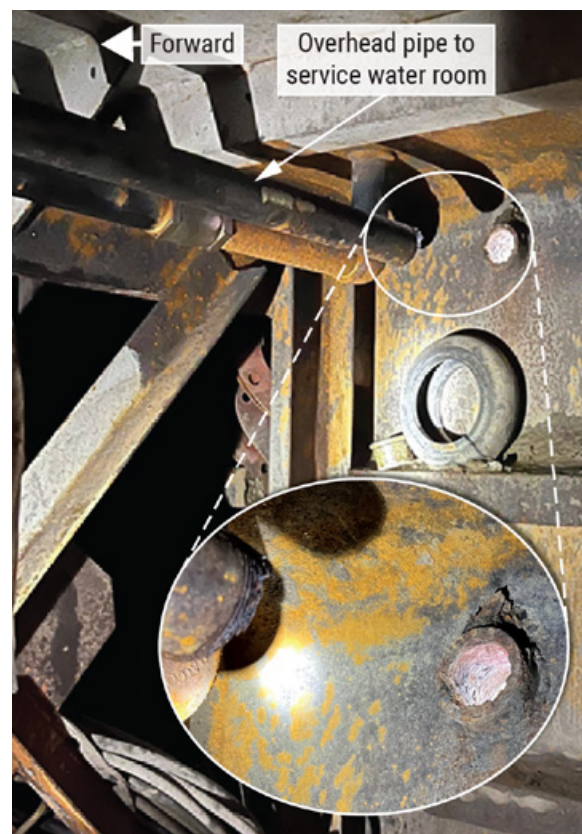
Postrecovery, a 2-inch through-hull pipe into the starboard storage space was found to be open, as its overboard check valve was missing and likely had been since before the casualty. The center of the through-hull pipe was about 5 inches above the dredge's normal waterline, so waves, a list to starboard, and/or an increase in stern trim could have submerged

the opening, allowing water to enter the storage space. Thus, it is likely that the initial starboard list was caused by flooding through the unsecurable through-hull pipe.

The starboard storage space showing the overhead pipe and the 2-inch through-hull pipe. Inset: The end of the overhead pipe and the unsecured through-hull pipe. SOURCE: COAST GUARD.

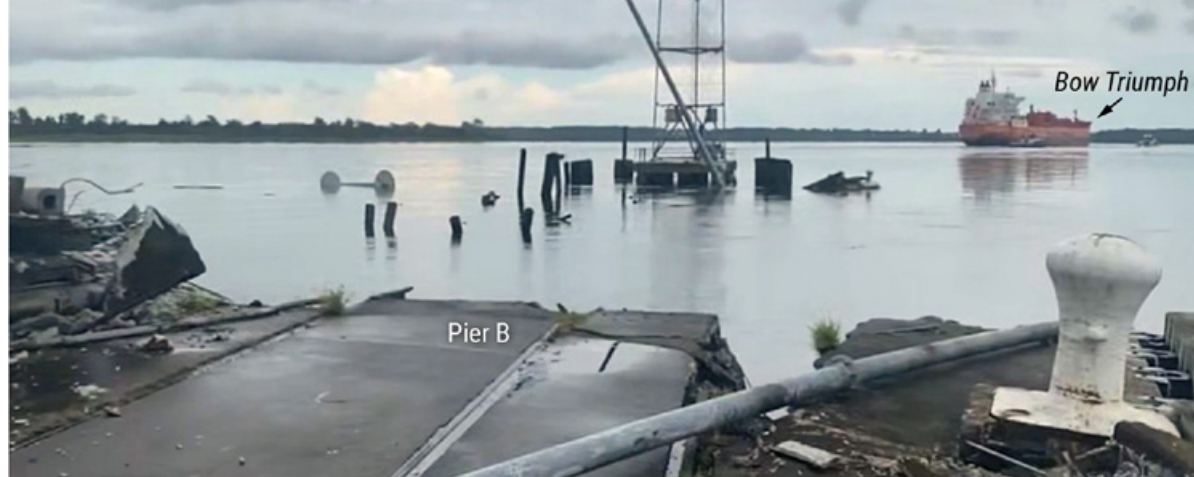
**Witness photograph taken shortly after the contact showing damage to Pier B.** BACKGROUND SOURCE: JACOB WALL.

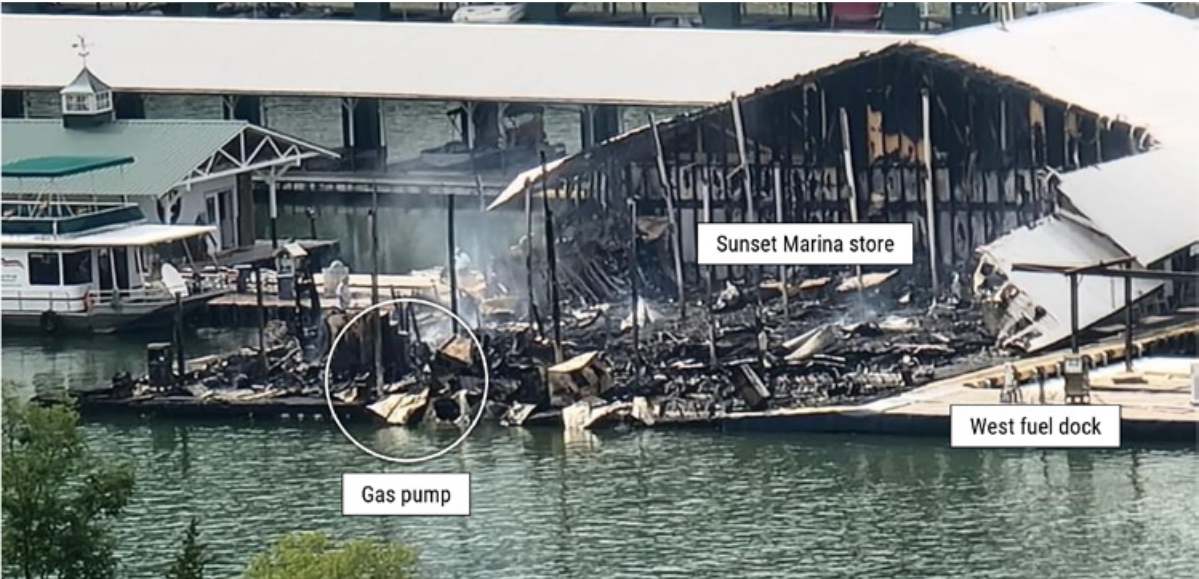
Sunset Marina store and fuel dock after the fire. BACKGROUND SOURCE: TENNESSEE WILDLIFE RESOURCES AGENCY.

THE PROBABLE CAUSE of the contact and subsequent fire at the Sunset Marina was a houseboat's "duckbill" bow striking a gasoline fuel dispenser (pump) when docking in windy conditions, which caused an undetermined electrical source on the dock to ignite vapors from the broken gasoline fuel line. Contributing to the contact was the proximity of the gas pump to the dock edge.

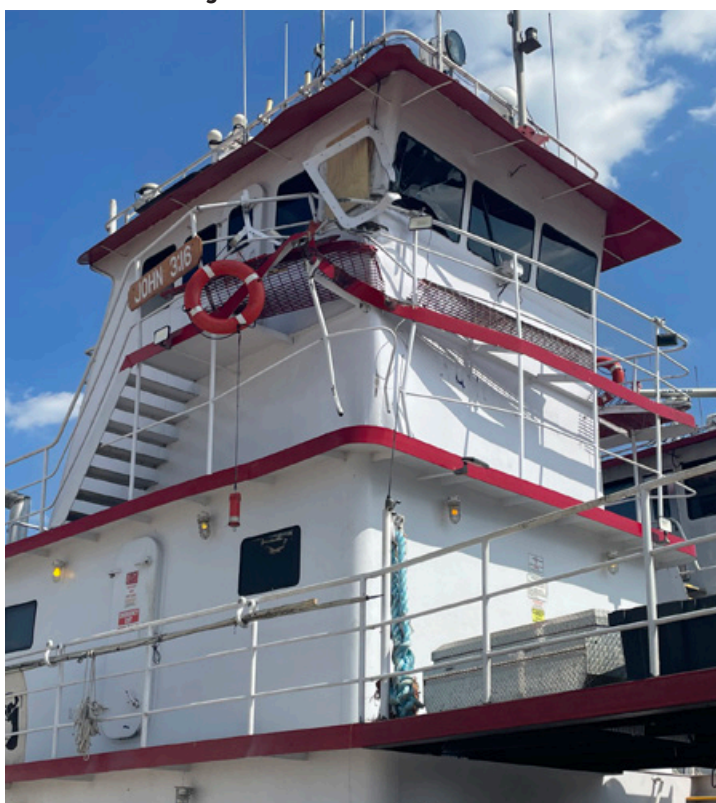
Damage to the *John 3:16* wheelhouse structure.

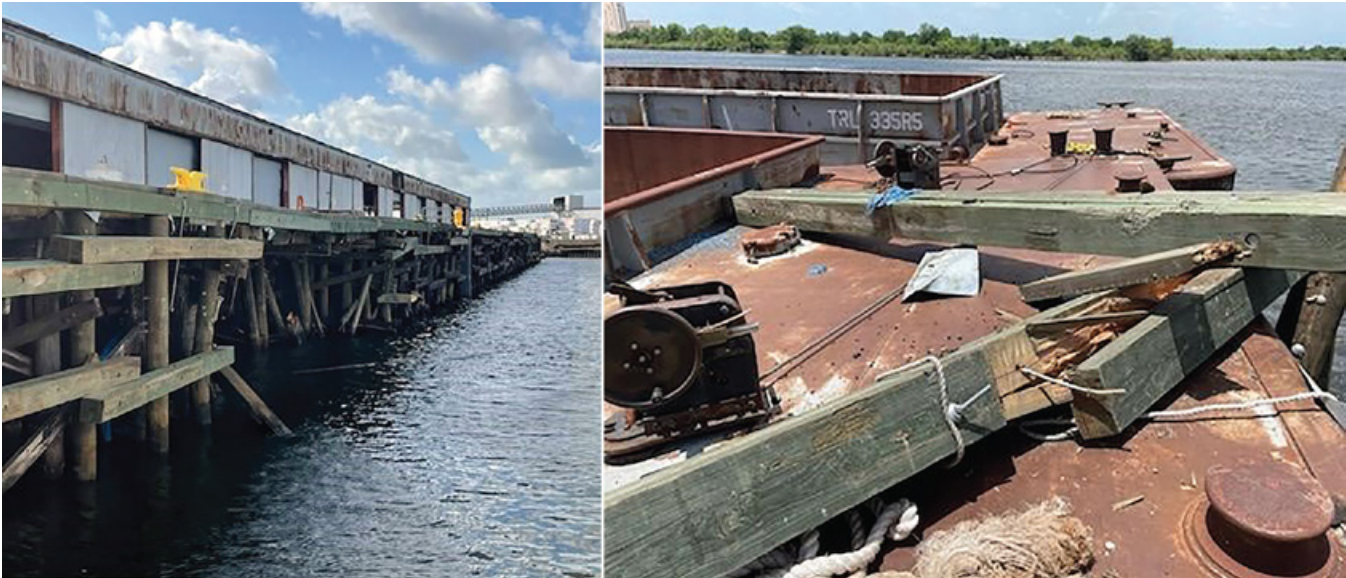
Left to right: Damage to the Port of Lake Charles pier. Timber from the pier found on the starboard lead barge of the Danny Terral. SOURCE: COAST GUARD.

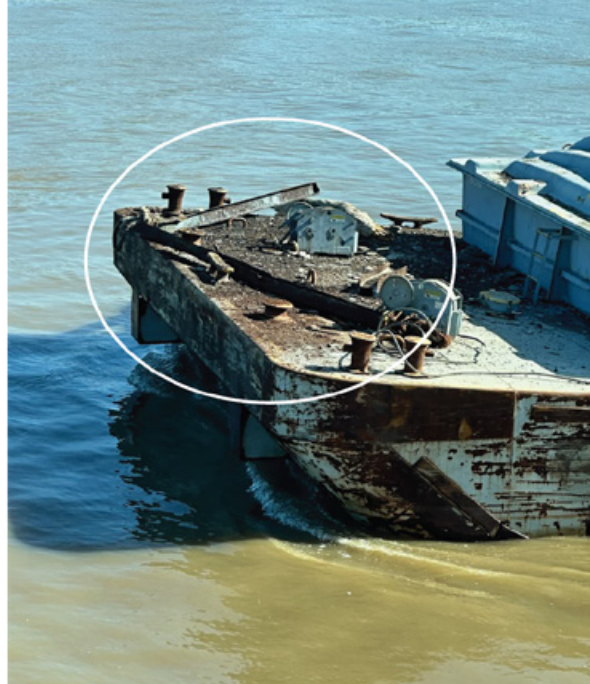
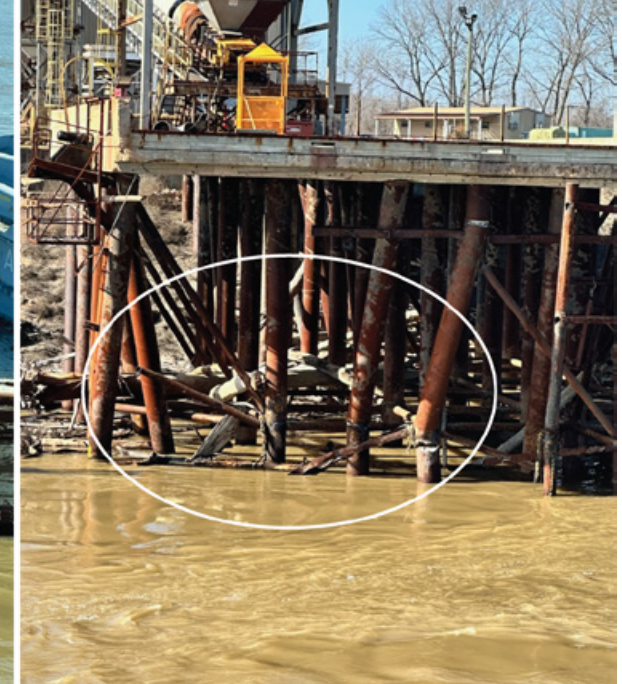
Left to right: The damage to barge ACBL2549 after the contact (circled), and the damage to the Port of West Memphis dock (circled). SOURCE: COAST GUARD.

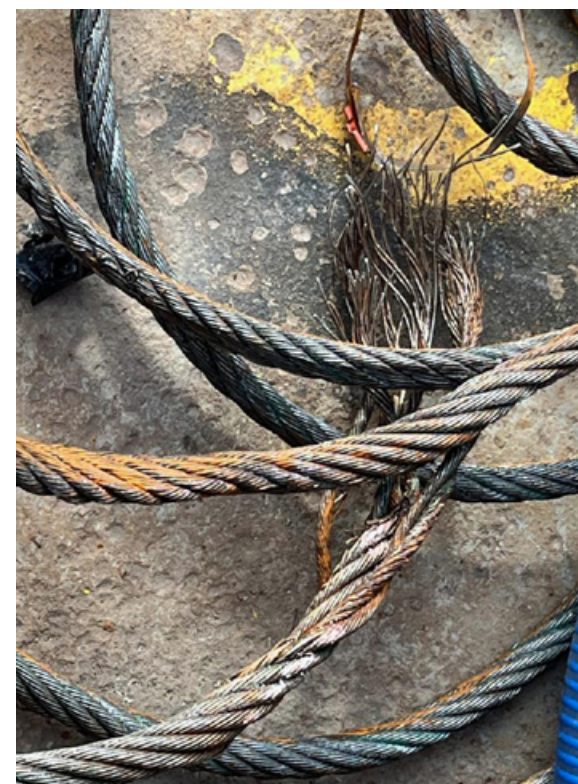
THE PROBABLE CAUSE of the breakaway of the barges **ACL23401** and **ACBL2549** and subsequent contact of the barge **ACBL2549** with the Port of West Memphis dock was the parting of the starboard facing wire connecting barge **ACL23401** to the towing vessel **Nell Womack**, likely due to undetected damage to its wire strands.

Parted wire after the breakaway.

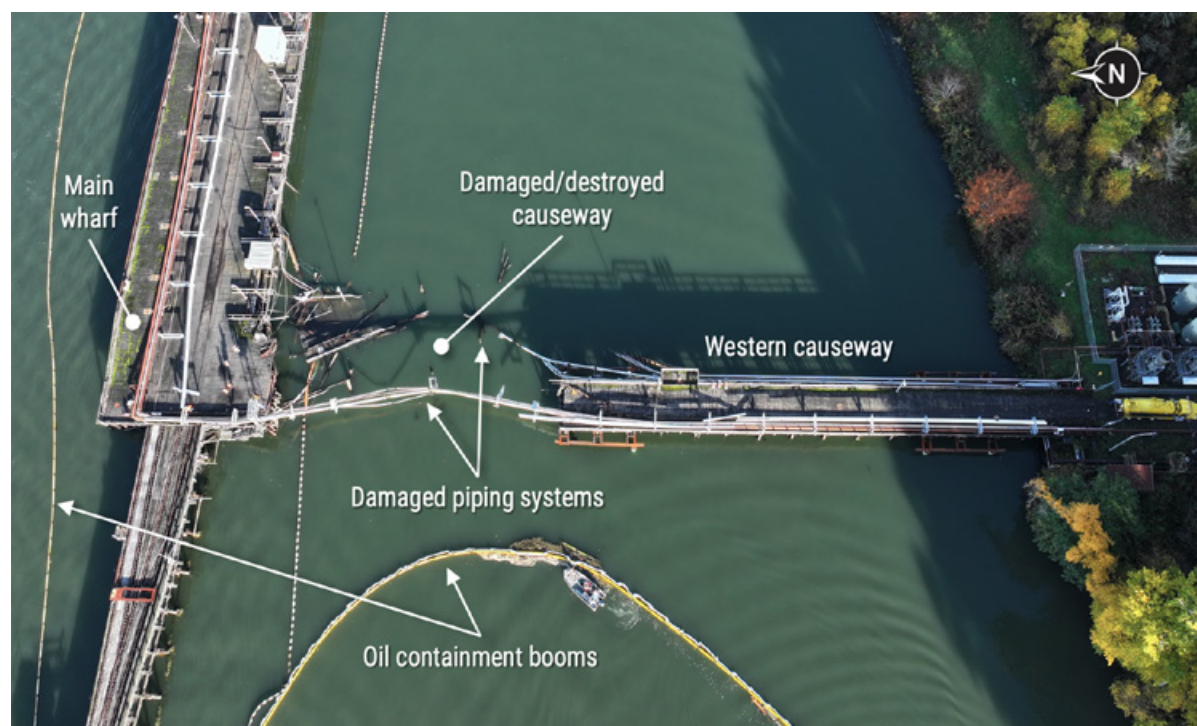
Beaver Dock after contact by the *Cindy B* tow. BACKGROUND SOURCE: COAST GUARD.

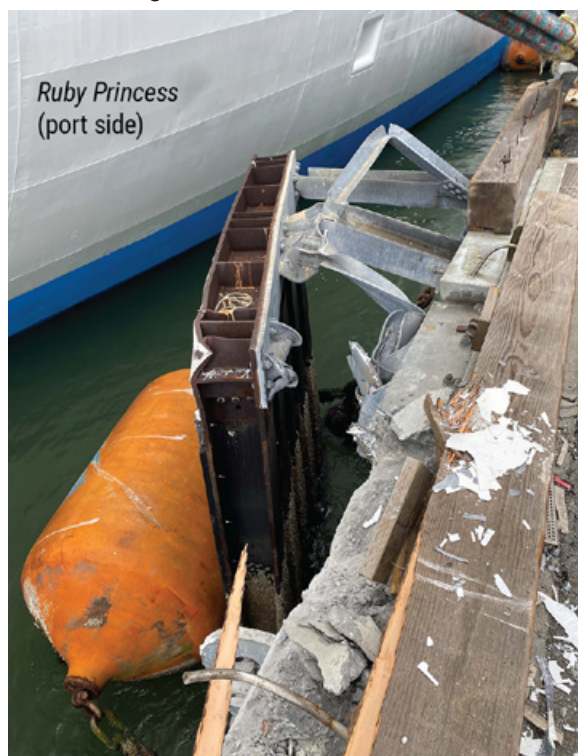
Ruby Princess damage. BACKGROUND SOURCE: COAST GUARD.

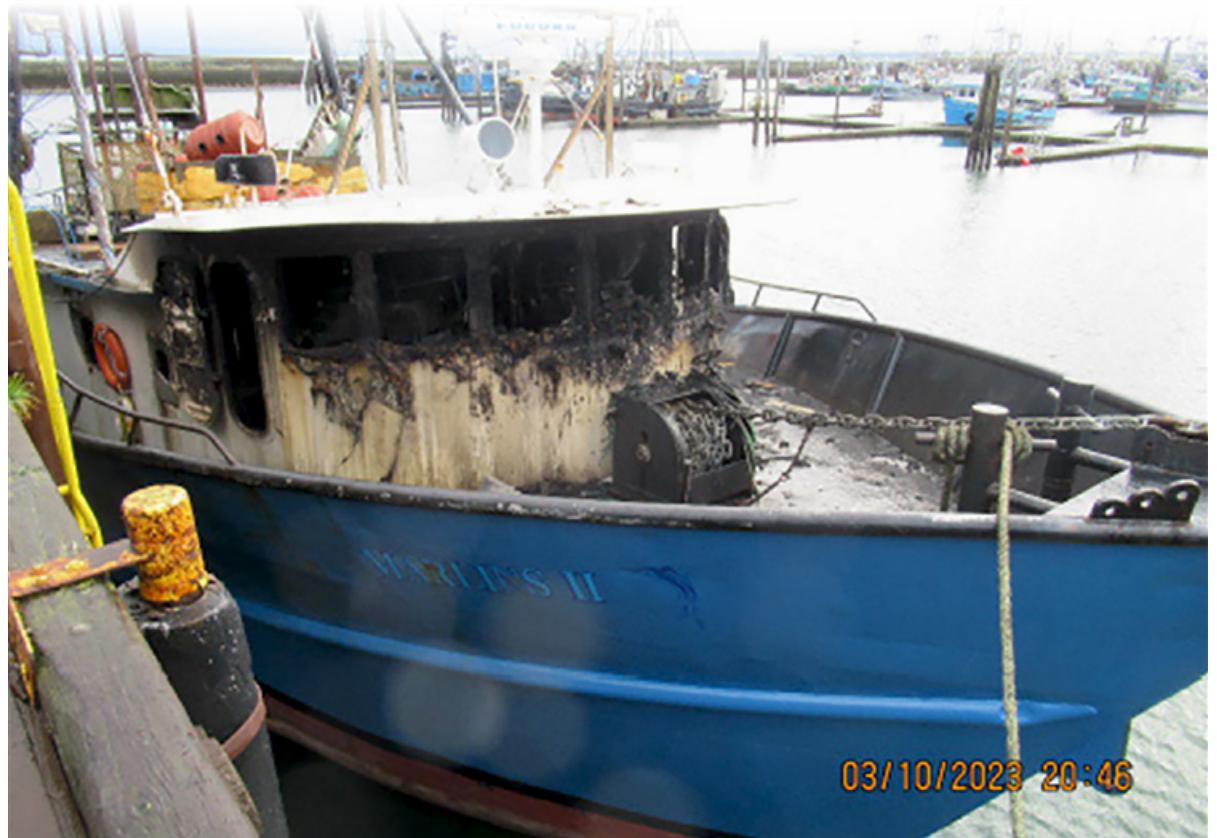
The burned-out *Marlins II* after the fire. SOURCE: BLOMQUIST MARINE SURVEYS.

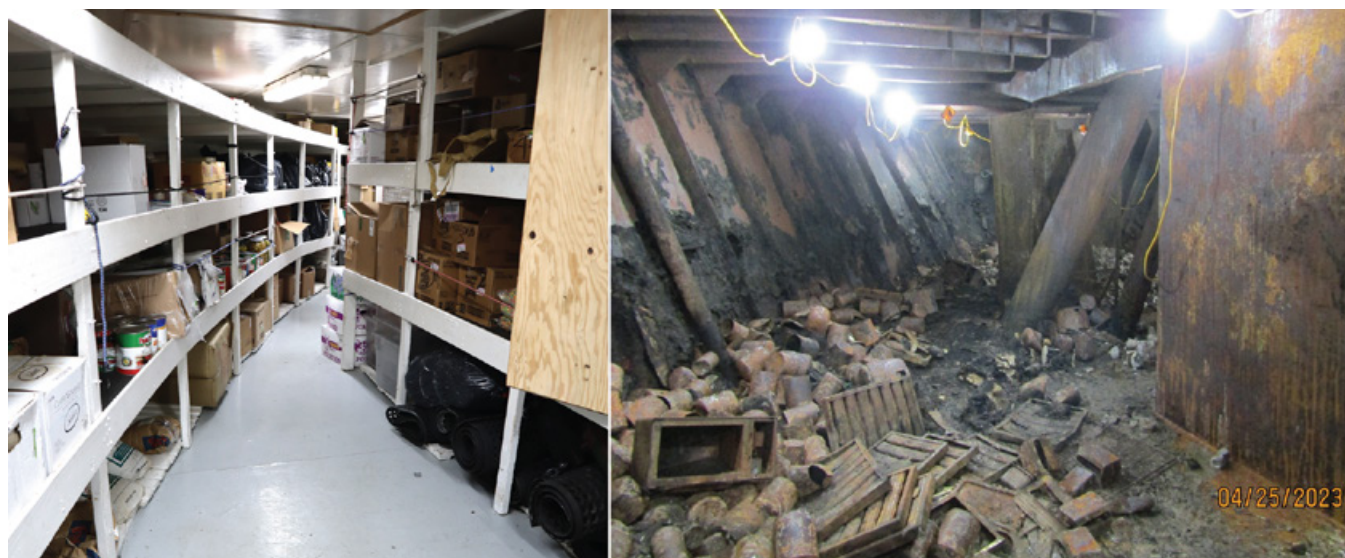
THE PROBABLE CAUSE of the fire aboard the *Kodiak Enterprise* was an unknown electrical source within the dry stores room. Contributing to the risk to the onboard crewmembers and to the severity of the fire was the vessel's inadequate fire detection and notification system, which was not designed to sound in crew accommodation spaces, and failed to wirelessly alert shoreside contacts.

The dry stores room, looking forward, before and after the fire.

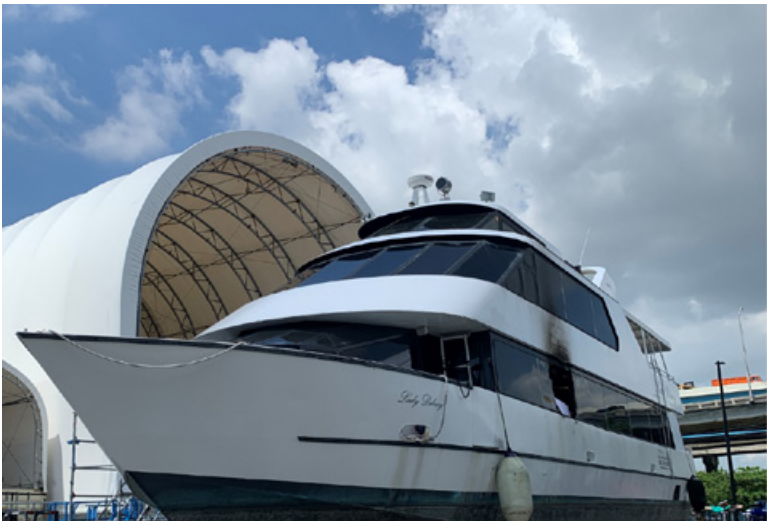
Left to right: Lady Delray after the fire, with fire-damaged portside window and portside main deck bar area.

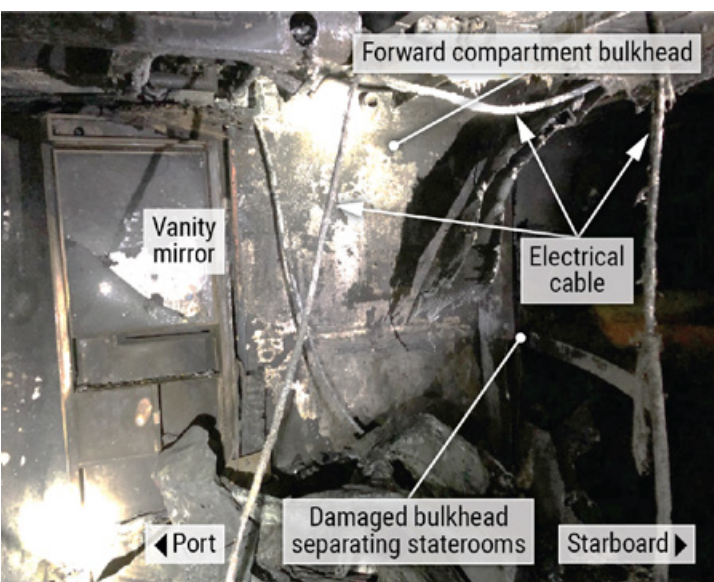
Qualifier 105 stateroom J interior postfire.

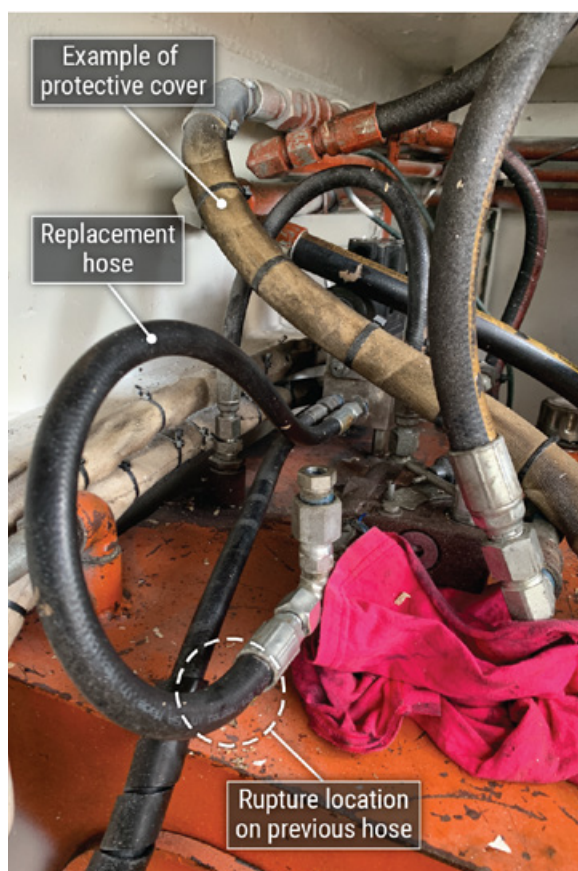
The replacement hydraulic hose, with the location of the rupture on the previous hose circled.

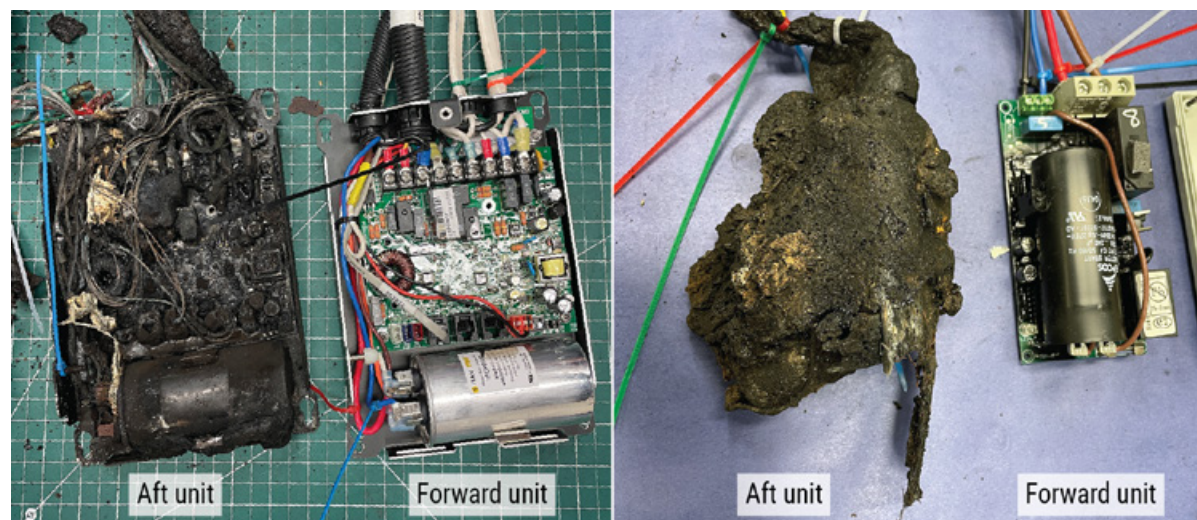
Left to right: Larger soft start control device from damaged air conditioning unit alongside identical forward unit (shown as an exemplar). Smaller soft start control device from damaged air conditioning unit alongside forward unit after fire.

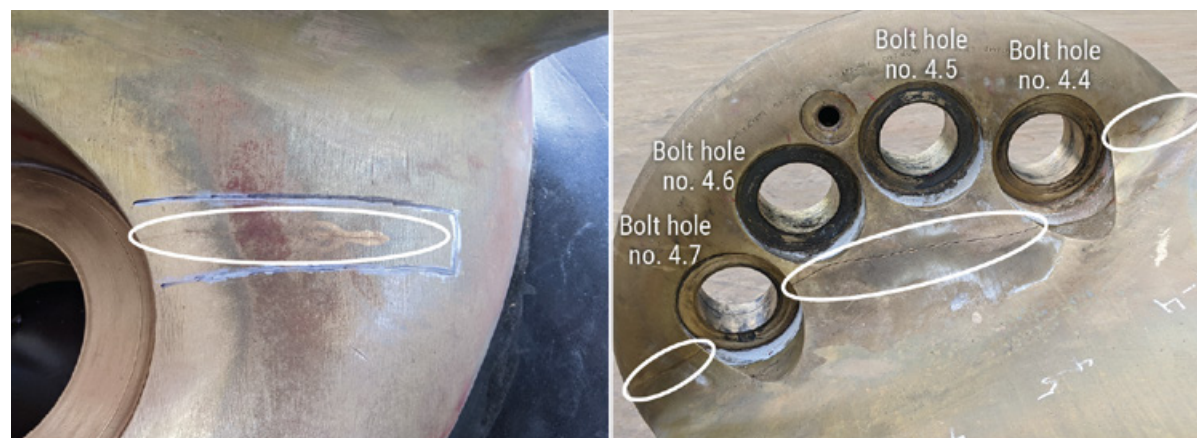
Left to right: Fractures (circled) on propeller blade no. 2, suction side and no. 4, pressure side.

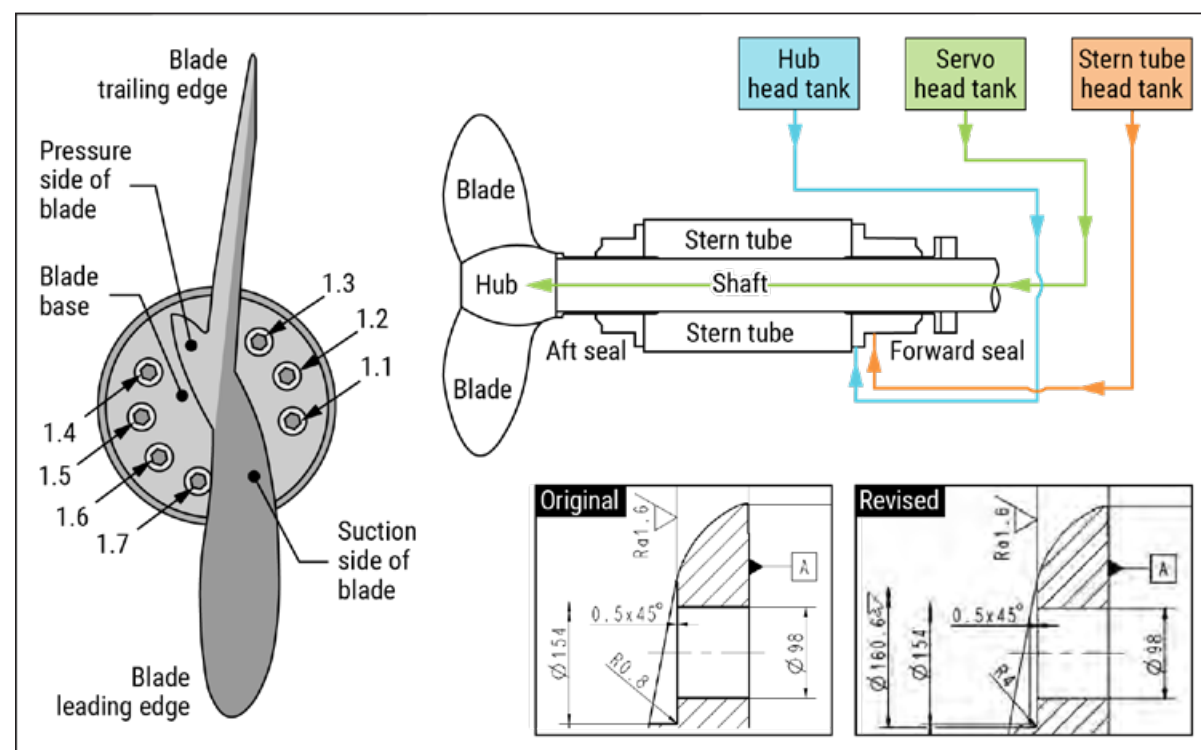
Maunalei propeller blade no. 1 bolt positions and simplified schematic of hydraulic oil system head tanks for CPP system. Insets show CPP blade original and revised machining drawings reflecting the increased internal radius required for the bolt holes. INSET SOURCE: MAN ENERGY SOLUTIONS.
