2025 Summer Safety Meeting

Groundings – What can we Learn?

August 14th, 2025

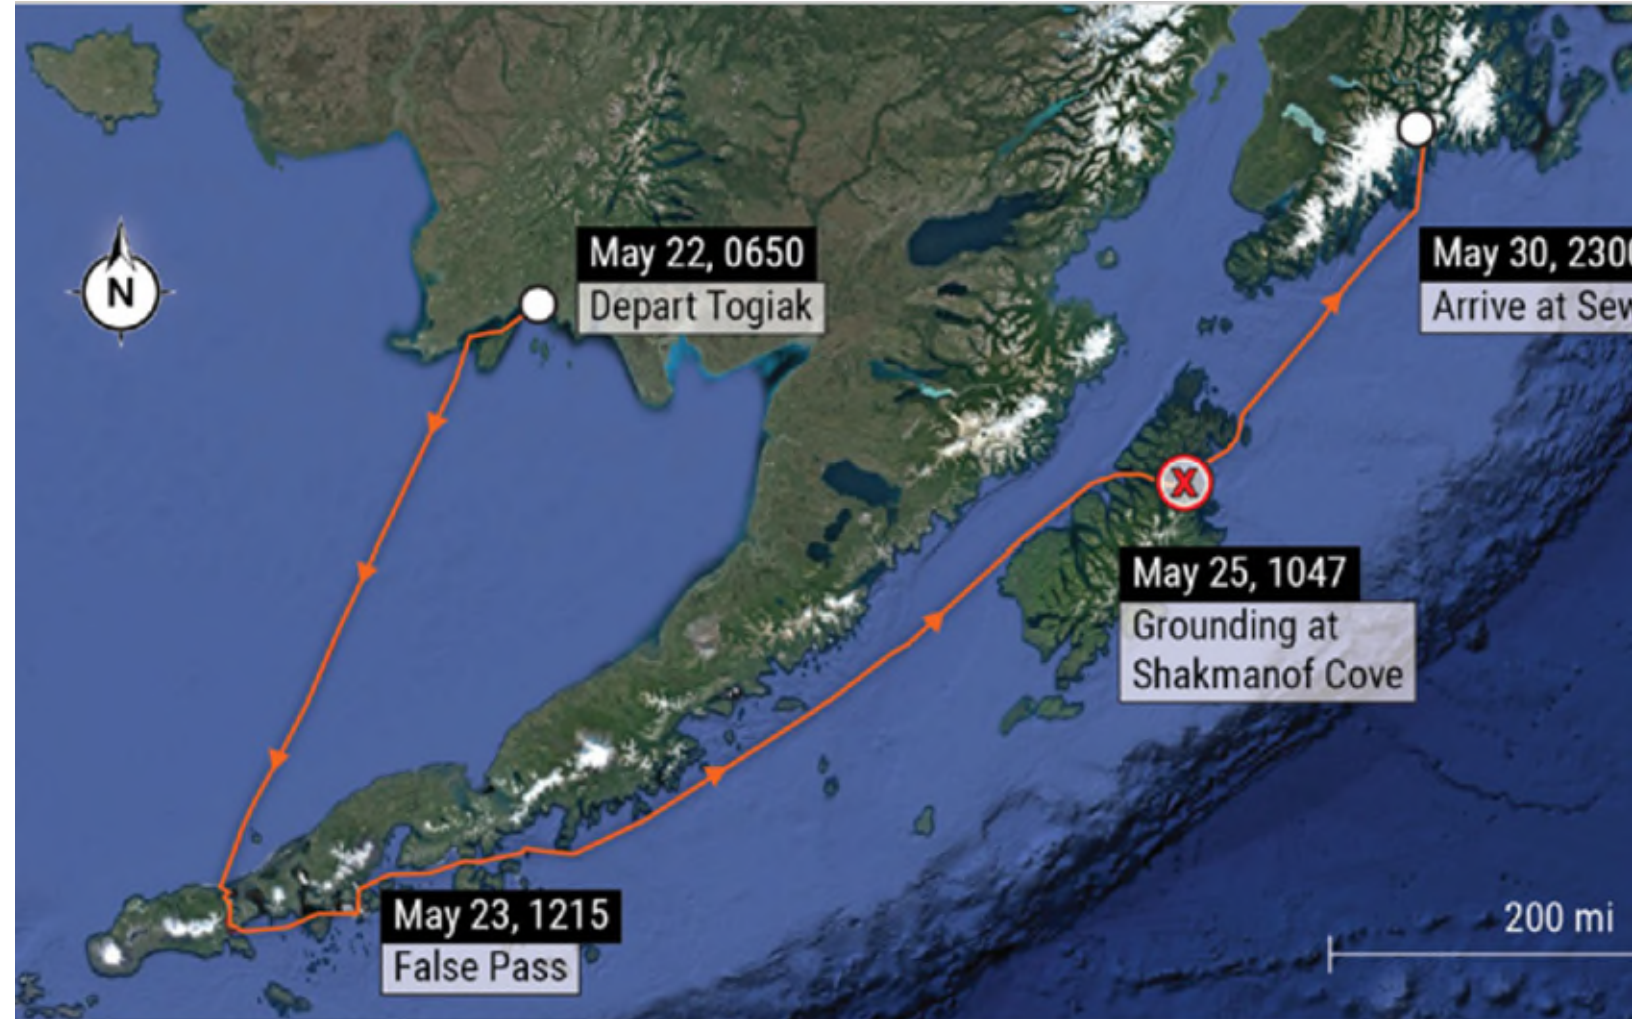
Approximate voyage trackline of the *Cingluku/Jungjuk*. BACKGROUND SOURCE: GOOGLE EARTH.

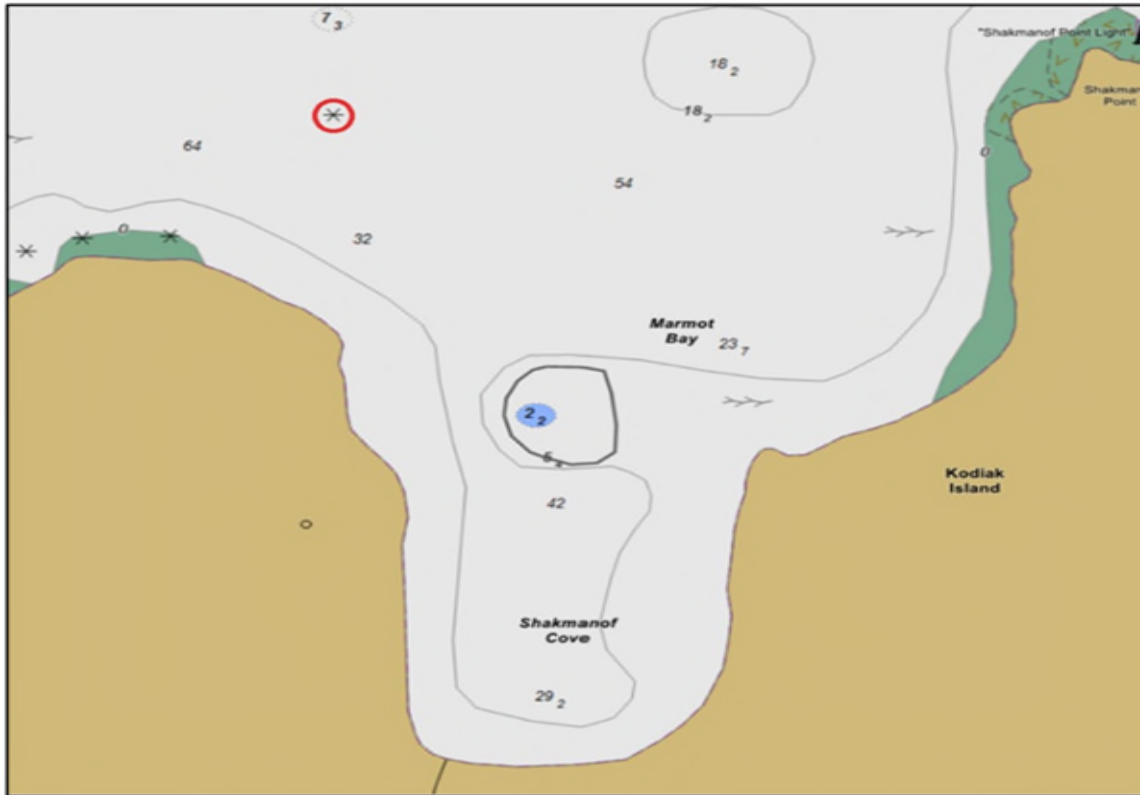
Figure 8. ENC US4AK5PM, for the area near Shakmanof Cove, as viewed by investigators using an equivalent ECS. The asterisk symbol for the rock in the area of the grounding is indicated by a red circle. (Background source:

- The Captain not identifying a rock that was indicated on the displayed electronic navigation chart when planning the vessel's route into Shakmanof Cove.
- Contributing cause was the Captain not using all available navigational resources, including the Coast Pilot and the grounding avoidance features of the electronic chart system, when planning the route.

- Owners and operators should ensure their crews are sufficiently trained in the use of their electronic chart system (ECS) and understand how to use the different functionalities of the ECS.
- Take advantage of ground avoidance features in your ECS
- Coast Pilot usage
 - provided knowledge that the rock would submerge during the tidal cycle
- [MIR2414 CORRECTED.pdf \(SECURED\)](#)

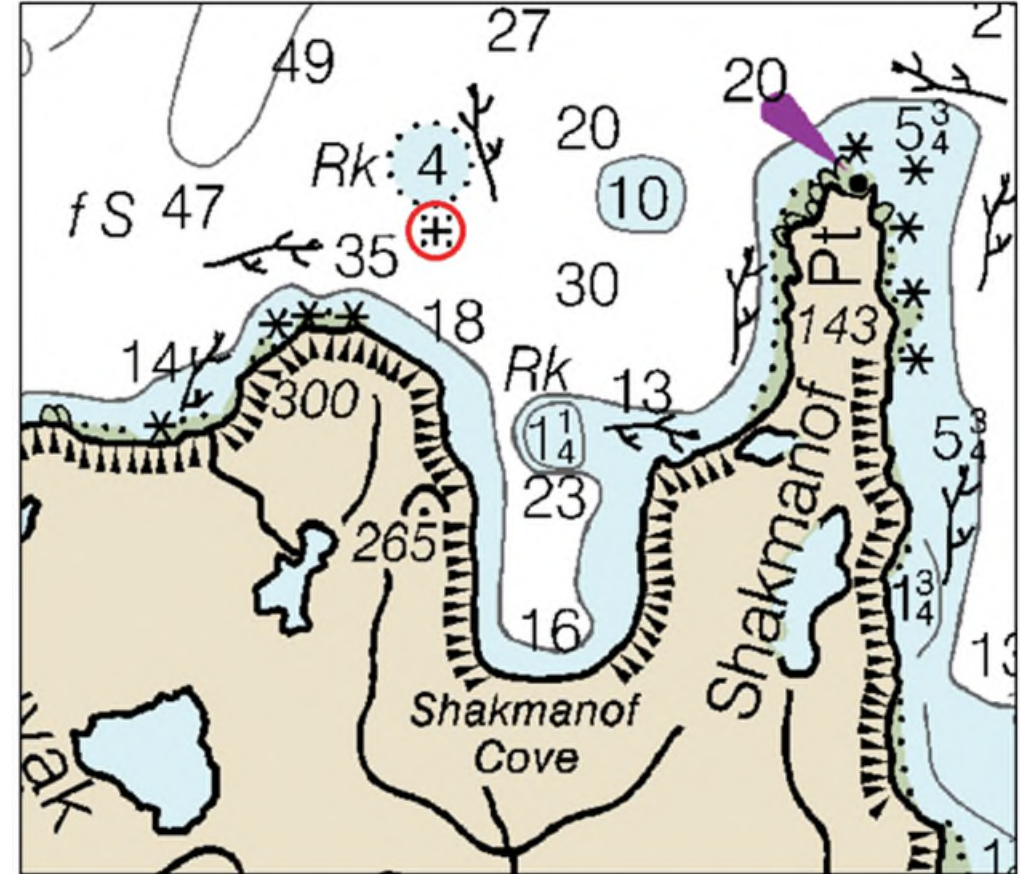
Figure 7. RNC for the area near Shakmanof Cove. The symbol for the rock in the area of the grounding is indicated by a red circle. (Background Source: NOAA Chart 16594, 14th Edition, January 2015)

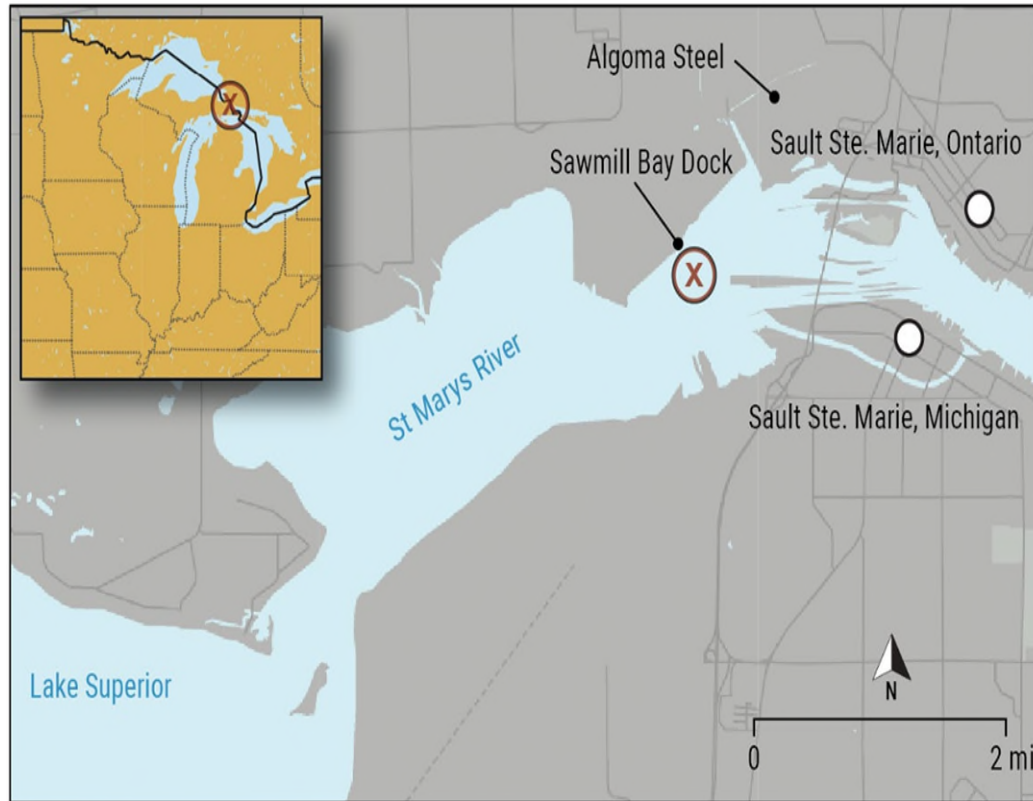
Figure 2. Area where the *American Mariner* grounded, as indicated by a circled X.

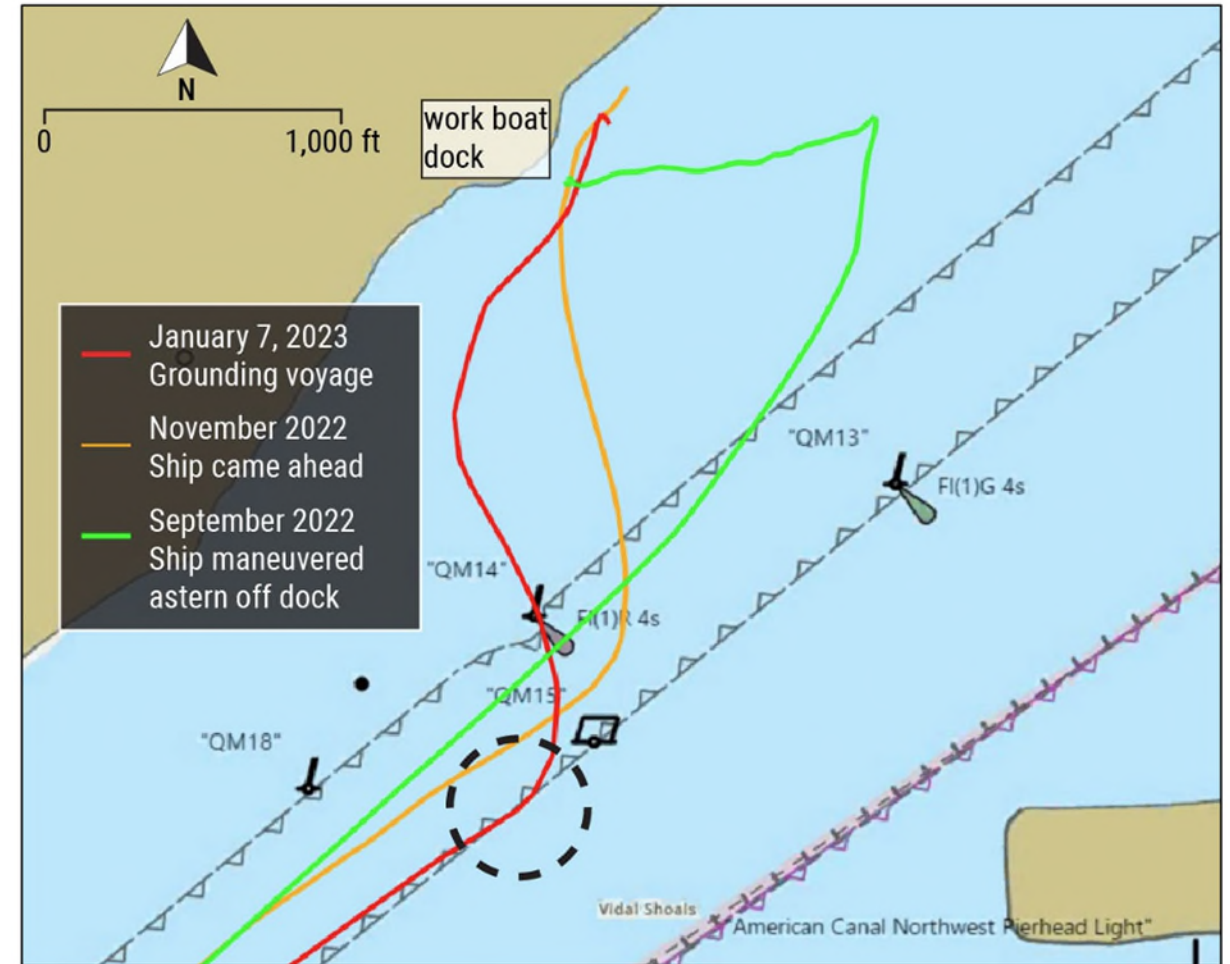
Figure 7. AIS tracklines of the *American Mariner* navigating into the channel from the facility. The area where the vessel's course took it near the edge of the channel is circled with dashes.

- The Master maneuvering the vessel away from the dock and into the channel while alone on the bridge, which required him to multitask (navigation, steering, and lookout duties) and resulted in the vessel overshooting the turn into the channel and running aground on the shoals on the opposite side of the channel.
- Do you see any Contributing causes?

- Owners, operators, and vessel masters are responsible for ensuring that bridge teams are staffed with enough certified mariners who are familiar with all bridge navigation equipment and able to independently take immediate action.
- Effective use of all available resources by a bridge team, including visual scanning, radars, electronic charts, and an automatic identification system, increases collective situational awareness and contributes to a safe navigation watch.
- [DCA23FM013.aspx](https://www.ntsb.gov/publications/industry/2013/01/20130101.asp)

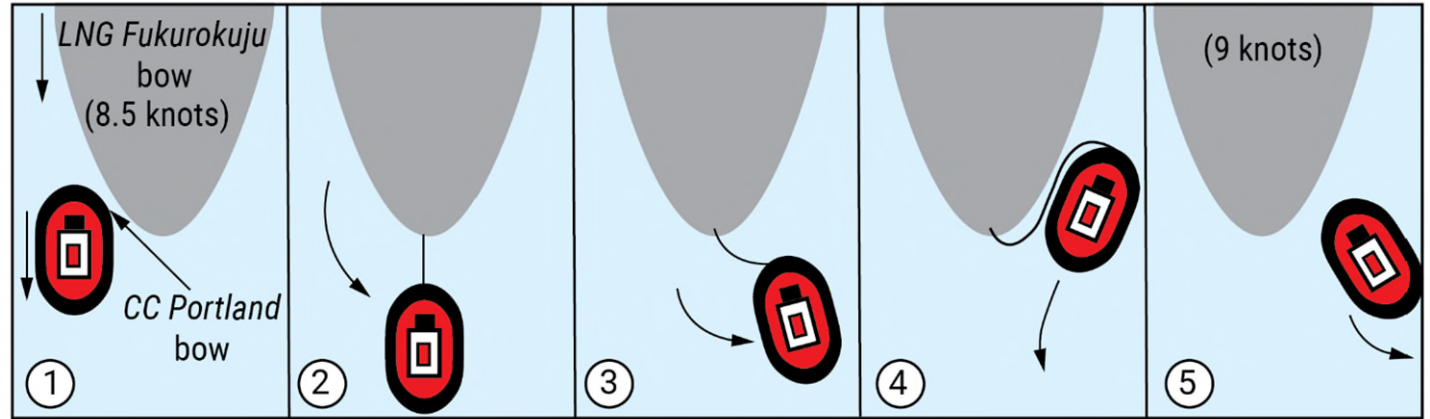
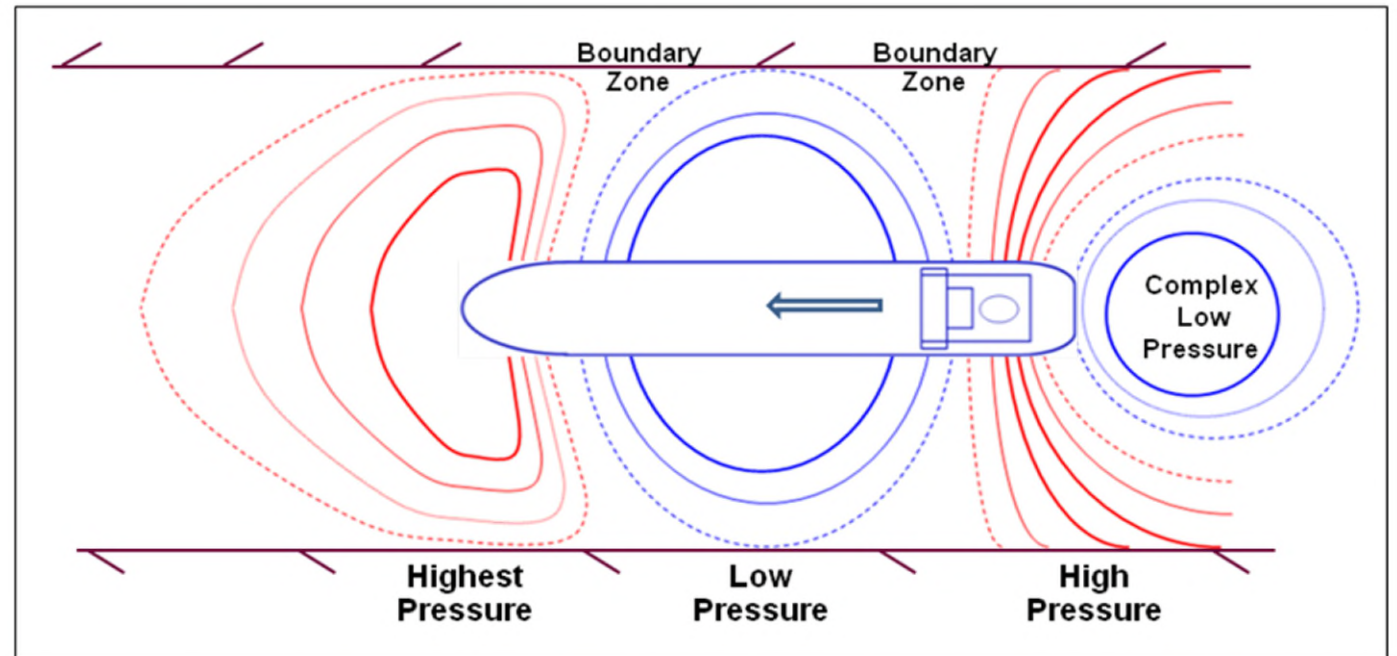
Figure 7. Ship-generated pressure fields for vessel navigation in enclosed/confined water.

- The Mate's attempt to make up bow to bow with the LNG carrier while the tugboat and liquefied natural gas carrier were transiting at an excessive speed for the advanced harbor-assist maneuver.
- Contributing cause: The lack of a Company policy regarding maximum allowable speed for bow assist maneuvers.

- Owners and operators of ASD tugboats that perform bow-to-bow harbor-assist operations should set speed limits for these maneuvers. These limits may vary for different classes of tugboats based on design.
- Tugboat operators should communicate these pre-determined speed limits to pilots and ship masters in command of the vessels that they are assisting before engaging in these maneuvers.
- [NTSB: Accident Brief: The Grounding of Tugboat CC Portland - Marine Construction Magazine](#)

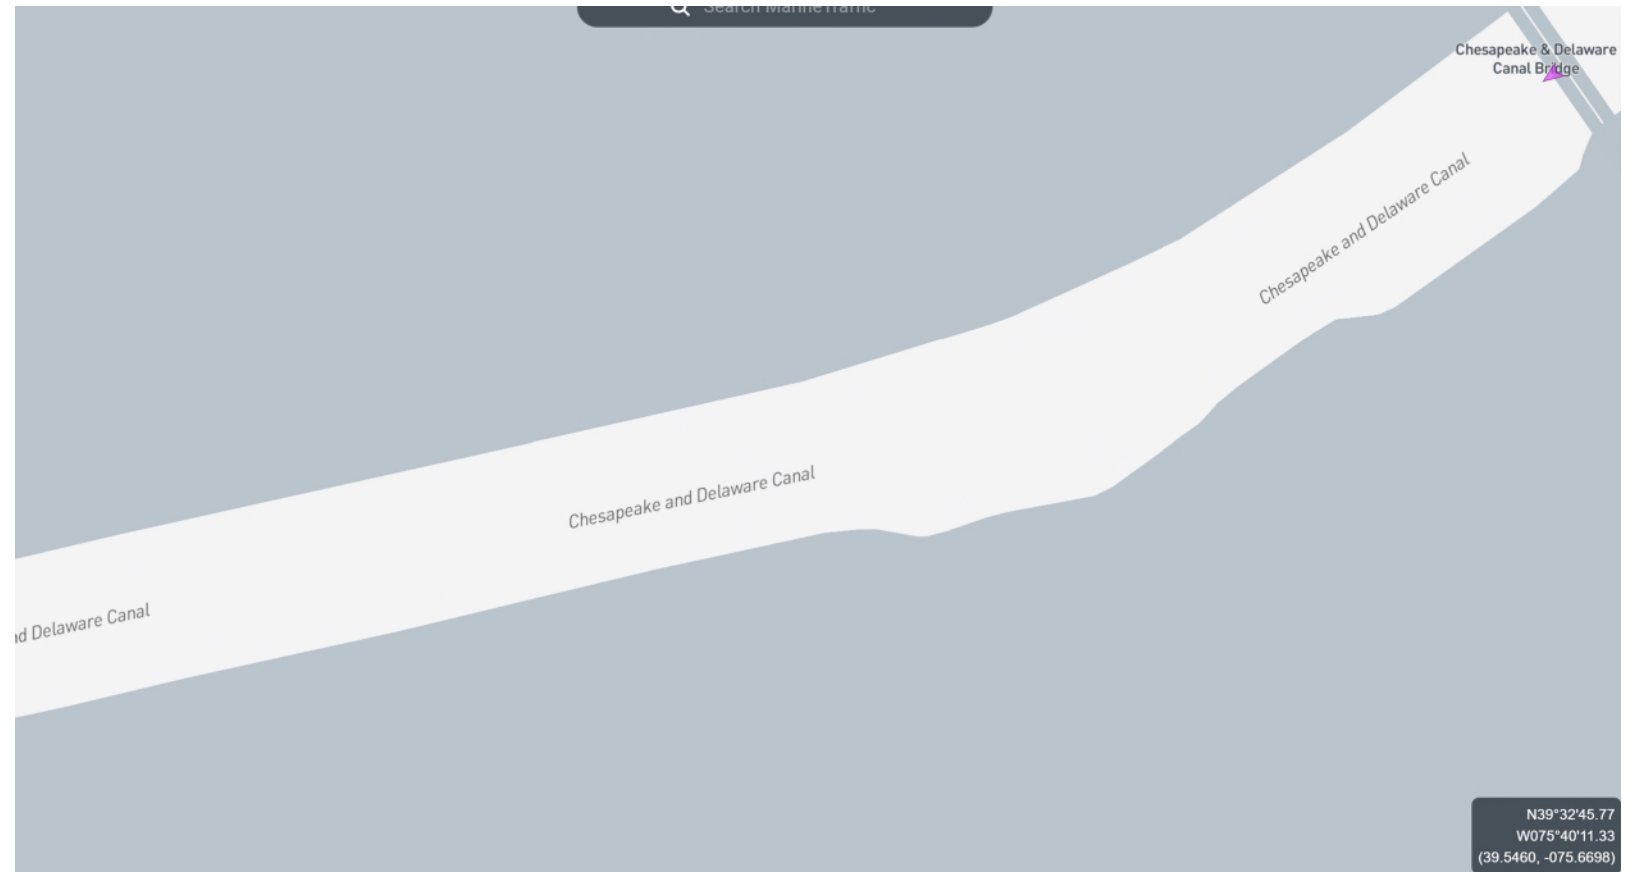
- It is nighttime, Mate and deckhand (steering) on watch
- Mate inadvertently trips 24V circuit breaker with knee, causing multiple alarms
- Ultimately required turning on houselights to find breaker
- Boat veered left in the process; Mate reacted, slowed and redirected vessel , but grounded on northern bank

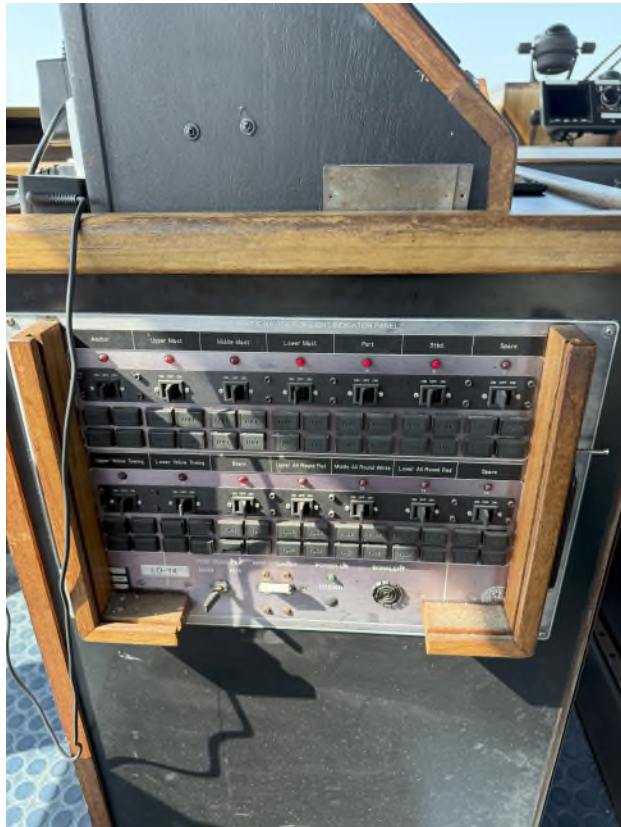
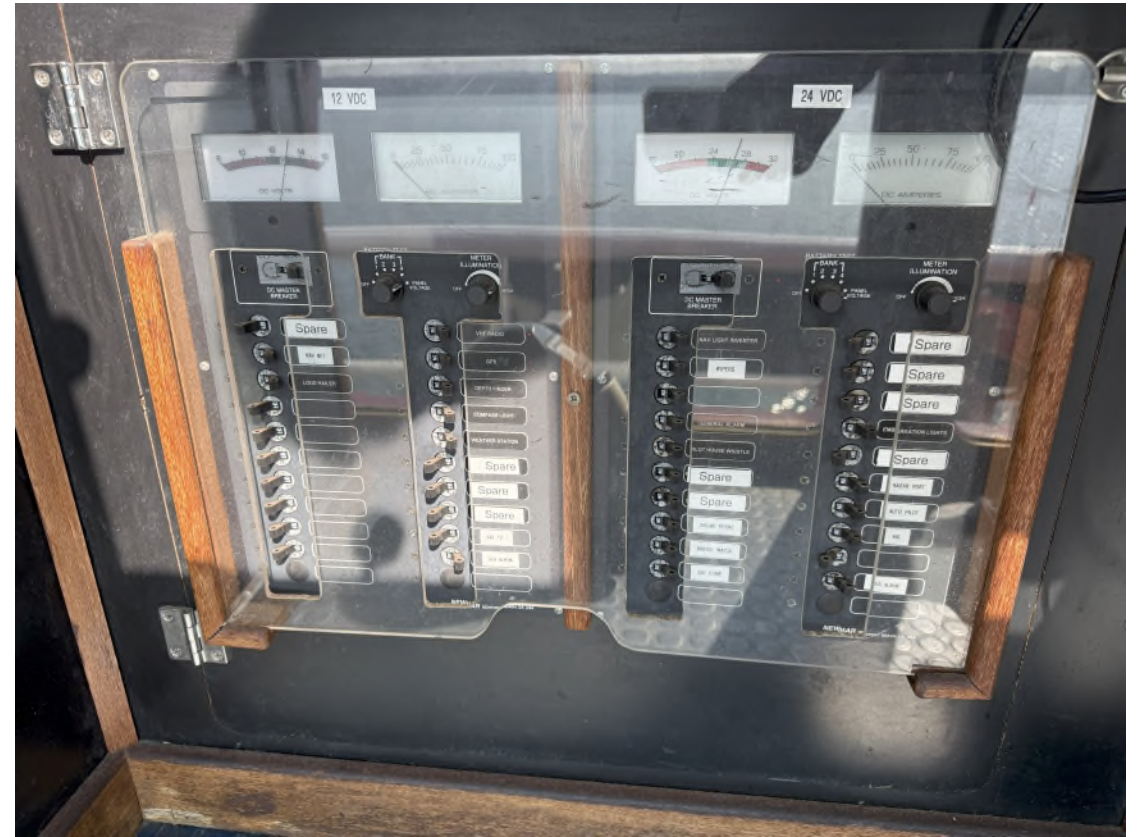
- Physical proximity –
 - Distractions?
 - Availability of a flashlight?
 - Engineering Controls?
