The Vane Brothers Company

Damage Control Standardization

AWO Safety

22 Feb 2024

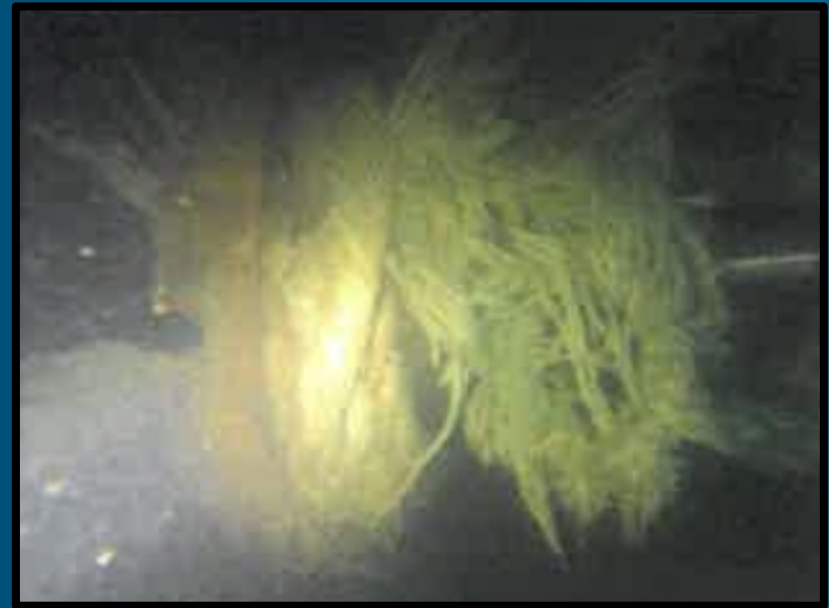
- The shaft broke 14 inches forward of the aft bulkhead and slid aft, resulting in flooding.
- Dive reports and photos revealed a large diameter hawser line was entangled in the propeller and shaft.

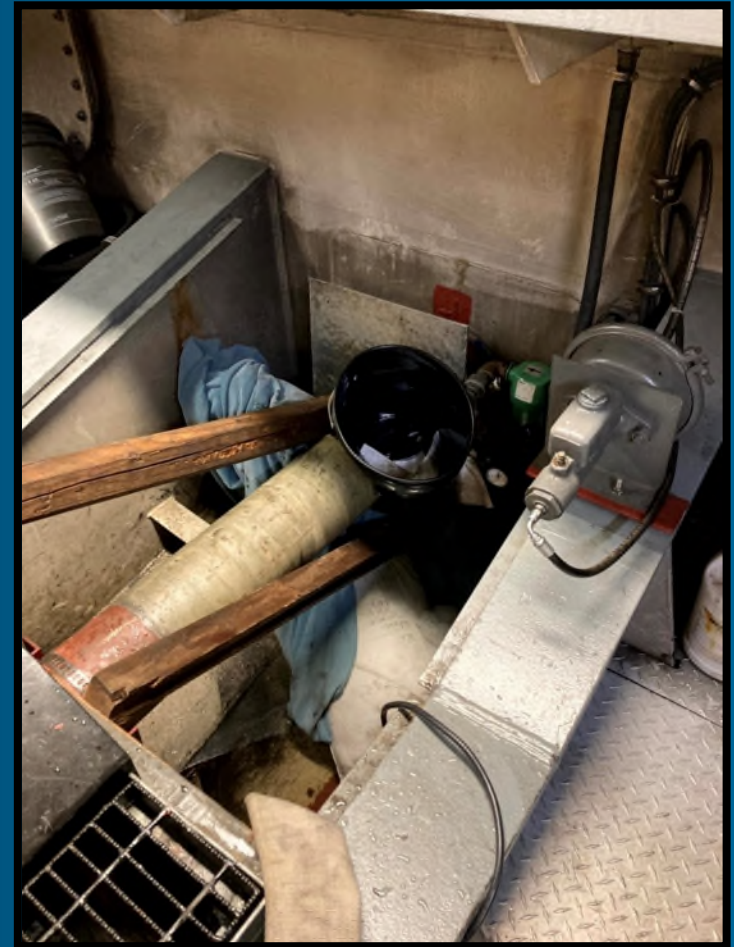
- Multiple vessels responded immediately to assist with damage control, dewatering, and safe transport efforts.
- The crew utilized onboard equipment as well as damage control equipment from assisting vessels.
- Assisting vessel crewmembers were instrumental in mitigating water ingress.

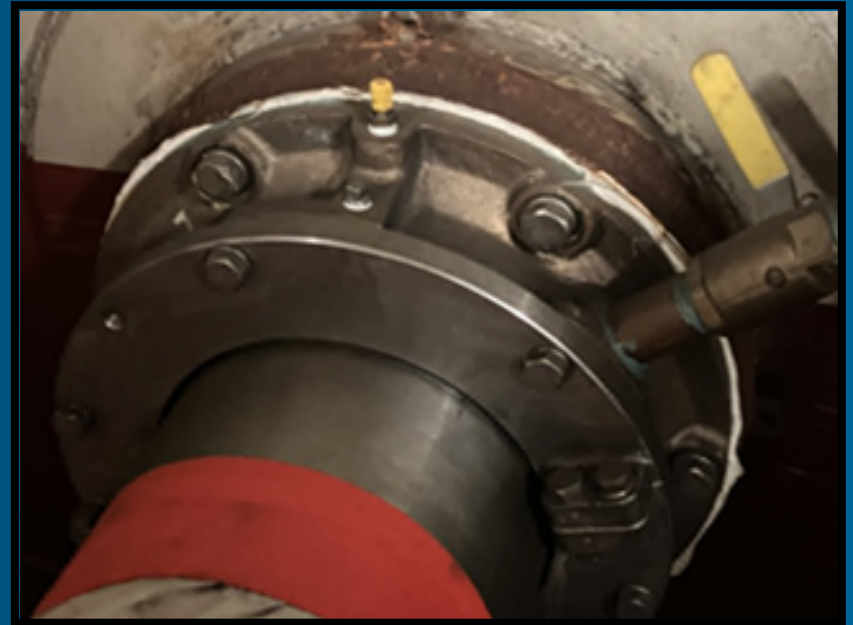
Dripless shaft seals are equipped with inflation bladders to allow for maintenance and repair of the system. This bladder also can seal the area in an emergency.

Are the service air tools and hand pump available and are inflation procedures understood by all?

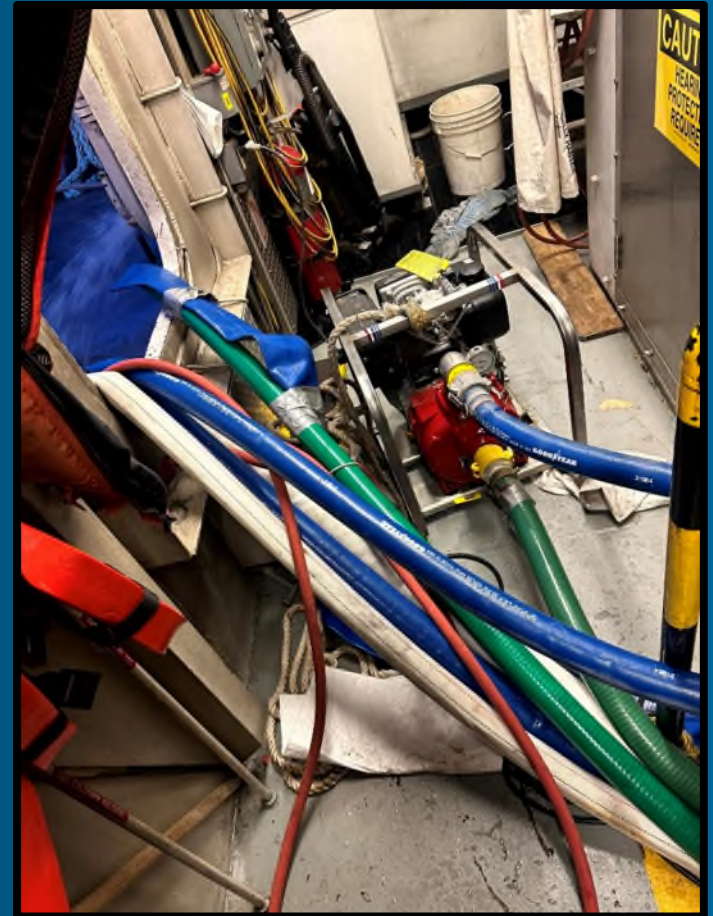
Portable dewatering equipment was readily available and deployed quickly.

- Other vessels' dewatering fittings were incompatible with incident vessels.
- Some of the hoses did not reach the lower bilges.

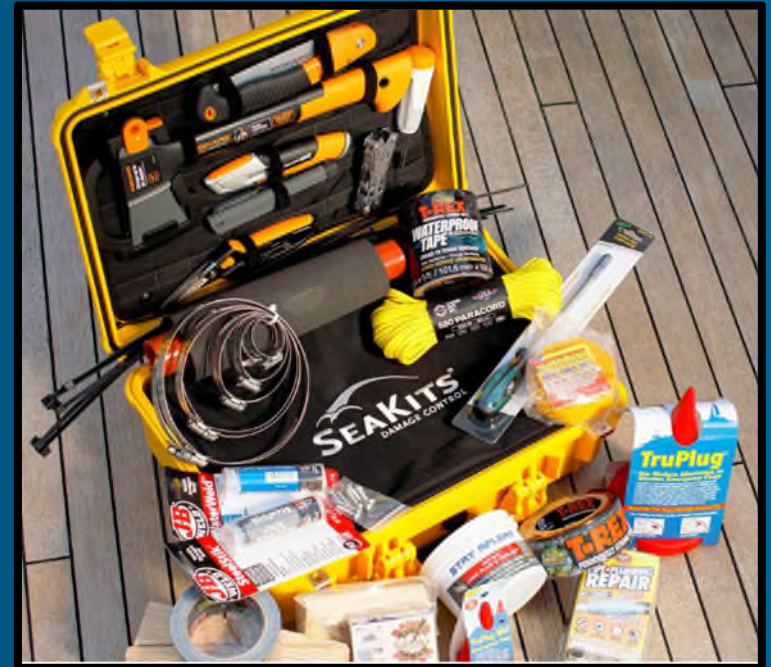
Damage control equipment inventories were standardized upon outfitting.

Each vessel crew added more equipment based on their experiences and industry knowledge.
