Baydelta Maritime

AWO Summer Safety Forum 2025

Environmental Incident

1 Spill to Water

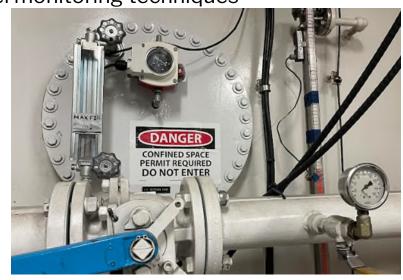
Magnetic
Liquid Level Indicator

Fuel tank level gauge issue

Magnetic level indicator flags lagging behind actual fuel level.

Fuel level rise triggers magnetic flags on gauge to turn red

- Advise fleet regarding lagging fuel gauge reading.
- More explicit fuel transfer procedures
 - Added requirement for additional level monitoring techniques
- Provided Training
 - Lessons learned from this incident
 - Procedure changes
- Added short sightglass and an old school alarm switch on a tank hatch as verification for gauge reliability
