From Safety Equipment to Safety Hazard

Investigating a Life Raft Related LTI in Marine Operations

The American Waterways Operators

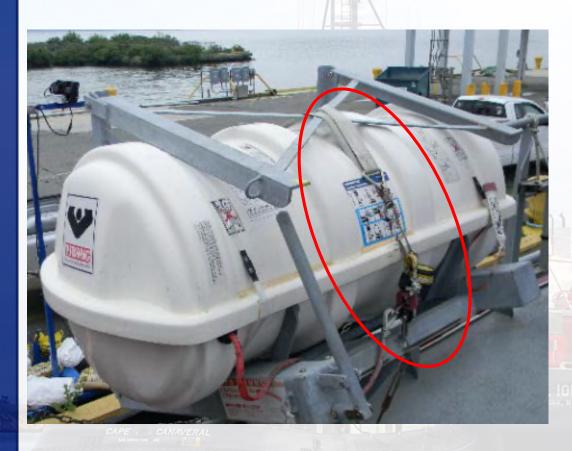
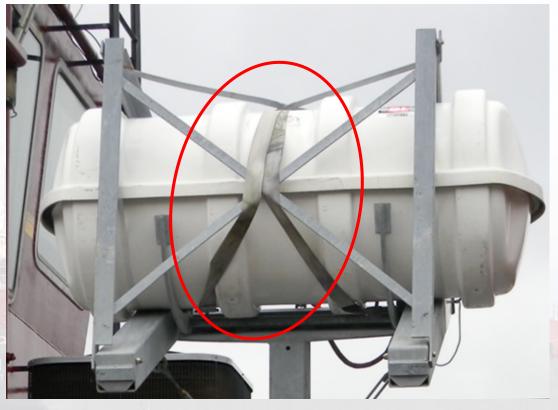
A CLOSER LOOK

- Crewmember tasked with preparing liferaft to be picked with crane.
- Crewmember to rig 2 slings on both ends of liferaft canister, connected to hook.
- While releasing the pelican hook, drop-down mechanism deployed.
- Liferaft released from cradle and slid off the vessel to the drydock floor.
- Crewmember attempted to stop liferaft from sliding resulting in a hurt shoulder.

(Photos provided by an uninvolved company with similar equipment)

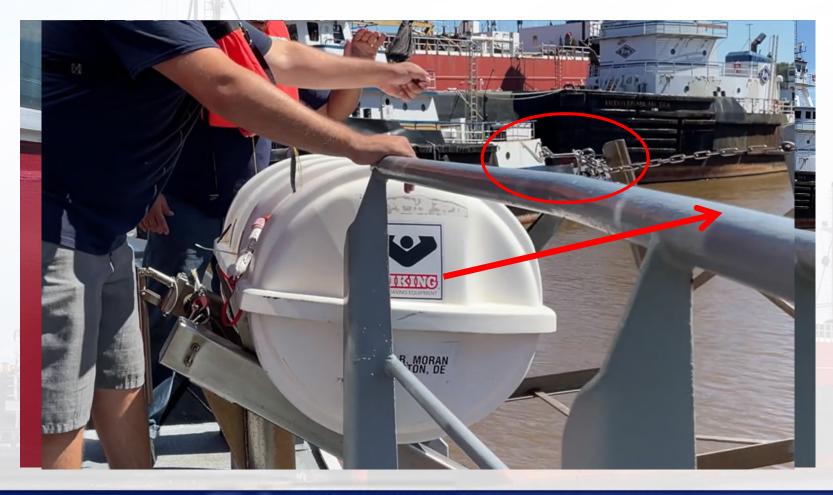
A CLOSER LOOK

(Video provided by an uninvolved company with similar equipment)

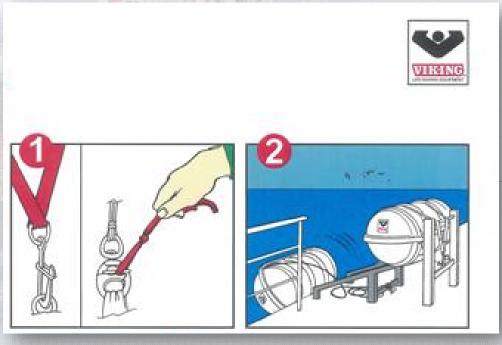
- Created a task-specific Risk Assessment template
- PMS Job Description includes hazard warnings and Risk Analysis requirement.
- 3. Added Signage near the liferaft
