NATIONAL TRANSPORTATION SAFETY BOARD

SAFER SEAS Digest

Lessons Learned from
Marine Investigations

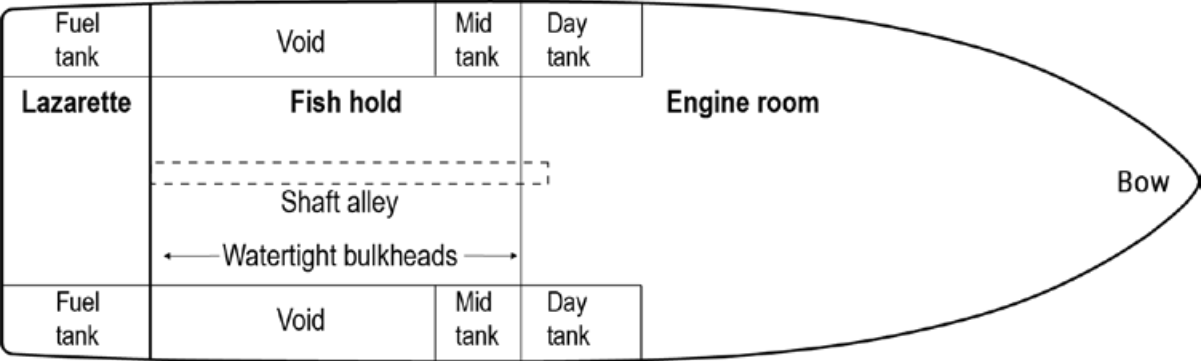
wind, waves, or turning would have likely induced a sustained list as the fuel in the tanks would have flowed to the low (port) side of the vessel. The combination of the weight of floodwater increasing the vessel’s draft, the free surface effect from the slack tanks, and the free surface created by flooding of the port void or lazarette decreased the vessel’s remaining stability, resulting in capsizing.

THE PROBABLE CAUSE of the capsizing and sinking of fishing vessel *Hotspur* was flooding from an unknown source into the lazarette or the port void space, causing the vessel to lose stability, capsize, and sink.

Layout of *Hotspur* lower level, based on owner’s drawing (not to scale).

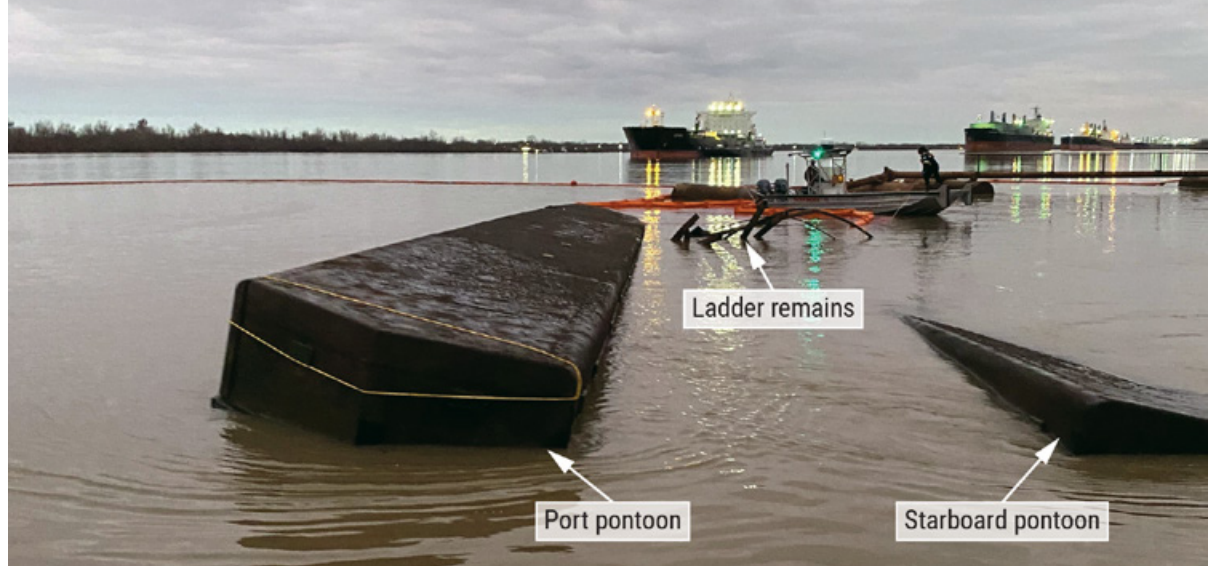
The overturned hull of the *WB Wood* with its pontoons downside up, the morning after the capsizing.

Postrecovery, a 2-inch through-hull pipe into the starboard storage space was found to be open, as its overboard check valve was missing and likely had been since before the casualty. The center of the through-hull pipe was about 5 inches above the dredge's normal waterline, so waves, a list to starboard, and/or an increase in stern trim could have submerged

Investigators found wastage holes along the bottom 10 inches of the transverse forward bulkhead of the starboard aft void. If the adjacent starboard storage space flooded first, the water level in the starboard aft void would eventually increase from communication with the storage space. Additionally, investigators found that the 2-inch through-hull pipe with the missing valve ran transversely along the overhead from the storage space and through the bulkhead into the service water room—where it was uncapped. Therefore, once the storage space filled with water, it would have begun flooding the service water room. The only

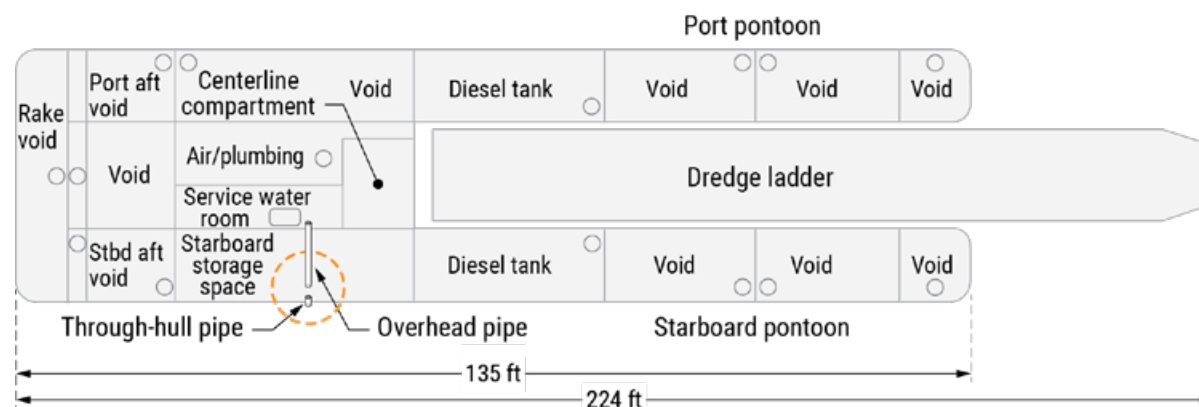
space fitted with a bilge alarm was the service water room, but the alarm did not activate until just before the dredge rolled over, indicating the room was not the initial compartment to flood. Therefore, progressive flooding through compromised watertight bulkheads occurred, which, combined with the initial flooding, resulted in the capsizing.

Approximate plan view of the *WB Wood*'s hull below the main deck (not to scale). Hatches on the main deck are depicted as circles.

Vessel crews should regularly check tanks and voids that are adjacent to the vessel's hull to identify hull integrity issues (such as potential corrosion and steel wastage, and watertight integrity deficiencies) that can lead to flooding. The presence of water can indicate an issue with watertight integrity or wastage and should be addressed. Vessel operators should ensure crews have procedures for anticipating, preventing, and addressing the potential for water ingress and flooding, including establishing scheduled checks. Bilge alarms set to detect water at a low level in voids and other spaces are another means to ensure early detection.

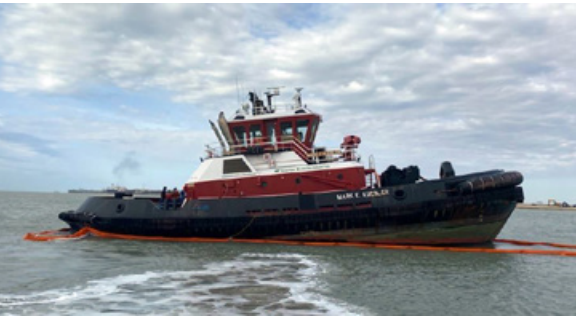
Mark E Kuebler aground following the collision.
SOURCE: G&H TOWING.

In the collision, the *Nisalah's* propeller struck the *Mark E Kuebler*, resulting in multiple gashes in the *Mark E Kuebler's* hull at the stern, along with hull warping and damage to the vessel's fendering system. The tugboat's aft peak tank and Z-drive machinery room were breached, flooding both spaces to the waterline and inundating equipment. All four blades on the *Nisalah's* propeller sustained damage when it struck the *Mark E Kuebler's* hull.

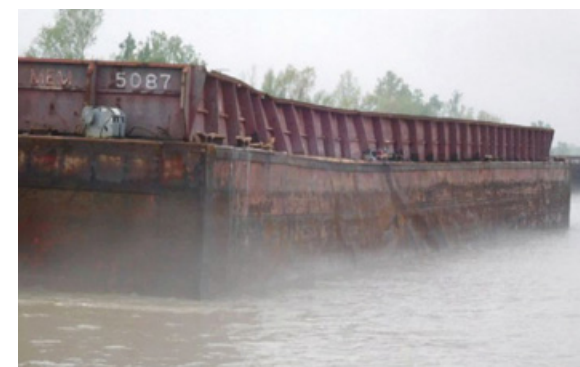
The damaged barge *MEM 5087*.

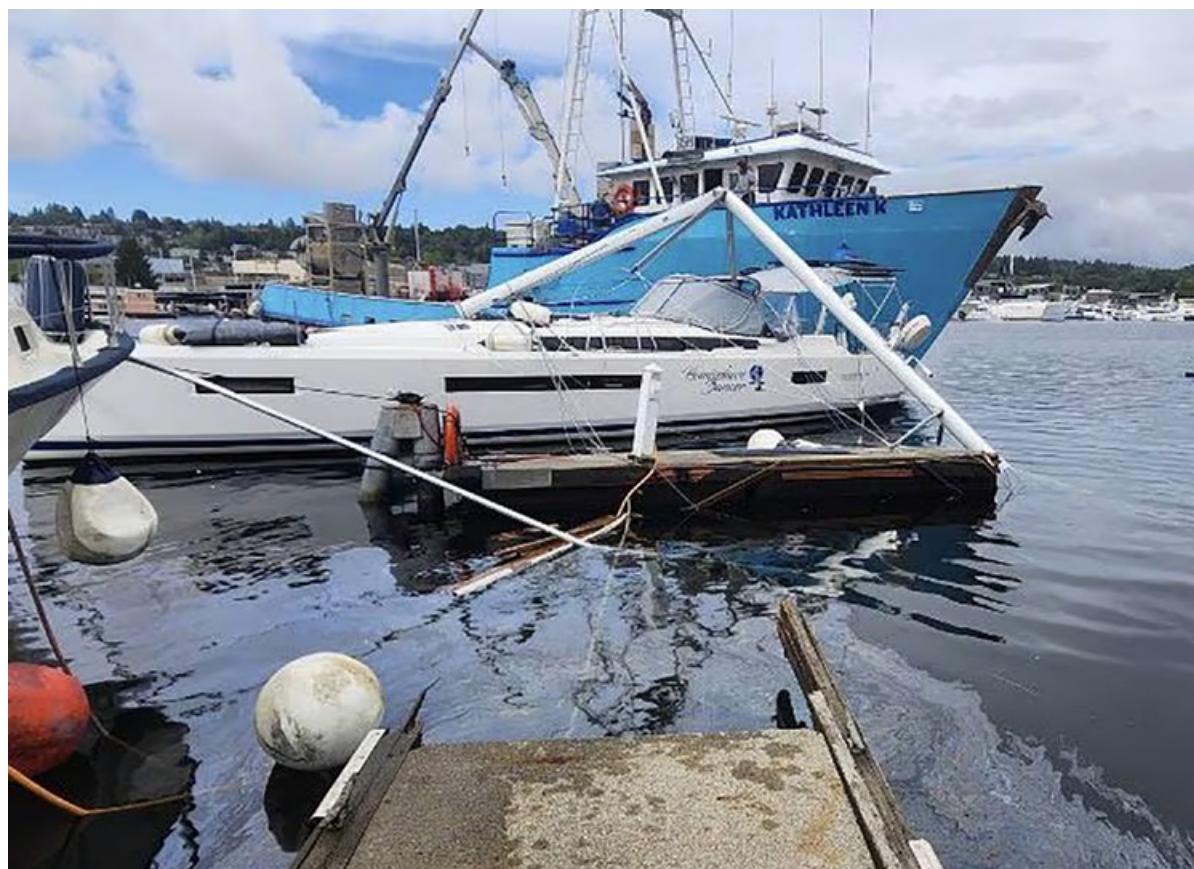
The Kathleen K, a damaged sailing vessel, and a damaged dock following the collision. SOURCE: COAST GUARD.

While the captain was in the engine room, the *Kathleen K* had moved toward docks (occupied by recreational sail and motor vessels) at a boatyard across the bay. The *Kathleen K*'s bow subsequently struck a vessel moored at one of the floating docks, struck another vessel moored at a second floating dock, and pushed that vessel into another vessel moored at a third dock. The *Kathleen K* then struck the second floating dock, severing a section of the dock and damaging several other moored vessels. In total, nine moored vessels were damaged.

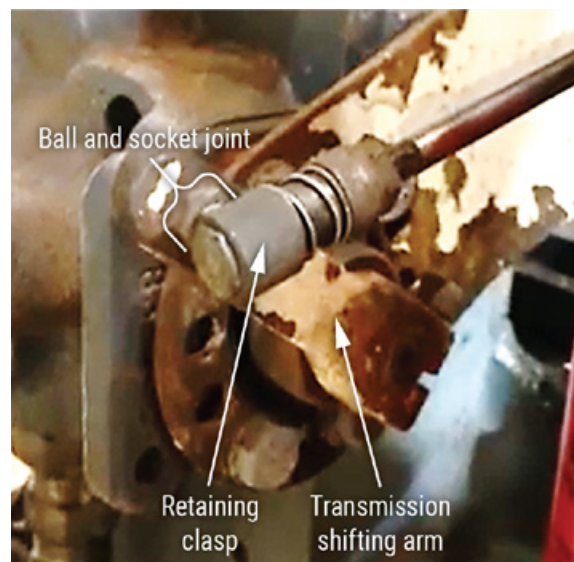
had conducted maintenance on the vessel's main propulsion systems. During the maintenance, he had disconnected both engines' transmission linkages at the ball and socket joints, which connected the mechanical linkages to the shifting levers on the transmissions. Each ball on the joint was held in place in the socket with a spring-loaded clasp. The captain reconnected the joints when the maintenance was completed; however, he stated that the ball for the port transmission linkage joint may not have been fully seated in the socket when it was reconnected, even though it would have appeared to be seated correctly. A postcasualty examination found no material discrepancies with the transmission linkage, including the ball and socket joint. Therefore, disconnection of the port transmission linkage at the ball and socket joint was most likely due to the ball not being fully seated in the socket when the joint was reconnected after maintenance.

***Kathleen K* transmission mechanical linkage at ball and socket joint.** SOURCE: COAST GUARD.

THE PROBABLE CAUSE of the collision of the fishing vessel *Kathleen K* with recreational vessels moored at a marina was the loss of directional control to one of the *Kathleen K*'s propulsion engines due to the disconnection of its transmission linkage, likely because the linkage's ball and socket joint was not fully reconnected after maintenance.

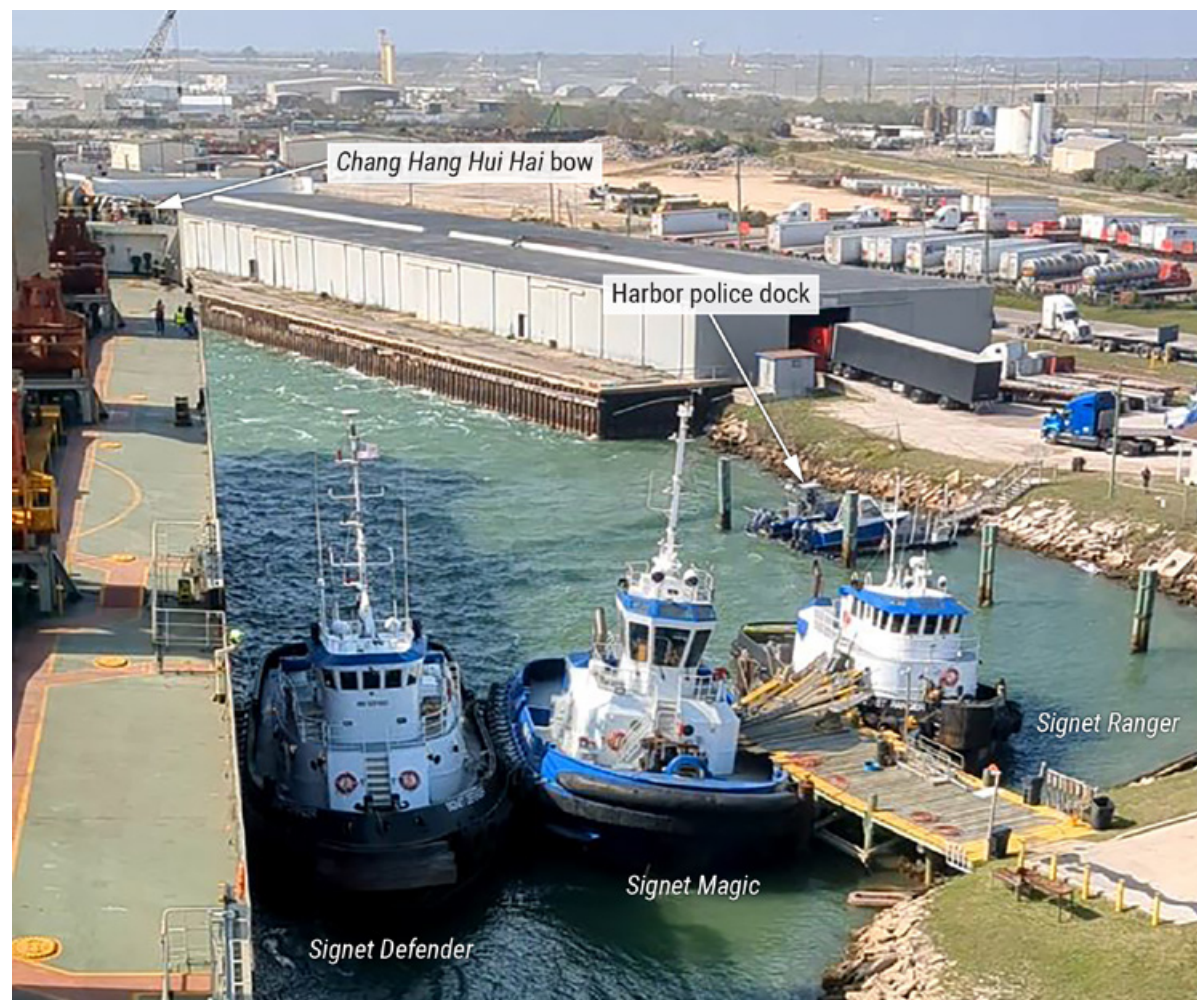
Chang Hang Hui Hai colliding with the tugboat Signet Defender. BACKGROUND SOURCE: COAST GUARD.

THE PROBABLE CAUSE of the breakaway of the dry bulk carrier *Chang Hang Hui Hai* from a dock and subsequent collision with the tugboat *Signet Defender* was the force of the wind acting on the exposed freeboard of the *Chang Hang Hui Hai*, which overcame the breaking strength of several mooring lines.

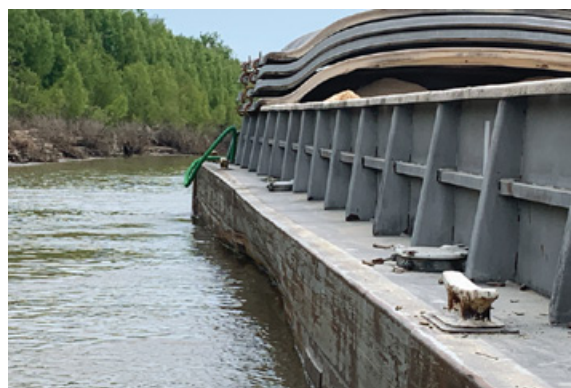
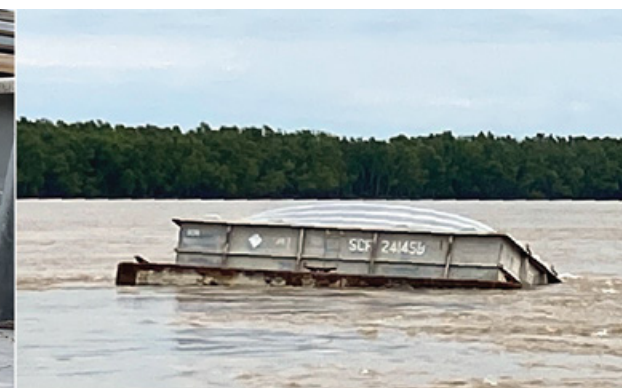
Left to right: Hull indentation on barge SCF14119B and partly sunk barge SCF24145B. SOURCE (RIGHT): COAST GUARD.

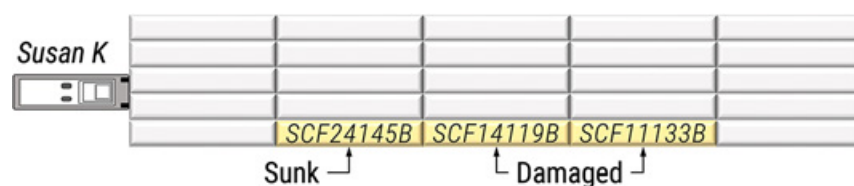
Susan K tow arrangement and barges damaged or sunk in the casualty.

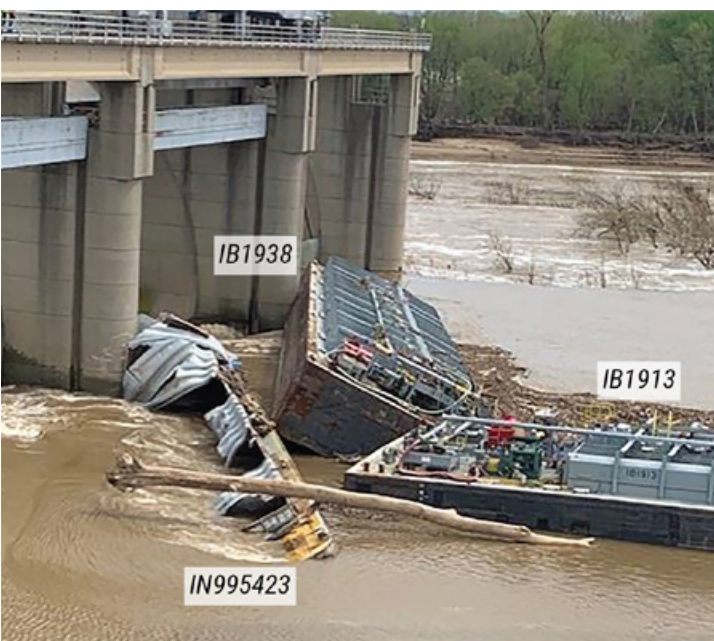
About 0224, the tow struck the vane dike mooring cell. The tow broke apart after the contact; six barges went through the lower dam gates, and three were pinned against the gates.

Barges IN995423 and IB1938 against the lower dam gates. IB1913 is receiving methanol from IB1938 through a cargo transfer hose.

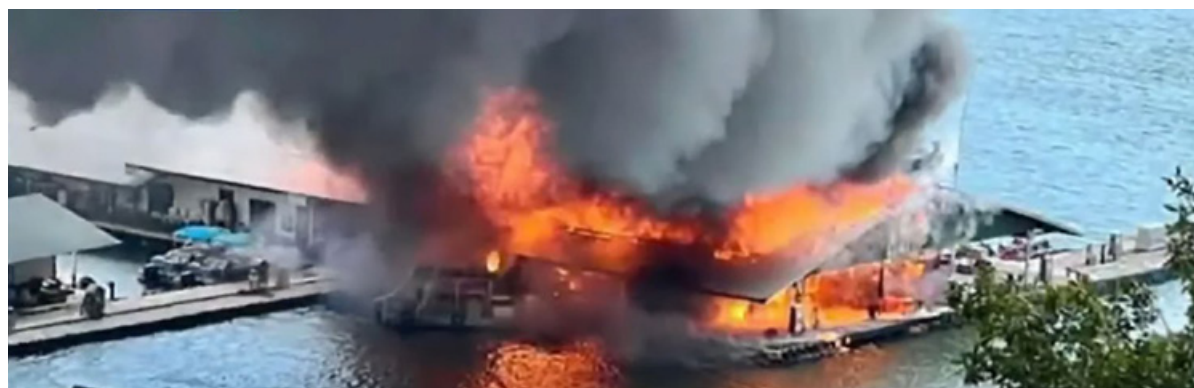
The contact dislodged the gas dispenser, and the fuel line broke, exposing wiring and spraying gasoline from the line onto a bait tank and ice machines powered by electric motors. The marina's general manager pushed the emergency stop for the fuel pump and attempted to close the dispenser's fuel shutoff valve (under the dispenser and above the dock) to stop the flow of fuel from the damaged fuel line. However, before he could close the valve, a fire began, igniting his clothing. With the presence of the exposed wiring and electric motors within the fuel spray's radius, it is likely that an electrical arc ignited gasoline vapors. The marina manager was later transported to a hospital where it was determined that he incurred second- and third-degree burns.

The marina store was destroyed. Three rental pontoon boats tied up on the west side of the marina store incurred damage to their seats and deck carpeting from the heat of the fire. The *Flagship 604* was not damaged.

THE PROBABLE CAUSE of the contact and subsequent fire at the Sunset Marina was a houseboat's "duckbill" bow striking a gasoline fuel dispenser (pump) when docking in windy conditions, which caused an undetermined electrical source on the dock to ignite vapors from the broken gasoline fuel line. Contributing to the contact was the proximity of the gas pump to the dock edge.

Sunset Marina fuel dock and store on fire after the contact. SOURCE: WIRED2FISH.COM.

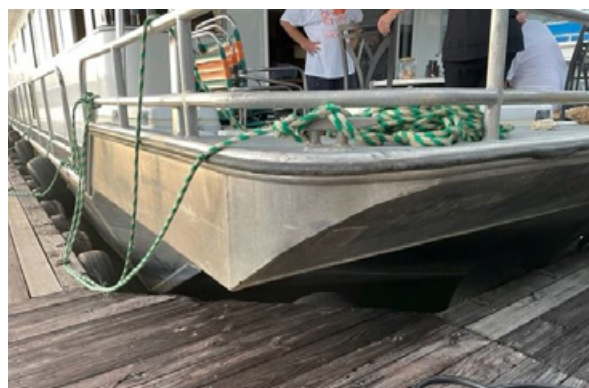
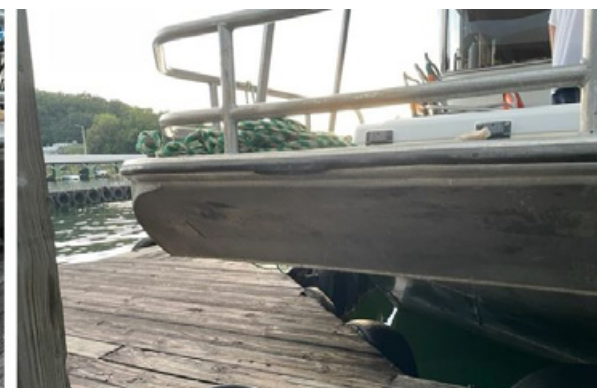
The gas dispenser was set back 5 feet from the dock face to meet the standard for protecting fuel pipes against physical damage arising from impact for marina fuel docks as required by the Tennessee Fire Code. The setback was intended to prevent contact with the gas dispenser by boats with standard bow designs coming alongside the dock. However, in this casualty, the dock’s height and houseboat deck’s overhang dimensions (above the water and from the bow stem) allowed the houseboat’s duckbill bow to freely move over the fueling

Below: The *Flagship 604*'s duckbill bow extended over the dock.

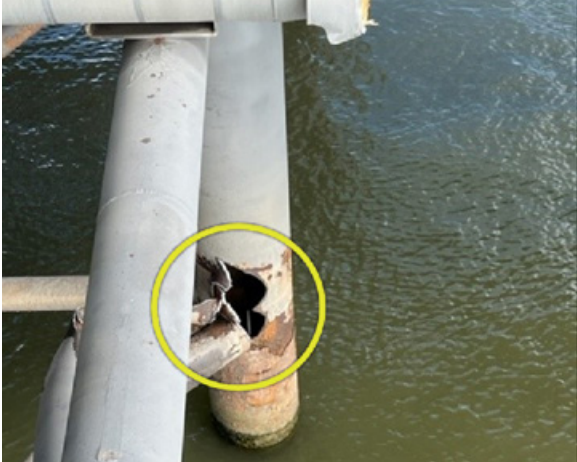
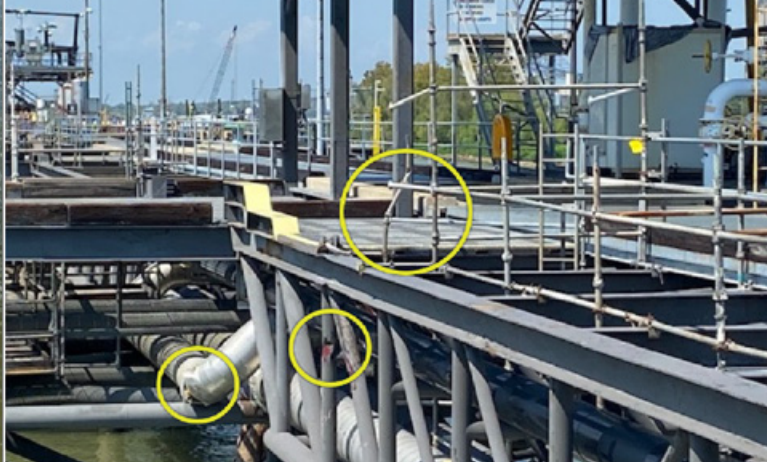
Damage to pier (circled). Left to right: A vertical piling. Insulated pipe, pier support bracings, and railing.

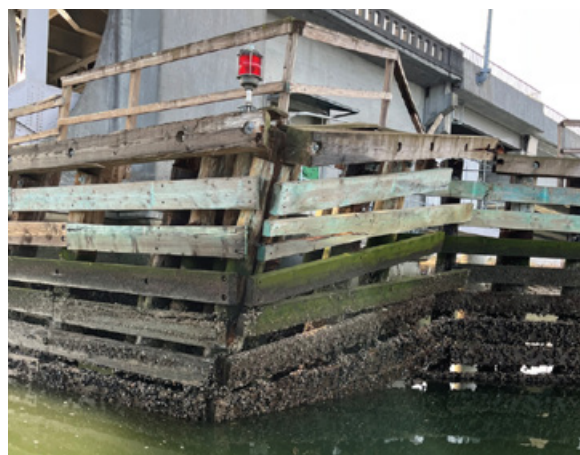
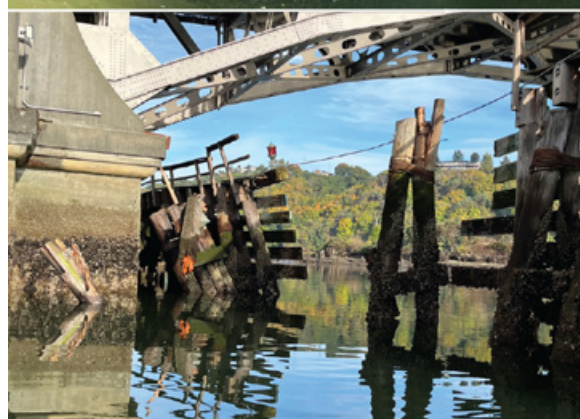
Damage to Hylebos Bridge fender system.

From top: Displaced center section and damaged dolphin. Broken and missing timber facing boards on eastern and center sections. SOURCE: COAST GUARD.

The bridge was undamaged during the casualty, but the fender was catastrophically damaged. Precasualty inspections of the bridge's fenders in 2017 and 2022 noted significant deterioration of the fender piles from marine borer damage and fungal decay. A postcasualty inspection found similar damage. It is

notable that the entire fender sustained catastrophic damage when the *Olympic Scout* struck it at one end (at an angle—not directly), yet the tugboat sustained almost no damage. The Hylebos Bridge fender system prevented damage to the bridge structure by the *Olympic Scout*; however, the system's degraded condition contributed to its extensive damage.

THE PROBABLE CAUSE of the contact of the assist tugboat *Olympic Scout* with the Hylebos Bridge fender was the captain of the ATB *Montlake/Sodo* not stopping or slowing the ATB's forward motion to correct the ATB's lineup before attempting the bridge transit. Contributing to the severity of damage to the bridge's fender system was the system's deteriorated condition.

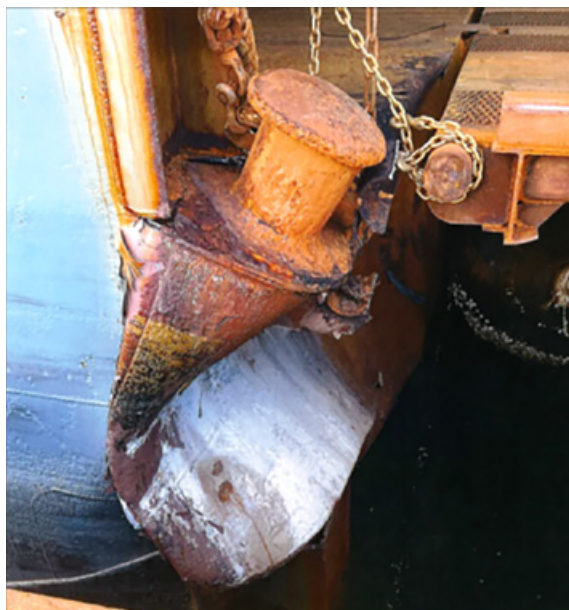
Due to the height of the barge, the captain of the *Brooklyn McAllister* was not able to see the Army Terminal Pier from where his tug was positioned at the barge's starboard quarter. According to the docking pilot, he first instructed the *Brooklyn McAllister's* captain to keep the barge's stern clear of the *Axios*. However, he then gave instructions intended to move the barge's stern away from the Army Terminal Pier so that the barge would clear the corner of the dock while entering the slip, given a light breeze on the starboard beam. The *Brooklyn McAllister* captain later stated that he had heard the docking pilot's instructions as "ahead and to starboard." The docking pilot stated that he requested and received confirmation that the captain was carrying out his instructions. However, the captain of the *Brooklyn McAllister* maneuvered his vessel in a way that pushed the port quarter of the barge toward the pier, contrary to the docking pilot's intention. The miscommunication resulted in the barge contacting the pier.

THE PROBABLE CAUSE of the contact of the barge *San Juan-JAX Bridge* with the Army Terminal Pier was miscommunication between the docking pilot and an assist tug captain while docking the barge.

***San Juan-JAX Bridge's* damaged port quarter.**

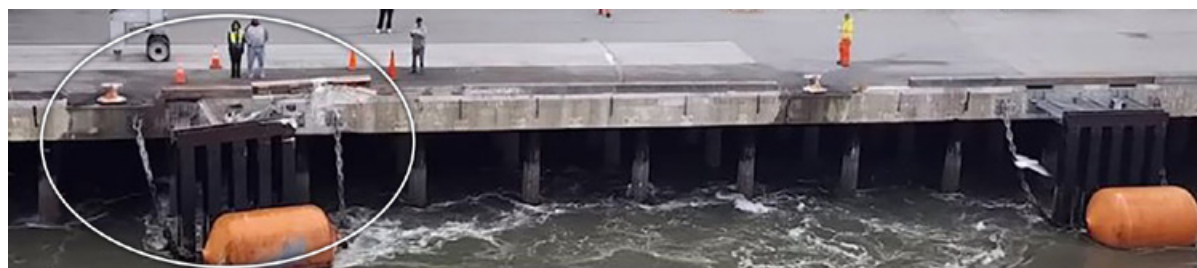
Pier 27 damage (circled). BACKGROUND SOURCE: KRON4.

Pier 27 damage. BACKGROUND SOURCE: COAST GUARD.

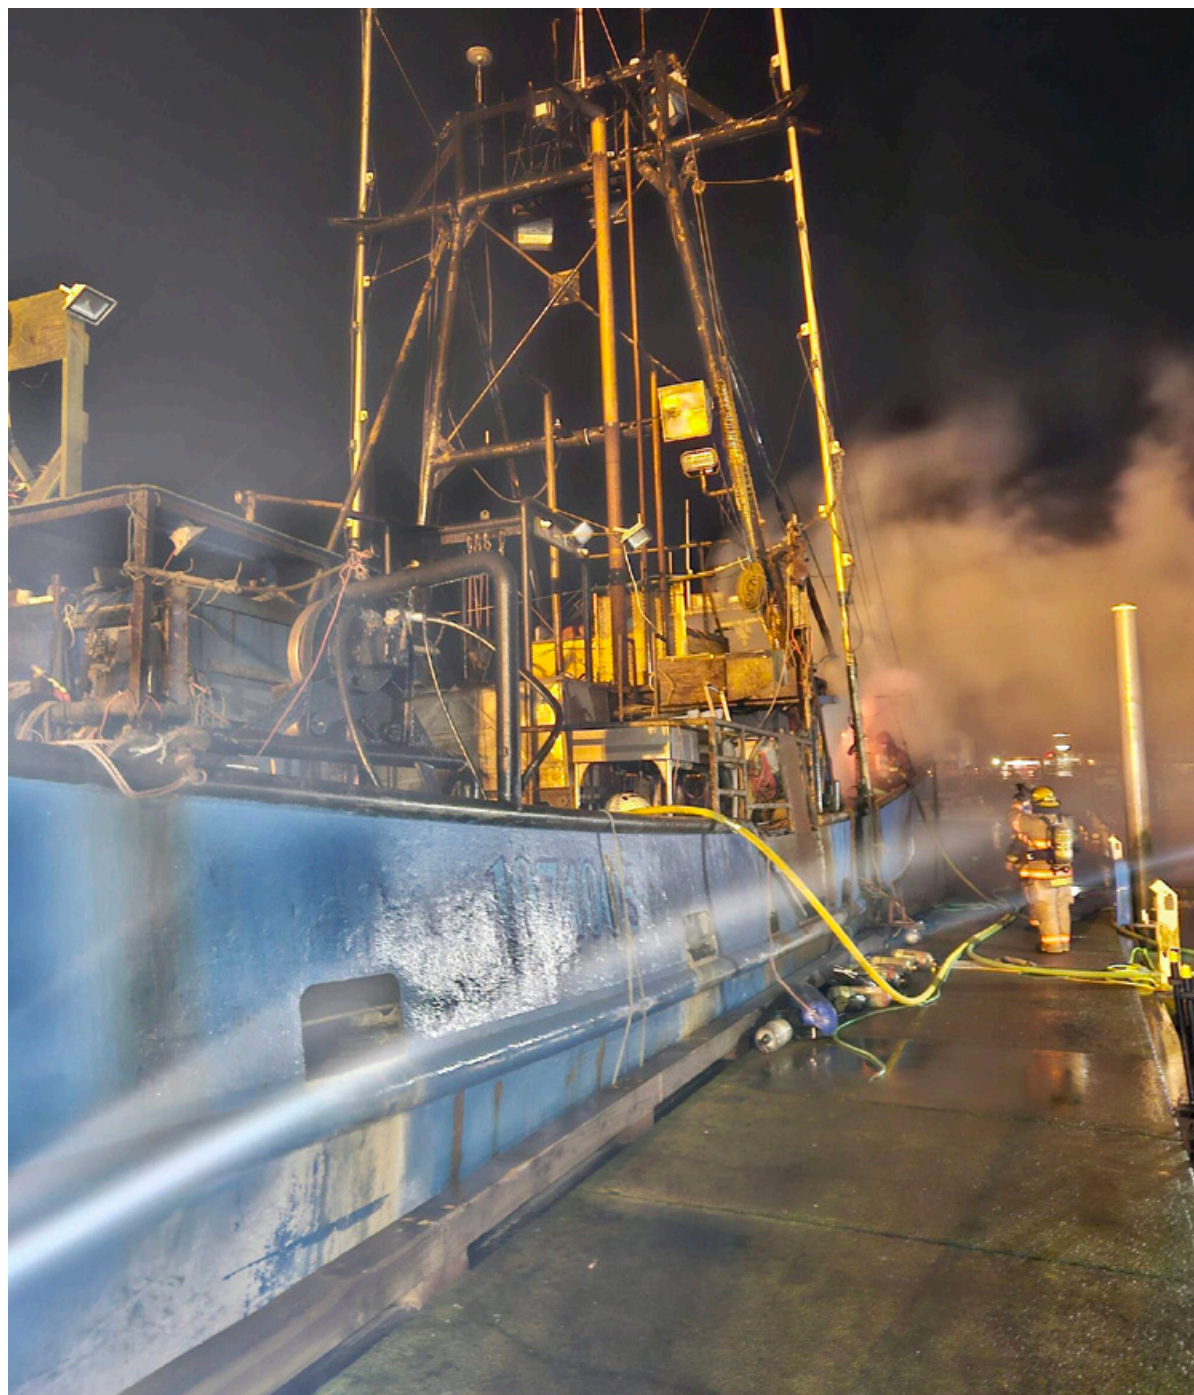
THE PROBABLE CAUSE of the fire on board the fishing vessel *Marlins II* was the failure of an extension cord used to energize galley appliances when on shore power.

Right: *Marlins II* at the dock during firefighting efforts.

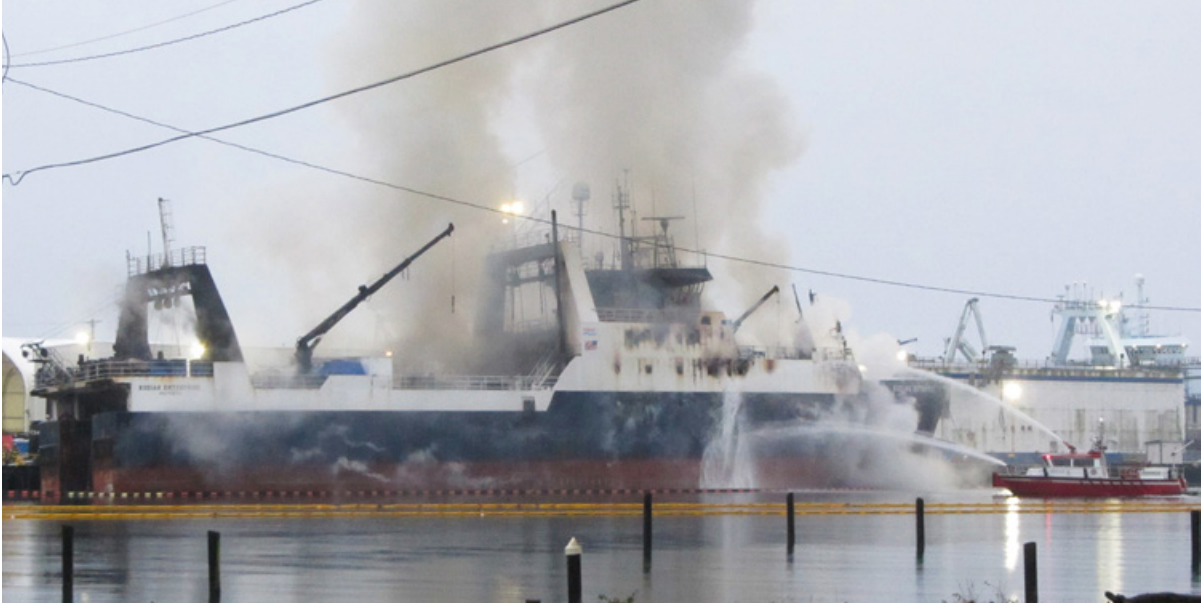
Kodiak Enterprise during firefighting efforts. SOURCE: COAST GUARD.

After the fire, investigators examined the deck locker, mess, galley, and dry stores room; they found more “specific and isolated damage” in the dry stores room, meaning the dry stores room was likely the area of origin for the fire.

THE PROBABLE CAUSE of the fire aboard the *Kodiak Enterprise* was an unknown electrical source within the dry stores room. Contributing to the risk to the onboard crewmembers and to the severity of the fire was the vessel's inadequate fire detection and notification system, which was not designed to sound in crew accommodation spaces, and failed to wirelessly alert shoreside contacts.

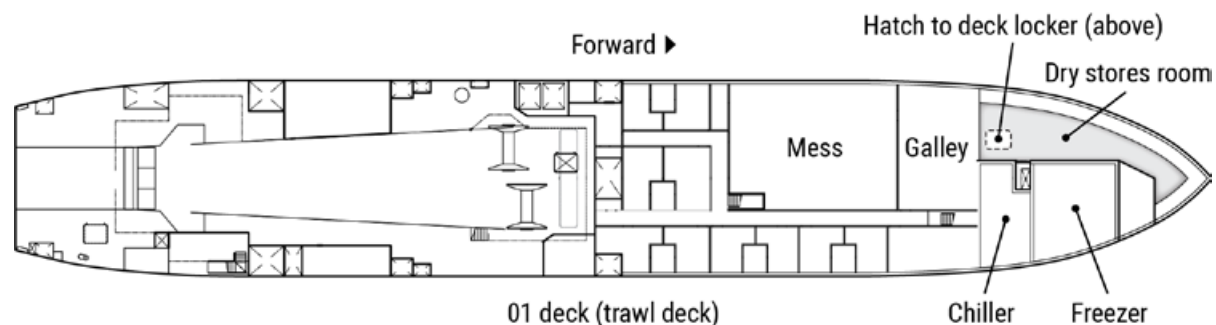
Plan view of the *Kodiak Enterprise* 01 deck showing the dry stores room, where the fire most likely originated.

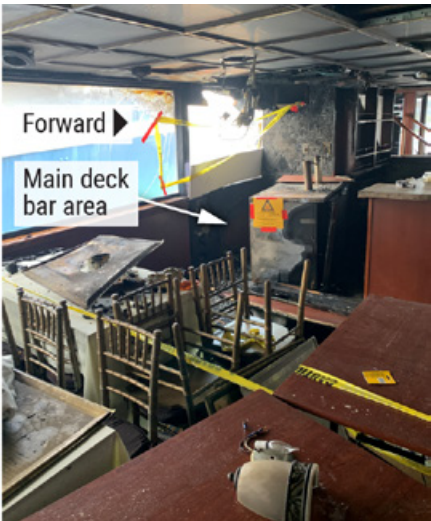
Left to right: Lady Delray after the fire, with fire-damaged portside window and portside main deck bar area.

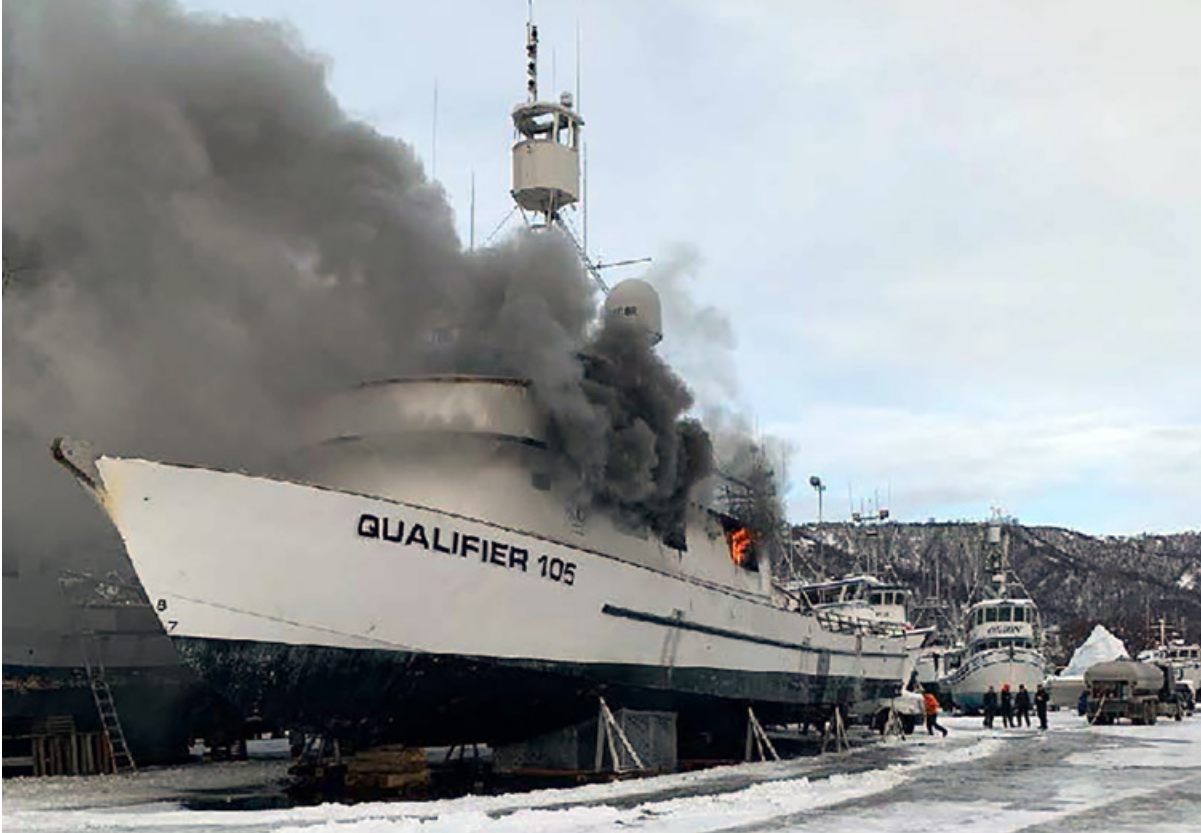
Qualifier 105 on fire in the boatyard. SOURCE: HOMER VOLUNTEER FIRE DEPARTMENT.

THE PROBABLE CAUSE of the fire aboard the passenger vessel *Qualifier 105* was an undetermined electrical source that ignited a stateroom ceiling. Contributing to the extent of the fire damage was the substantial use of combustible materials composing the stateroom ceilings and bulkheads throughout the vessel's accommodation spaces.

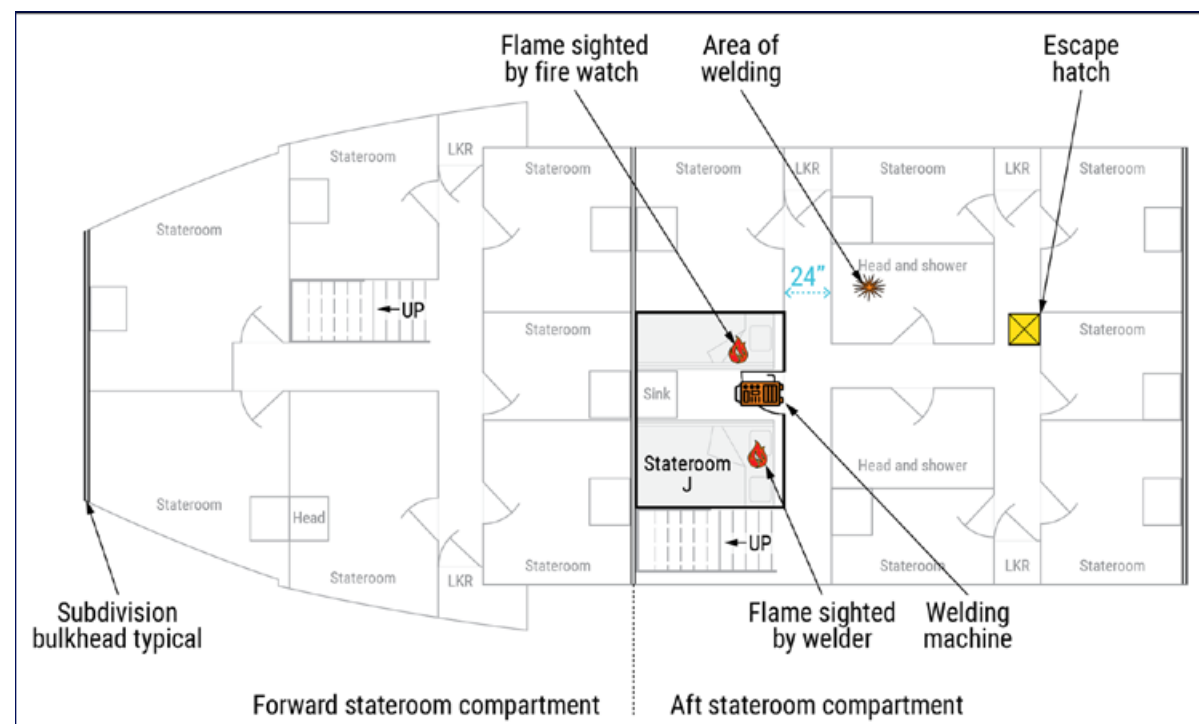
The fire started in stateroom J, below the main deck of the *Qualifier 105*, and was discovered by a crewmember who was serving as the fire watch. At the time the fire started, welders were on board performing aluminum hot work, cleaning up the area around a fuel tank that had been repaired and tested the day before, and reinstalling the deck in a head that was directly above the fuel tank.

An electrical wire in the overhead of stateroom J could have served as an unintended conductor and become overheated and eventually led to a fire. However, investigators could not definitively determine that stray welding current caused wires to overheat. Additionally, there were several wires and electrical boxes in stateroom J that may have been energized and become a potential electrical ignition source due to a fault. Therefore, the exact ignition source could not be determined.

Qualifier 105 forward and aft stateroom compartments.

Stray welding current is a fault condition in which current goes through unintended conductors and back to the return terminal of a welding machine; it can cause fires by overheating wires. To avoid potential fires caused from stray welding current, maintenance personnel, owners, and operators should follow industry practice to place the work clamp (the return current clamp) of the welding machine as close as possible to the point of welding.

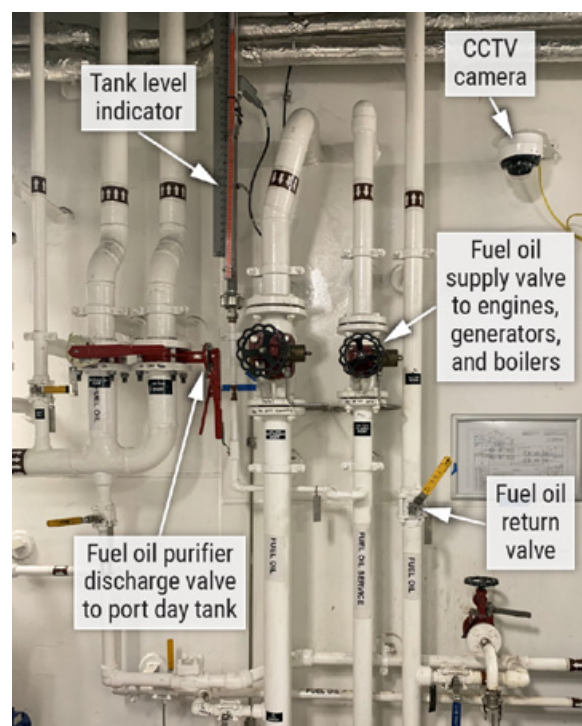
of the two fuel oil day tanks. They adjusted several valves at both fuel oil stations and adjusted the fuel oil service supply globe valve to the engines, generators, and boilers on the port day tank several times. They also adjusted the fuel oil purifier discharge valves and the fuel oil return isolation ball valves to both day tanks. In their ongoing response to correct the divergence in the fuel oil day tank levels, the oilers closed both the port and starboard day tank fuel oil return isolation ball valves, causing the fuel oil system to overpressurize.

Fuel oil piping at the port (Staten Island end) fuel oil station aboard SSG Michael H. Ollis, which was a vessel of the same class as the Sandy Ground and had a similar piping arrangement (SSG Michael H. Ollis piping shown due to postfire condition of Sandy Ground fuel oil station). The fuel oil return valve is a ball-type valve. Note the valve is partially closed (ball valve open-to-close range is 90° and indicated by handle position).

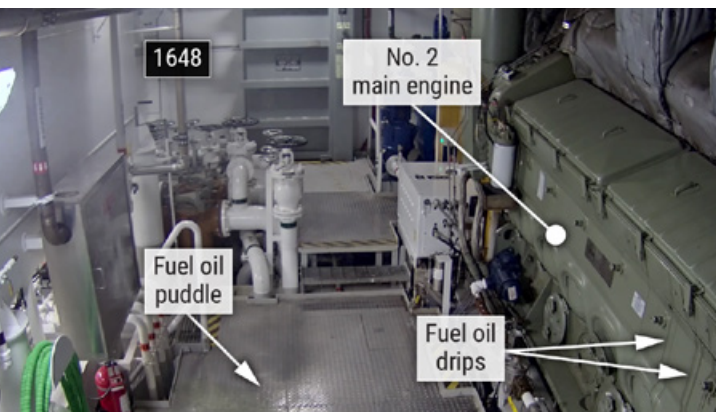
The chief engineer began acknowledging and silencing alarms on the MCS computer. He stepped out into the engine room and saw fuel oil leaking from the no. 2 main engine secondary duplex spin-on fuel filter assembly and that nos. 3 and 4 main engines had "fuel on them." The oilers, who were in the engine room at

Above: Fuel oil dripping onto the no. 2 main engine and on the adjacent deck in the lower engine room (looking toward the New York end) at 1648.

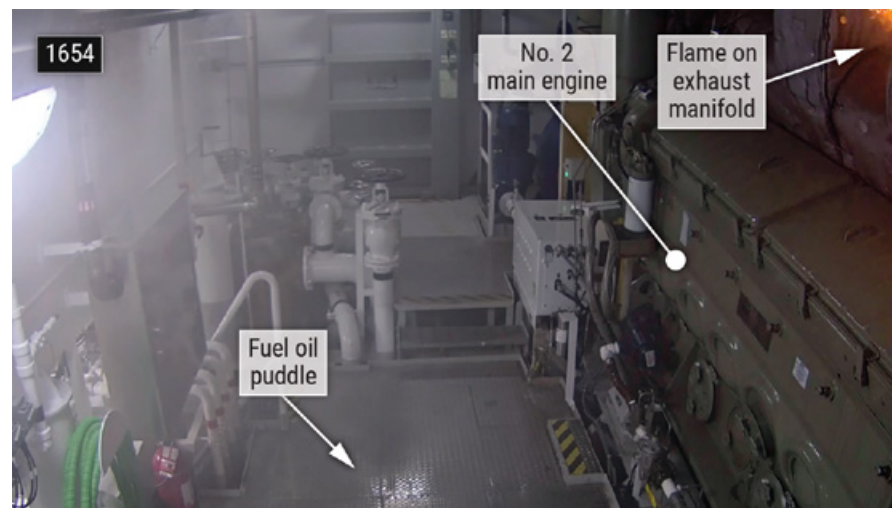
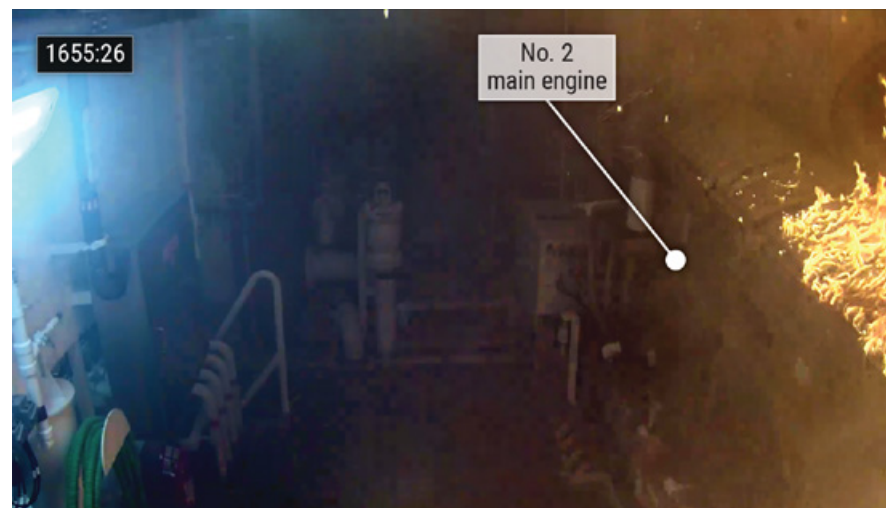
Below, from left: Initial fire breaking out on exhaust manifold on no. 2 main engine at 1654. Fire at 1655:26.

We found that the on-duty engineering crewmembers ineffectively managed fuel oil levels in the vessel's two fuel oil day tanks, causing the difference in the two tanks' levels to sharply increase. To correct this difference in levels, the engineering crewmembers closed the fuel oil return isolation ball valves to both day tanks, causing the fuel oil system to overpressurize and the fuel oil filters on the main engines to rupture. Fuel oil spraying from a ruptured fuel oil filter onto the operating no. 2 main engine ignited, causing a fire to break out in the engine room.

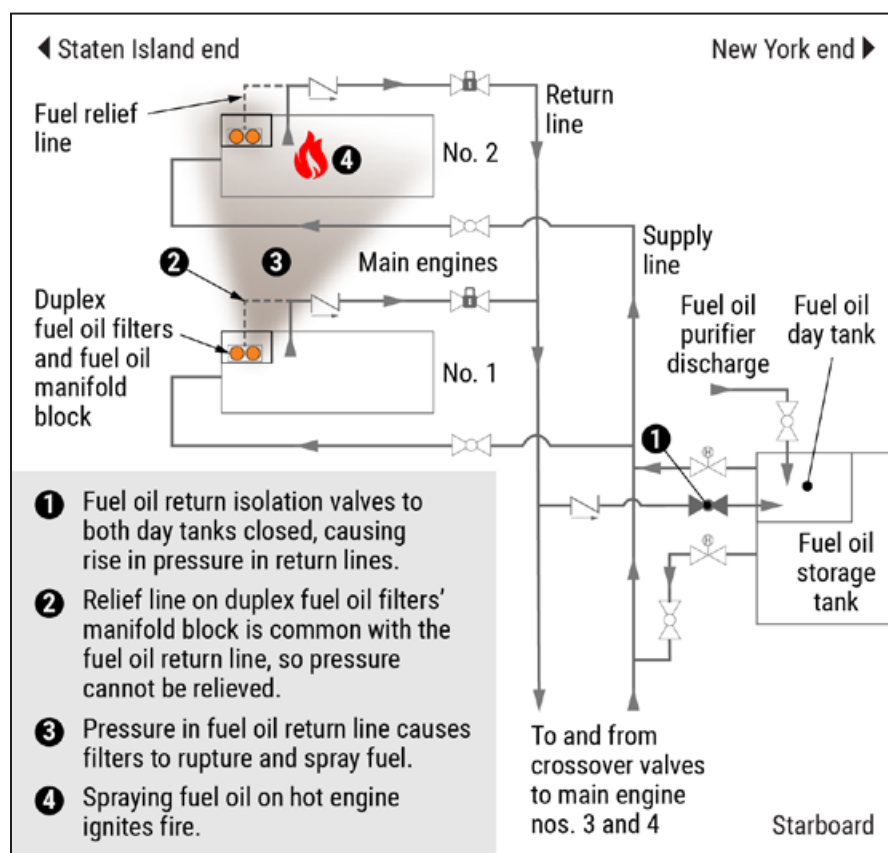
THE PROBABLE CAUSE of the engine room fire aboard the passenger ferry *Sandy Ground* was the design of the vessel’s diesel engine fuel oil return system, which included isolation valves that could be regularly adjusted by the crew and, when closed, stopped return fuel oil flow from all operating engines, resulting in the overpressurization of the fuel oil system and the ignition of fuel oil spraying from ruptured fuel oil filters onto the exhaust manifold of a running engine. Contributing to the overpressurization was the operator’s inadequate training program on fuel oil system operation, which did not provide follow-on instruction after the installation of fuel oil return isolation valves at the day tanks.

Simplified New York end main engine fuel oil supply/return system drawing for *Sandy Ground* and sequence of events leading to overpressurization and fire.

Staten Island Ferry determined that, for operational reasons, the Ollis-class ferries should be fitted with fuel oil return isolation valves before the day tanks to regulate day tank levels by throttling these valves. However, these vessels did not have a means to relieve the pressure in the fuel oil return line after the oilers closed both fuel oil return isolation valves. Had the *Sandy Ground* been equipped with a pressure relief valve installed in the fuel oil return line, the elevated fuel oil pressure caused by the closed fuel oil return isolation ball valves would have been relieved, and fuel oil system overpressurization would have been prevented.

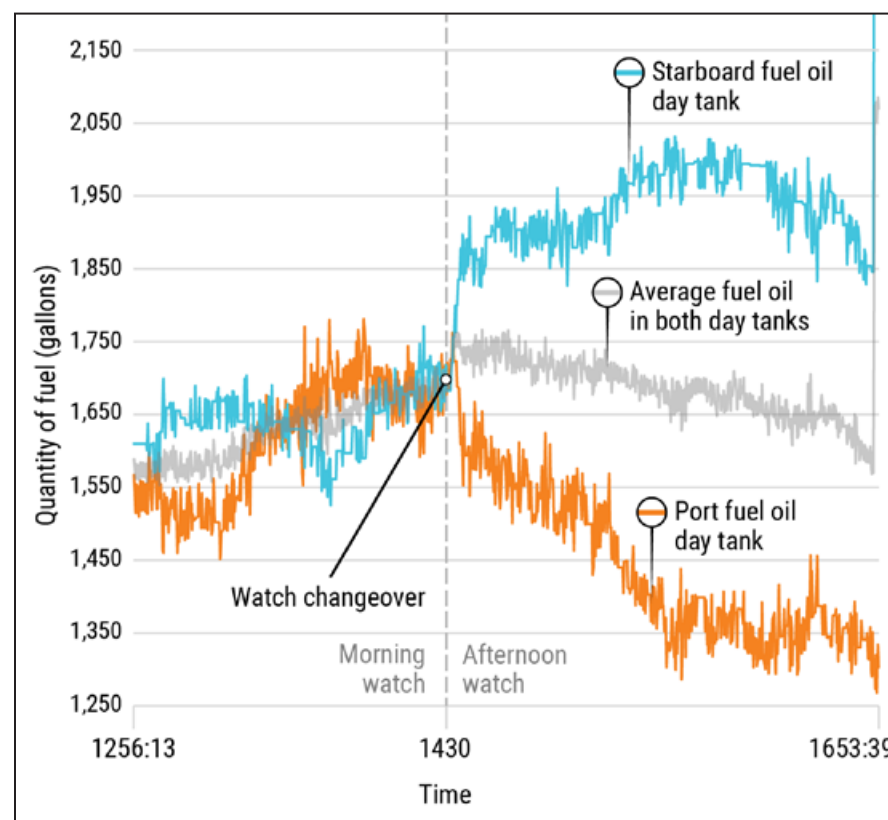
When the afternoon engineering watch took over from the morning watch at 1430, the MCS indicated a difference of 5 gallons between the two day tanks. Over the next four transits and during the casualty transit, as the ferry continued to operate, the engineering crewmembers observed substantial differences in the fuel oil levels of the vessel’s two fuel oil day tanks (about 1600, the MCS logged a difference of about 550 gallons between the port and starboard fuel oil day tanks). Additionally, the total amount of fuel oil in the day tanks (combined amount) decreased steadily.

Graphic representation of fuel oil quantities in port fuel oil day tank and starboard fuel oil day tank. Average fuel oil in both tanks, calculated by NTSB, is depicted in gray. DATA SOURCE: *SANDY GROUND* MCS.

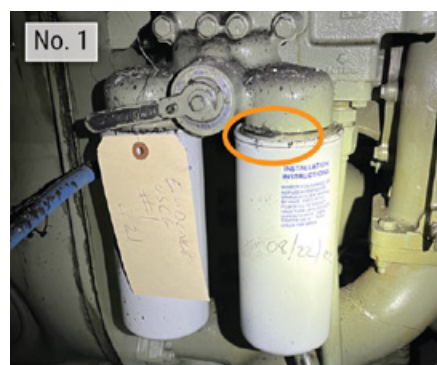
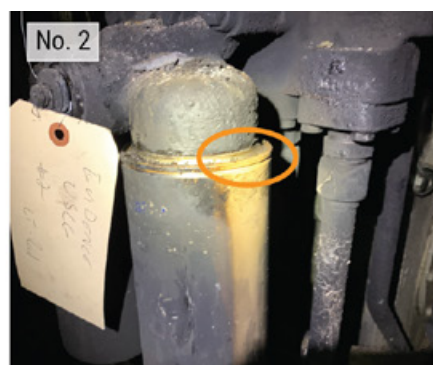
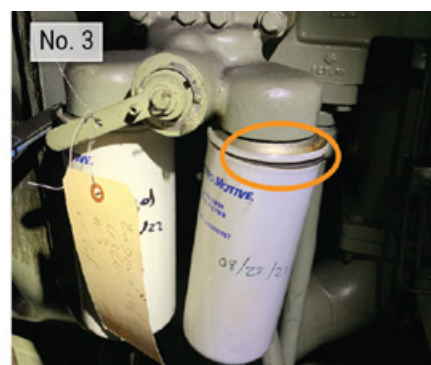
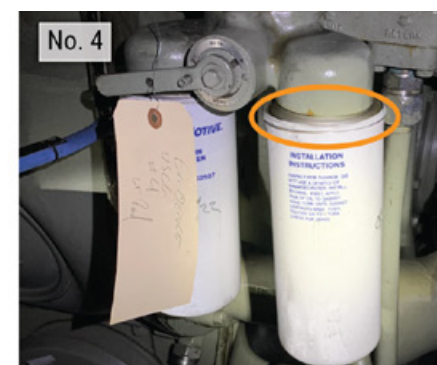
Damage (circled) found on secondary spin-on duplex fuel oil filters from each of the four main engines after the casualty. The no. 1 main engine has a protruding gasket in the direction (outboard) of the no. 2 main engine, and the nos. 2, 3, and 4 main engine filter housings are distorted.

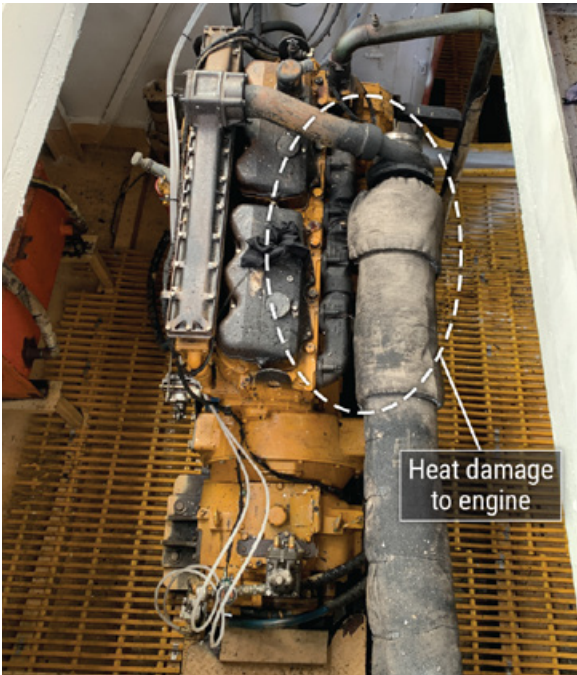
When inspecting the damage after the fire, the crew found damage was limited to the area of the port main propulsion engine, and, according to the captain, “Except the one [port] engine that was burnt, everything else was pretty much normal.” Therefore, the crew’s prompt actions to remove the fuel and oxygen sources for the fire helped limit the fire damage and extinguish the fire.

Port main propulsion engine damage on the *Desperado* after the fire.
