NATIONAL TRANSPORTATION SAFETY BOARD

SAFER SEAS Digest

Lessons Learned from
Marine Investigations

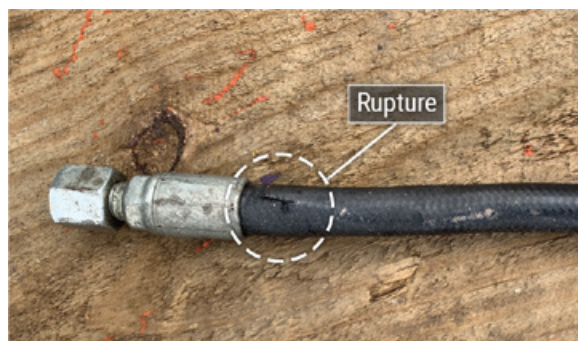
The captain told the Coast Guard that the cause of the fire was a ruptured hydraulic line on the portside steering pump, which subsequently caused flammable hydraulic oil to spray onto the hot port main propulsion engine exhaust manifold and turbocharger and ignite. The line was 0.5 inches in diameter and about 16.5 inches long, and the rupture was found near the hose end crimped fitting. The captain and deckhands removed the ruptured hydraulic line from the portside steering pump directional manifold valve and replaced the hose with an onboard spare.

The ruptured port steering pump hydraulic hose, after the fire.

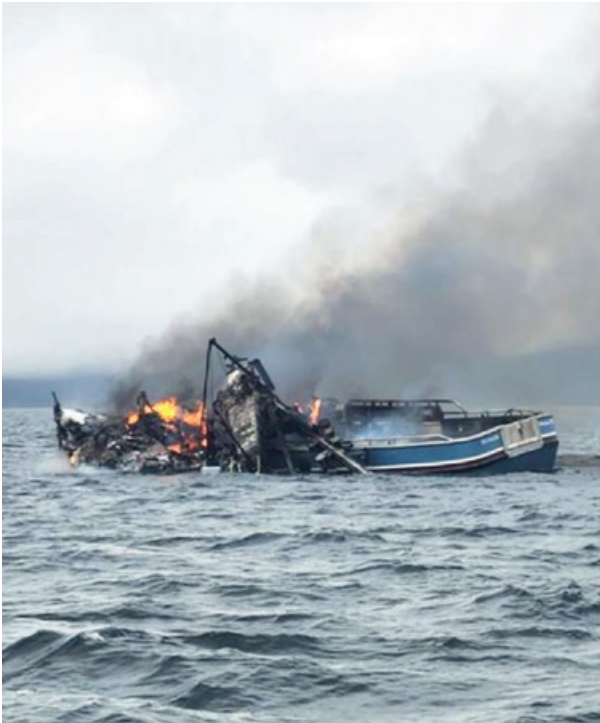
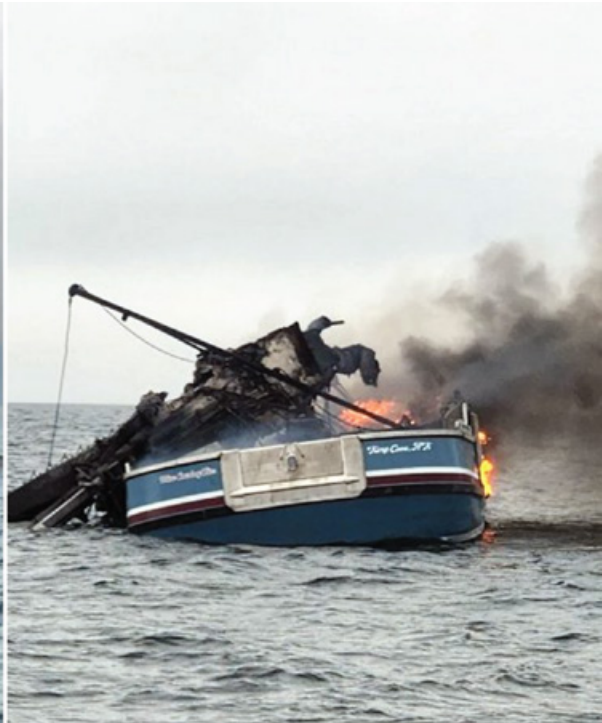
Miss Courtney Kim beginning to sink while burning. SOURCE: MISS COURTNEY KIM OWNER.

Given the burning electrical smell, the cause of the fire may have been electrical in nature. If there was an electrical fault within nearby circuits or equipment, it could have created excessive resistance heating, which may have led to the ignition of nearby combustibles. However, because the vessel sank and was not recovered, the cause of the fire could not be determined.

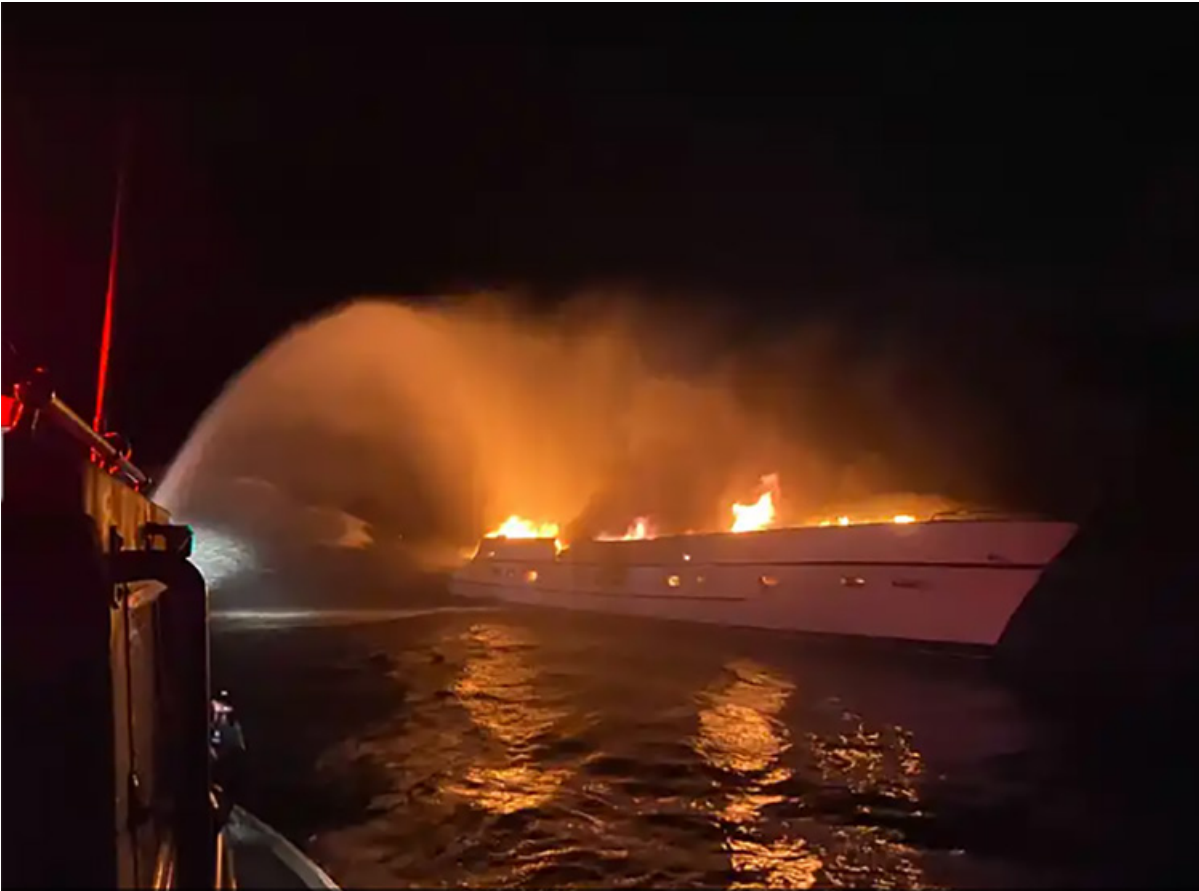
Savage during firefighting efforts. SOURCE: VIRGINIA BEACH FIRE DEPARTMENT VIA COAST GUARD.

Potential ignition sources include the operating diesel propulsion engines and electrical generator, and other equipment. The extensive damage to the vessel precluded examination of components, and, therefore, the exact ignition source could not be determined.

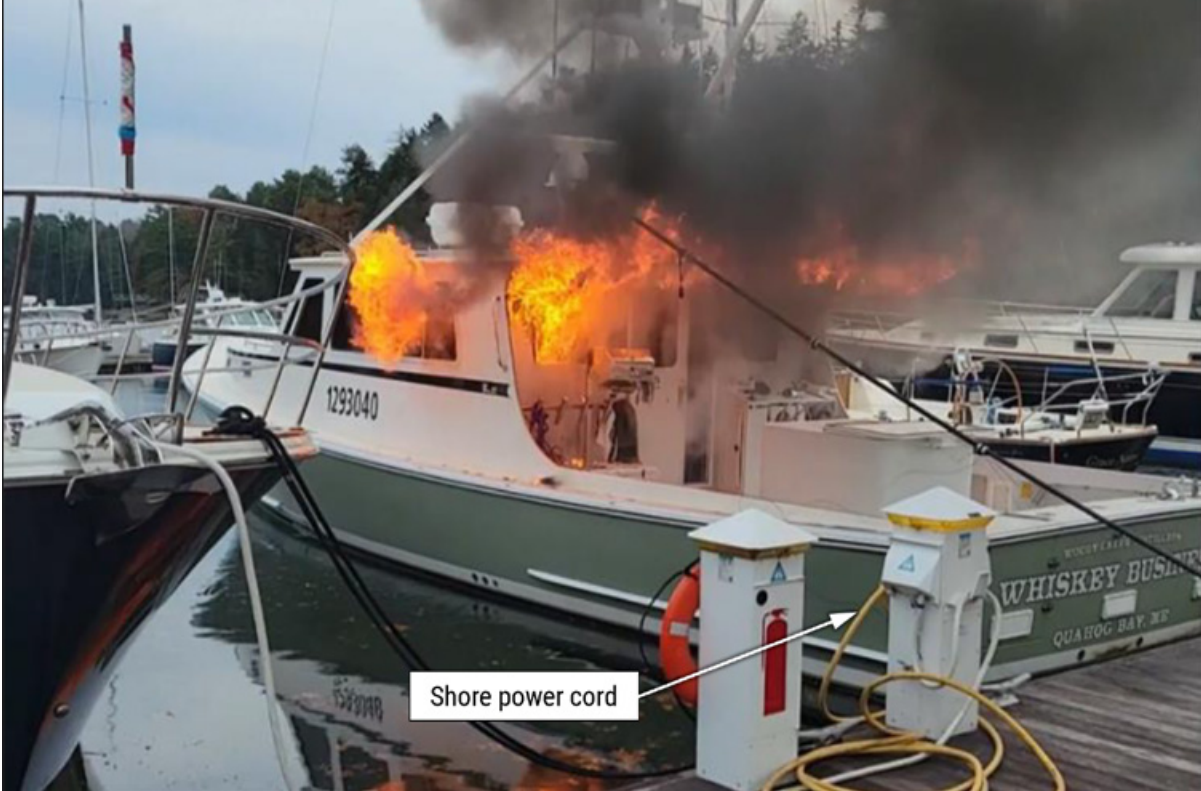
Fire aboard the *Whiskey Business*, about 0918 on November 5, 2024. The shore power cord had been connected from the shore power pedestal to the boat. BACKGROUND SOURCE: MARK LENZI.

According to a witness (nearby boat owner), and photos and videos taken at the time of fire, the first signs of smoke and flames originated in the port aft corner of the cabin. The fire grew in intensity in this area and was seen breaking through the port aft windows of the cabin. A postfire examination of the cabin interior space identified the greatest extent of fire and heat damage in the area near the

aft air conditioning unit. The examination also found diminishing damage to the starboard side of the cabin and in the forward stateroom, and no fire damage in the engine room. Therefore, the origin of the fire was likely the air conditioning unit in the port aft area of the cabin.

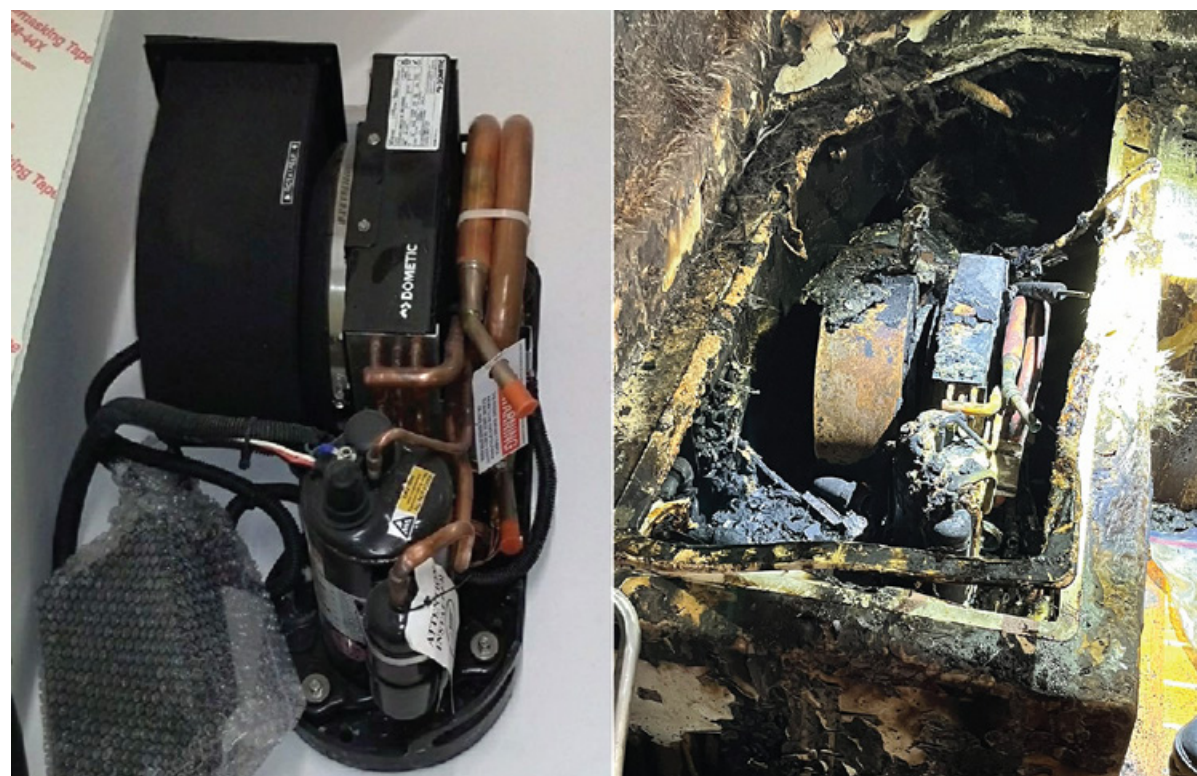
The most heavily damaged component of the air conditioning unit was a soft start control device for the air conditioning unit. According to the captain, he had replaced the device in the aft unit in 2021. Based on the captain's recollection, he believed the device was mounted on the floor without a waterproof enclosure, contrary to the manufacturer's instructions. The air conditioning unit was cooled by pressurized seawater via hoses, so it is possible that a seawater leak from a hose could have sprayed or pooled on the floor and entered the unit's soft start control device, causing an electrical fault. This water intrusion could have resulted in an electrical short circuit in the soft start control device that generated enough heat to start the fire.

THE PROBABLE CAUSE of the fire on board the fishing vessel *Whiskey Business* was a fault within an electrical soft start control device, possibly due to exposure to saltwater, for an air conditioning unit located under a bench in the vessel's cabin.

Left to right: Larger soft start control device from damaged air conditioning unit alongside identical forward unit (shown as an exemplar). Smaller soft start control device from damaged air conditioning unit alongside forward unit after fire.

Left to right: Air conditioning unit aboard *Whiskey Business* in 2019 after vessel construction, and same unit after fire. SOURCE (LEFT): *WHISKEY BUSINESS* CAPTAIN.

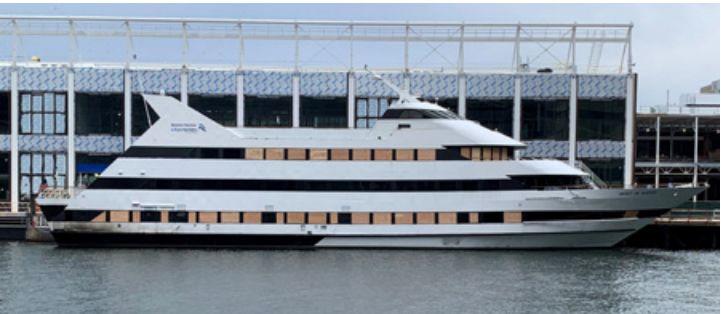
Passenger vessel *Spirit of Boston* after the fire.

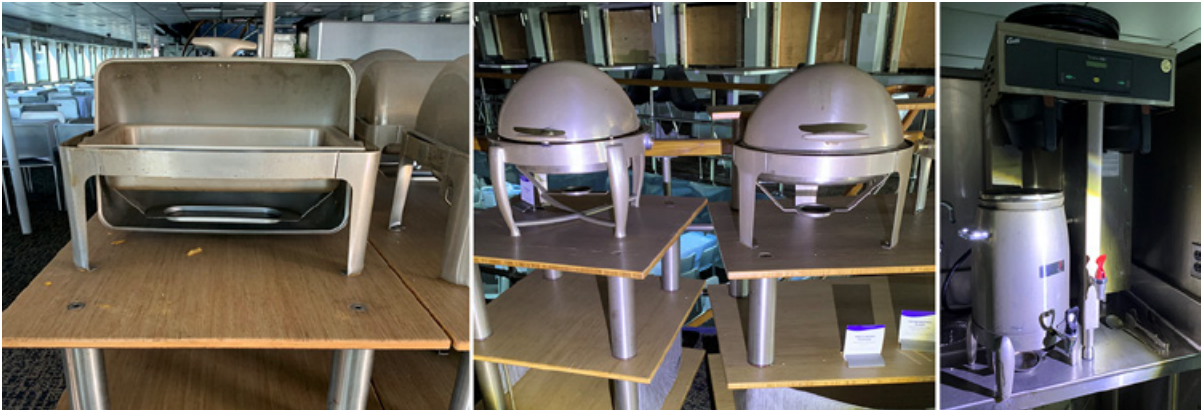
Toward the end of the cruise, galley staff extinguished the chafing fuel heating canisters—canned heat used to keep food and beverages warm—on the buffet tables in the passenger spaces. Server assistants 1 and 2 began cleaning deck 1, and about 2145, server assistant 2 extinguished the coffee dispenser’s chafing fuel heating canister in the deck 1 wait station and left the canister on the counter to cool. Contrary to the manufacturer’s guidance, she blew it out instead of placing the lid on to extinguish the flame.

Left to right: *Spirit of Boston* chafing dishes (with the chafing fuel heating canisters removed) in passenger areas on deck 2 and deck 3 after the fire. Exemplar coffee maker and dispenser used aboard *Spirit of Boston* with the chafing fuel heating canisters removed from under the dispenser.

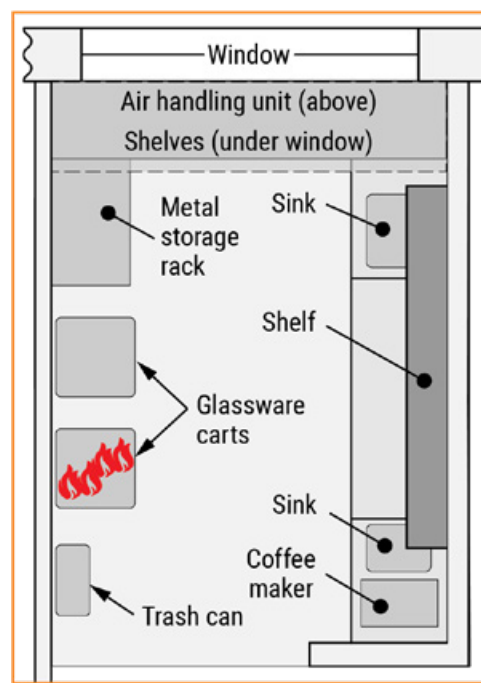
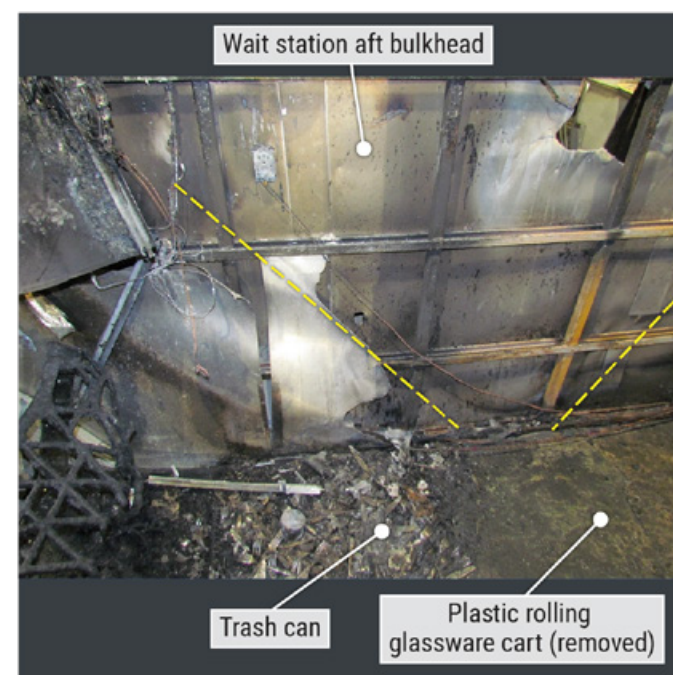
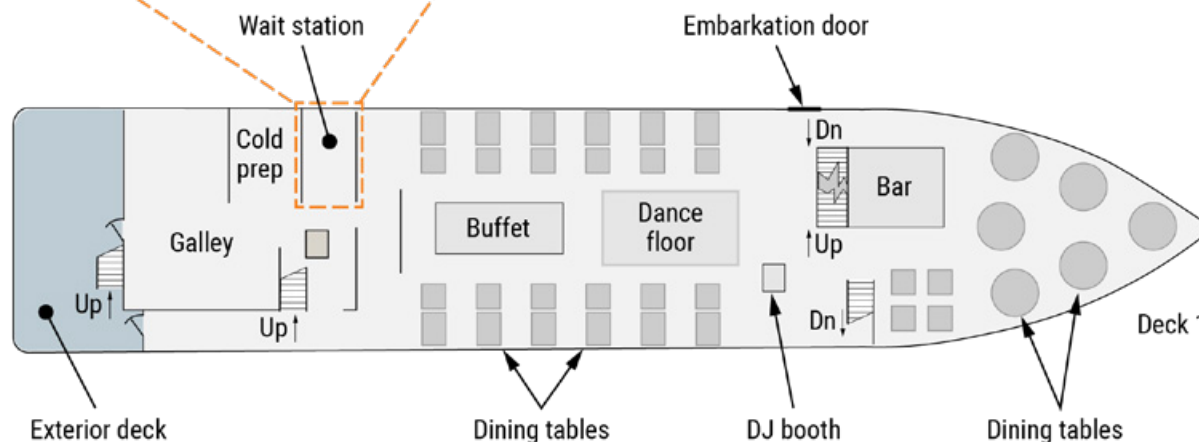
The restaurant manager entered the wait station and saw smoke and "a line of fire ... like a snake basically going across the floor." He believed it was coming from under one of the plastic glassware rolling carts. He called (via cell phone) the captain, who did not answer at that time. About the same time, the senior restaurant manager saw sparks under the plastic glassware cart break out into flames.

Plan view of *Spirit of Boston* deck 1 and detail of the wait station area including approximate location of fire, indicated by a fire symbol, as reported by the restaurant manager (scale approximate). Top right: "V" pattern (shown as yellow dashed lines) as observed by ATF on aft bulkhead of deck 1 wait station near waste trash can and plastic rolling glassware carts. BACKGROUND SOURCE: ATF.

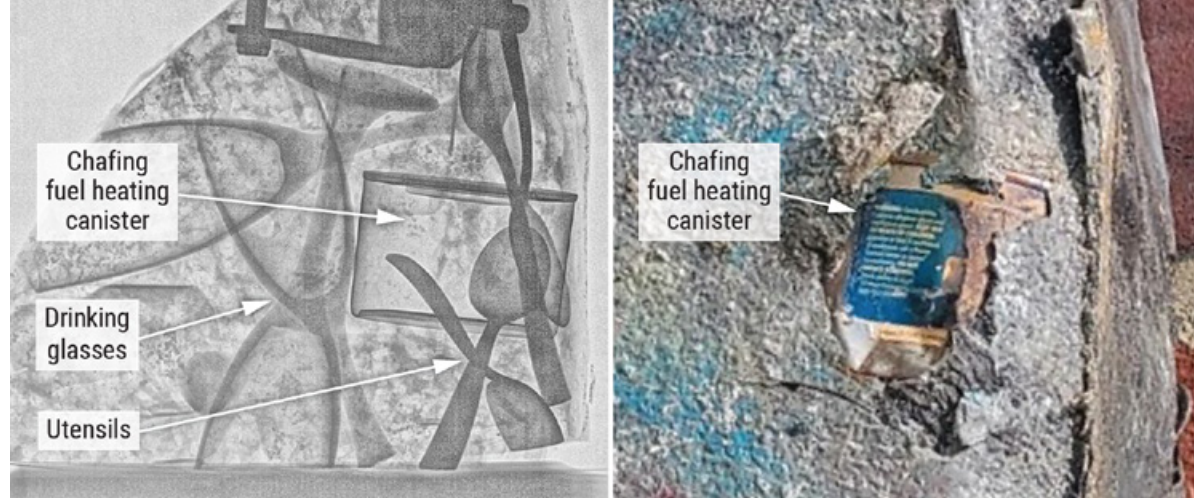
THE PROBABLE CAUSE of the fire aboard the passenger vessel *Spirit of Boston* was the improper extinguishing and disposal of a chafing fuel heating canister due to City Cruises US's lack of documented procedures for handling open-flame devices, which led to the ignition of a plastic glassware rolling rack. Contributing to the growth and spread of the fire was City Cruises US not requiring a marine crewmember—designated and trained to execute City Cruises US's emergency response plan for a fire aboard a vessel—to remain aboard the vessel until all hospitality staff and other noncrew personnel departed the vessel.

Left to right: X-ray image of debris removed from the *Spirit of Boston* deck 1 wait station showing chafing fuel heating canister. Closeup of chafing fuel heating canister found in the same debris.

We **recommended** that City Cruises US develop procedures for, and train personnel on, the proper handling and extinguishing of open-flame devices, like chafing fuel heating canisters. Additionally, we **recommended** that City Cruises US require at least one marine crewmember—who is properly trained to respond to shipboard emergencies, including fire—to remain on board the company's vessels until all other noncrew personnel depart. Documented procedures—such as procedures for handling open-flame devices and requirements for crewmembers to be on board—would typically be included in an SMS. However, City Cruises US did not have an SMS (nor were they required to). Therefore, we **recommended** they implement an SMS. We also **recommended** that the Passenger Vessel Association share the circumstances of this accident and the safety issues we identified during our investigation.

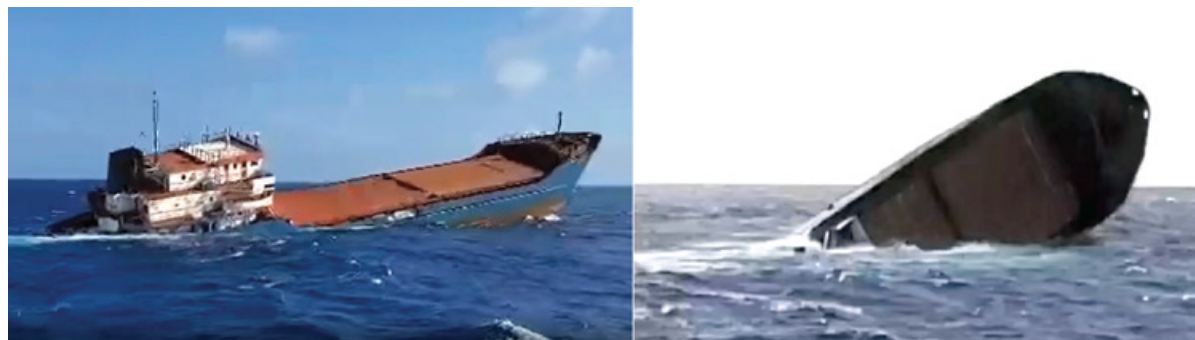
Left to right: *Carib Trader II* while flooding and sinking. SOURCE: CAPT. BEAU CREW.

THE PROBABLE CAUSE of the flooding and subsequent sinking of the *Carib Trader II* while under dead ship tow was the uncontrolled flooding of the engine room from an undetermined location below the waterline.

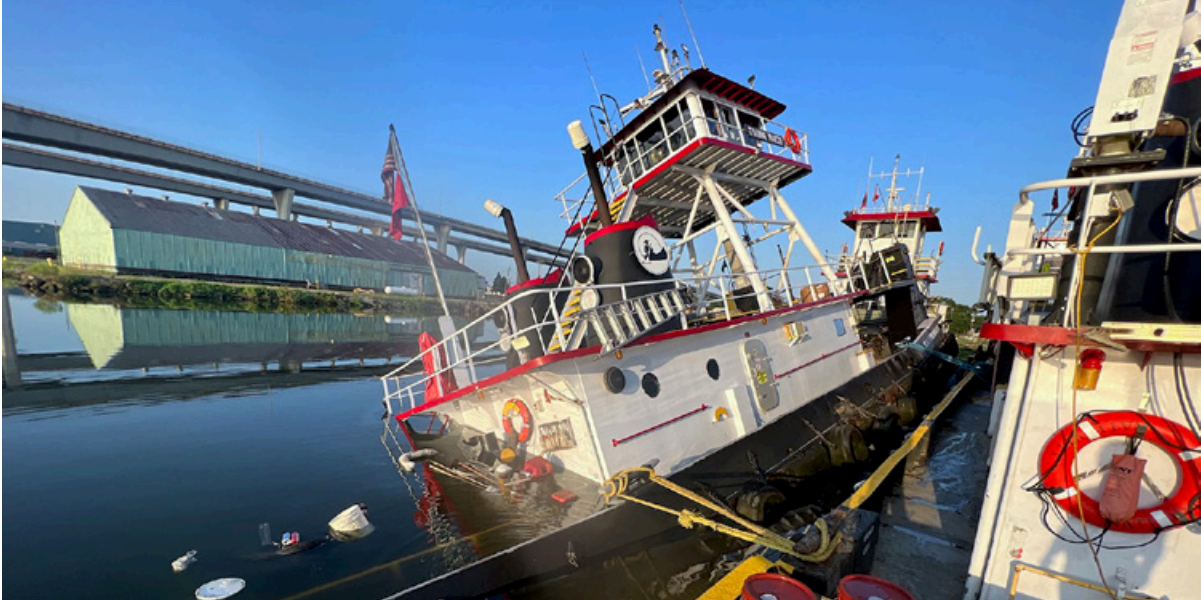
Joanne Marie listing at the shipyard on the morning of June 25. SOURCE: COAST GUARD.

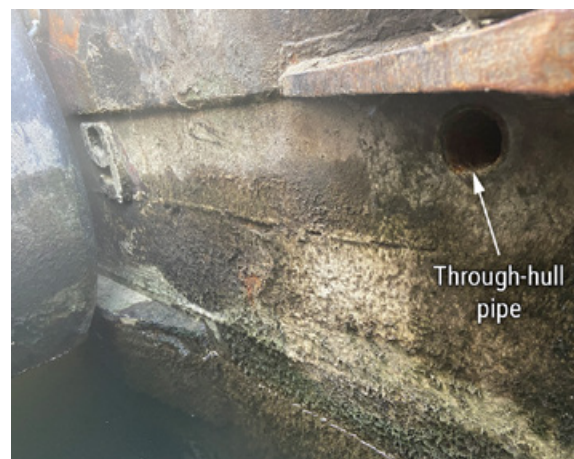
THE PROBABLE CAUSE of the flooding and partial sinking of the *Joanne Marie* was the ingress of water into the engine room through a through-hull pipe located near the waterline due to an obstructed spring-loaded check valve on a cofferdam bilge pump discharge. Contributing to the sinking were inadequate procedures for securing unattended vessels.

***Joanne Marie* through-hull pipe for the cofferdam pumps' overboard discharge on the port quarter shown postcasualty.**

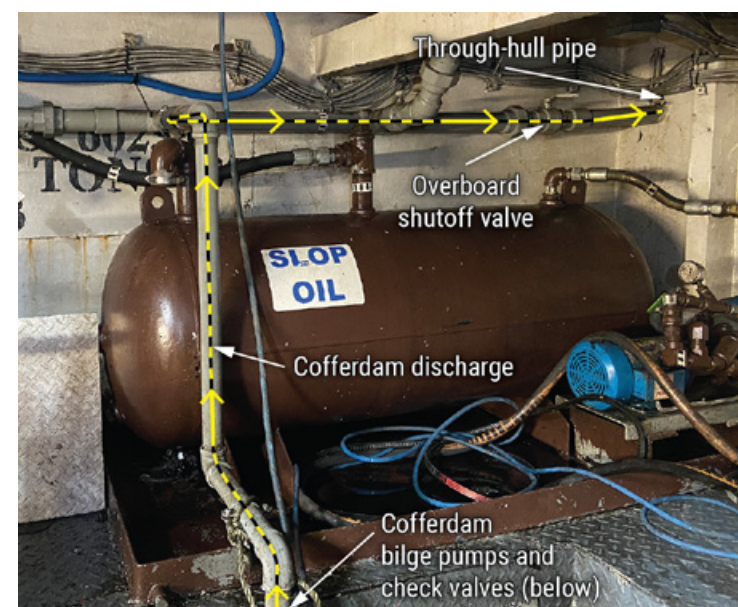
The deactivation procedures in the operating company’s TSMS, however, were limited to housekeeping items and did not address the configuration of onboard systems to prevent a casualty, such as closing the overboard shutoff valve. Therefore, the valve was left open when the *Joanne Marie* was secured on June 23. Additionally, after the casualty, investigators found that a wire nut had lodged in a spring-loaded check valve on the starboard-side bilge pump discharge line, obstructing the valve, forcing it to remain partially open, and leaving it susceptible to backflow. With the overboard shutoff valve left open and the spring-loaded check valve stuck partially open, water entered through the through-hull pipe—which was near or potentially below the waterline—causing the cofferdam—which was not watertight—to overflow and water to flood the engine room.

***Joanne Marie* cofferdam discharge system (facing aft).** BACKGROUND SOURCE: COAST GUARD.

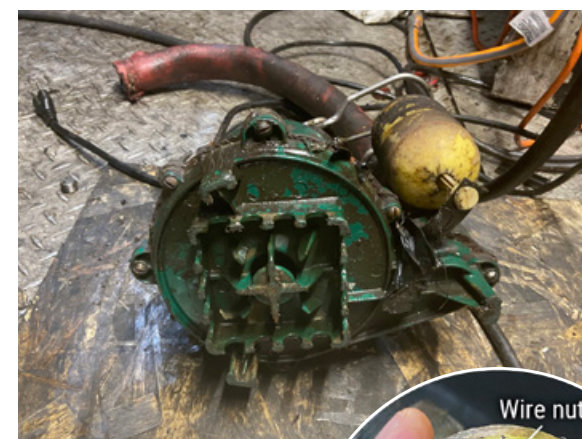
Cofferdam bilge pump with inlet shown with strainer removed. Inset shows associated spring-loaded check valve shown with lodged wire nut.

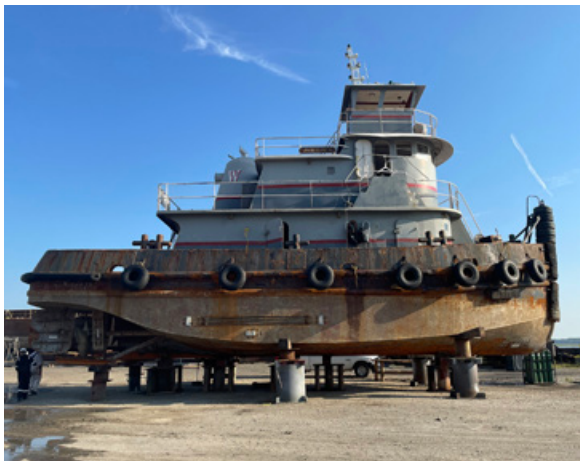
Jacqueline A following salvage after the sinking.

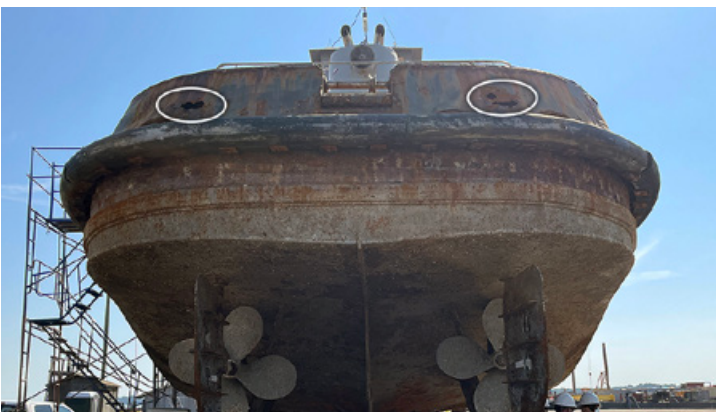
The vessel's stern sank first, with the bow remaining above the water for a period of time, indicating the flooding originated in the aft portion of the vessel. After the vessel was salvaged, investigators found several large wastage holes in the main deck plating above the lazarette within the voids formed by the enclosed bulwark on the main deck. The bulwarks on the *Jacqueline A* had been modified by adding plating to the inboard side of the bulwark frames, creating small void spaces within the bulwarks. The

voids were inaccessible spaces in which corrosion cells developed and eventually progressed into large wastage holes. Wastage holes were also found on the top and outboard side plating of the bulwarks.

THE PROBABLE CAUSE of the flooding and sinking of the towing vessel *Jacqueline A* was a lack of watertight integrity due to the poor material condition of the vessel's bulwarks and main deck plating, which allowed water to ingress through wastage holes into the lazarette, and unsealed penetrations in transverse bulkheads, which led to progressive flooding forward into the engine room. Contributing to the sinking was the lack of a high-water bilge sensor in the lazarette, which prevented early detection of flooding into the space.

Wastage holes (circled) on outboard plating of stern bulwarks.

Inaccessible voids or difficult to reach pockets or crevices that are poorly ventilated and provide no access for maintenance pose a risk to vessels due to the potential for severe rusting/corrosion. Because these spaces are inaccessible, corrosion can grow undetected. Operators and manufacturers should keep these risks in mind when designing, constructing, or modifying a vessel. Ensuring all spaces are accessible enables maintenance personnel to check for and remediate any potential hazards, such as corrosion.

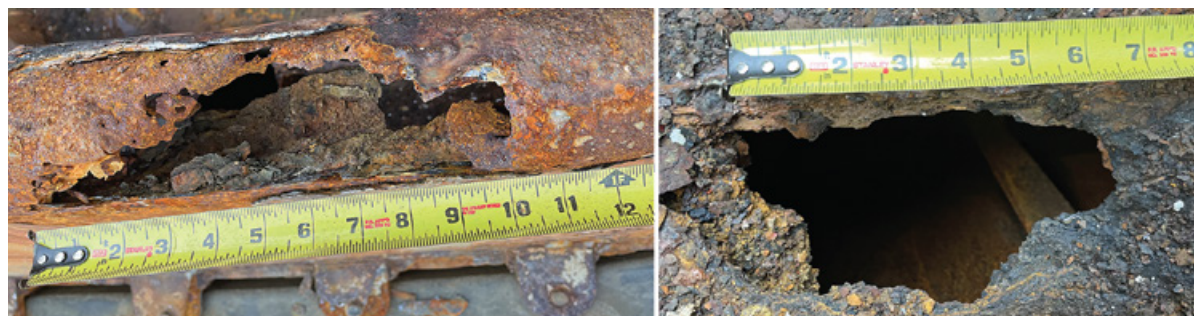
Left to right: Wastage holes on top rail of portside aft bulwarks and in main deck above lazarette within enclosed bulwarks.

For the safety of a vessel and all on board, the integrity of the hull and watertight bulkheads must be maintained, and any deficiencies must be appropriately addressed. Known issues with watertight integrity, including unsealed watertight bulkhead and deck penetrations and deck and hull plate wastage, need to be addressed by permanent means. The Coast Guard advises, "Ensure electrical cables and conduits, piping runs, remote valve actuators, and other components that penetrate watertight bulkheads, decks, and compartments are inspected frequently and properly maintained. Each may have a unique sealing method involving glands with packing assemblies, penetration seals, or other methods. Frequent inspection and proper maintenance of these various fittings and assemblies will assist in minimizing the possibility of progressive flooding."

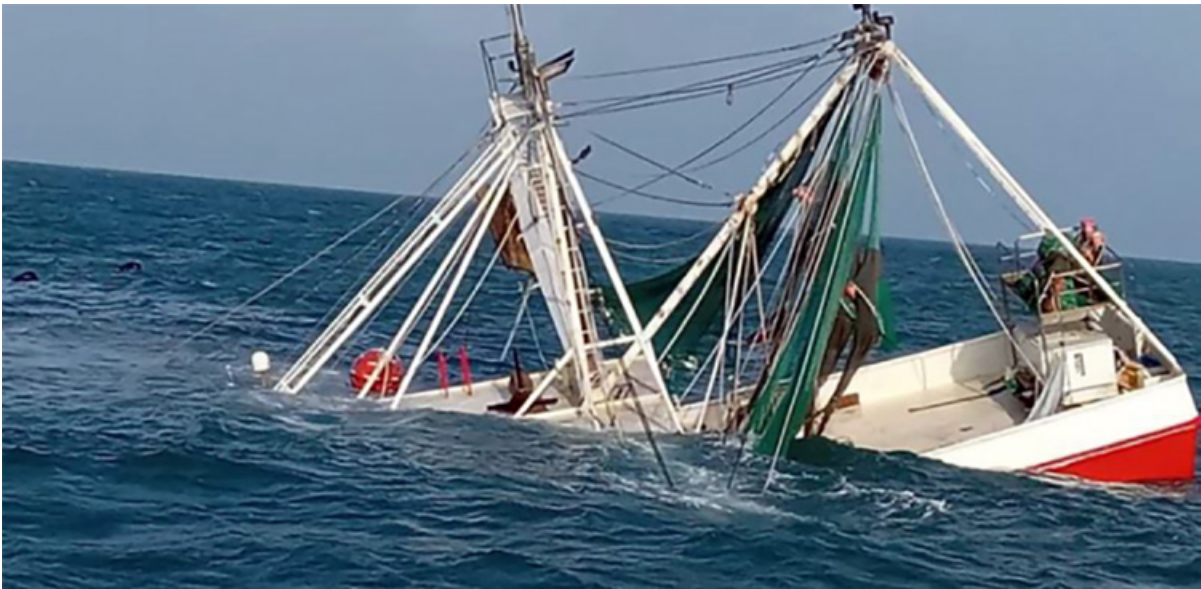
Christian G sinking in the Gulf of America on October 4, 2023. SOURCE: CREW OF THE *CHRISTIAN G*.

THE PROBABLE CAUSE of the sinking of the *Christian G* was flooding into the engine room—possibly caused by steel hull plating deterioration.

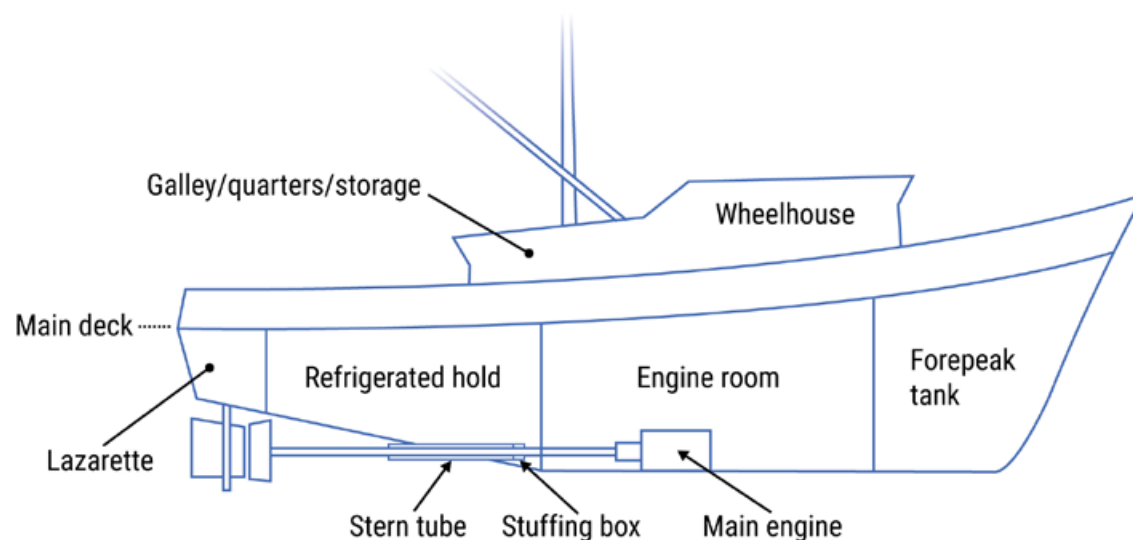
Because the vessel was not salvaged, a postcasualty vessel examination could not be performed, and the source of the flooding could not be determined. Because the flooding was initially found in the engine room and the captain could not locate the source of the leak elsewhere in the vessel, it is likely that the leak originated in the hull steel plate beneath the engine room. The vessel's manager told investigators that the *Christian G* was last out of the water in 2018 but could not recall what maintenance was performed. The steel plating had possibly developed a hole from deterioration during the intervening time. The hole in the plate was likely not large based on the rate of flooding with bilge pumps continuously pumping and the vessel remaining afloat for 52 hours.

Simple profile of *Christian G* (not to scale).

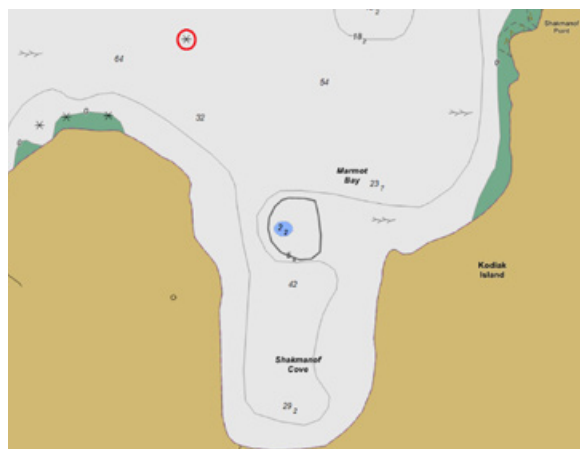
Although the rock was charted on the ENC, the captain did not notice the asterisk marking the rock’s location. Because ENCs are customizable based on vessel characteristics and user settings, investigators were unable to determine precisely how the information was presented to the captain when he was planning

the ATB's route. However, when investigators viewed the area on an equivalent ECS, the asterisk marking the rock was displayed alongside soundings of similar size and color, so it is possible that the captain mistook the asterisk for a depth sounding or other chart information when plotting and reviewing the route. The vessel had a copy of the *United States Coast Pilot* for the area, which called out the rock's location, on board. However, the captain did not reference it and relied on the ENC when planning and reviewing the route. Using other available resources, such as the *Coast Pilot*, would have helped the captain in identifying the rock when planning and reviewing the route.

ENC US4AK5PM, for the area near Shakmanof Cove, as viewed by investigators using an equivalent ECS. The asterisk symbol for the rock in the area of the grounding is indicated by a red circle. BACKGROUND SOURCE: NOAA ENC AS VIEWED ON ROSE POINT ECS.

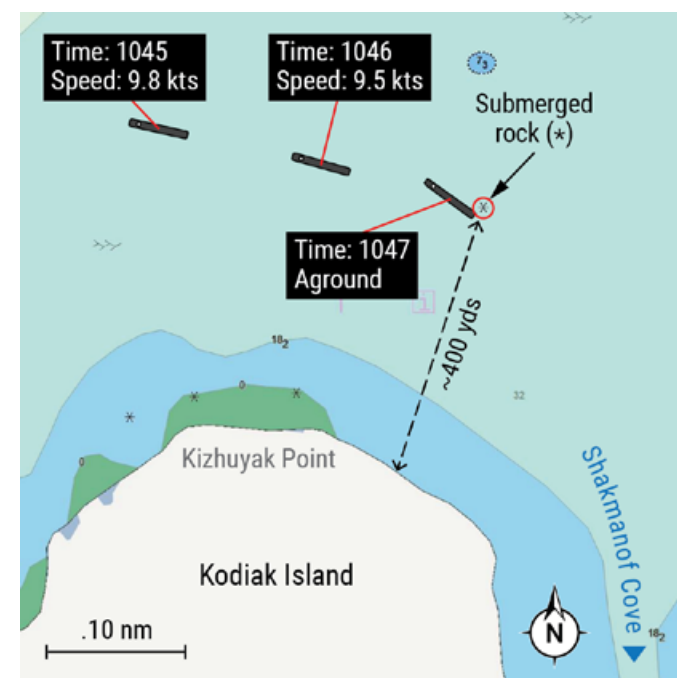
THE PROBABLE CAUSE of the grounding of the articulated tug and barge *Cingluku/Jungjuk* was the captain not identifying a rock that was indicated on the displayed electronic navigation chart when planning the vessel's route into Shakmanof Cove. Contributing was the captain not using all available navigational resources, including the *Coast Pilot* and the grounding avoidance features of the electronic chart system, when planning the route.

Track of the *Cingluku/Jungjuk* as it approached Shakmanof Cove. BACKGROUND SOURCE: NOAA ENC US4AK5PM AS VIEWED ON MADE SMART AIS.

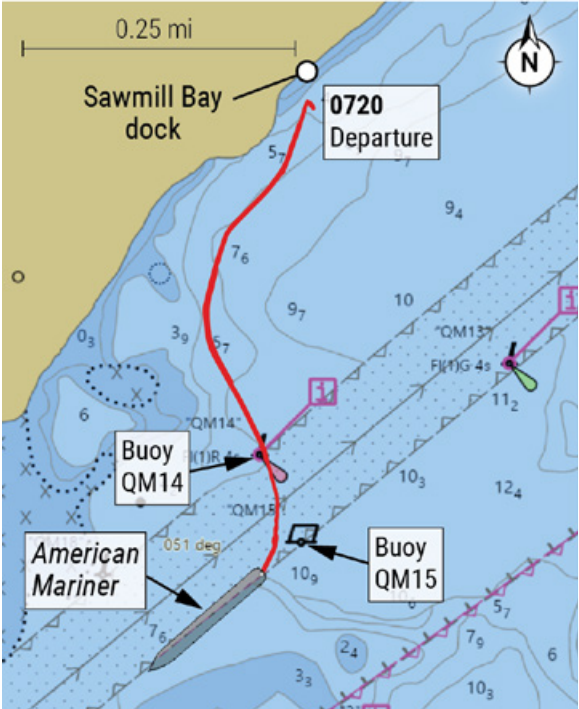
While the master was maneuvering the vessel into the Vidal Shoals Channel, crewmembers reported a sound and “shudder;” they then discovered that one of the vessel’s ballast tanks appeared to be communicating with the lake, and therefore was likely damaged. Although the master stated the ship was in the channel, the shoals were located immediately outside the buoyed channel, and the AIS data from that time showed the vessel on the far (southeast) side of the channel.

American Mariner's AIS path after it left the facility, in relation to the buoys, channel, and shoal water (final vessel position shown is at 0730:55). Soundings are in meters; shoal water is indicated with darker blue. BACKGROUND SOURCE: NOAA ENC US4MI2QU AS VIEWED ON MADE SMART AIS.

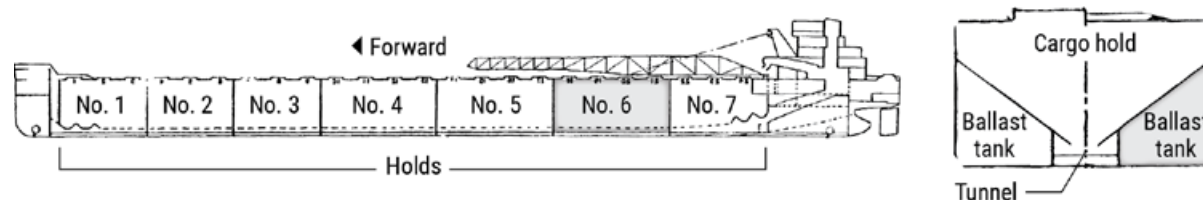
Left to right: Inboard profile drawing of *American Mariner*. Section drawing showing the vessel's no. 6P ballast tank (highlighted), where the engineers detected flooding, in relation to the cargo hold, void, and fore and aft tunnel. BACKGROUND SOURCE: GRAND RIVER NAVIGATION.

The vessel proceeded to a shipyard in Superior, Wisconsin, where it was drydocked, and damage to three ballast tanks at the bilge chine along the port side was found—including breaches of the hull to hold no. 6. Given the crew reports, damage to the port chine and bottom plating, and the vessel's position at the southeast edge of the channel, the *American Mariner* grounded on Vidal Shoals at the edge of the channel.

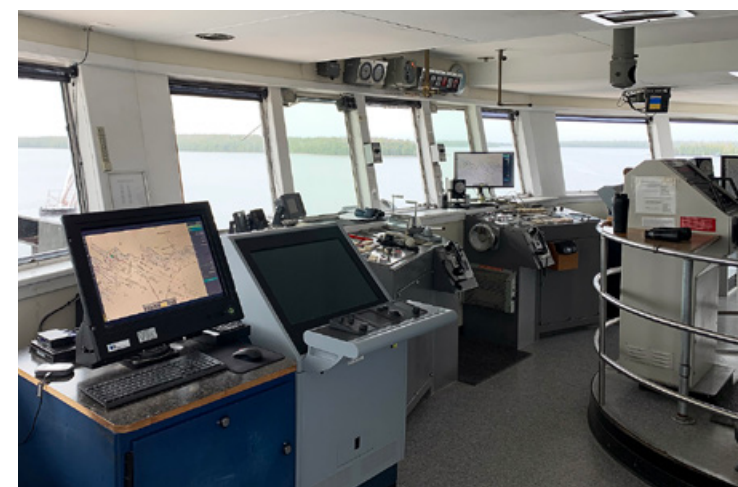
While maneuvering in confined waters, it is difficult for a single bridge crewmember to effectively drive, lookout, and monitor and use available bridge equipment. The composition of a bridge team may vary based on the complexity of the maneuver or operation being carried out. Typically, maneuvers like docking or undocking, transiting in or out of port, or operating in areas of high traffic density require additional personnel to handle navigation-related duties. Owners, operators, and vessel masters are responsible for ensuring that bridge teams are staffed with a sufficient number of certified/credentialed mariners who are familiar with all bridge navigation equipment and able to independently take immediate action. Additionally, the effective use of all available resources by a bridge team, including visual scanning, radars, electronic charts, and an automatic identification system, increases collective situational awareness and contributes to a safe navigation watch.

***American Mariner*'s bridge and centerline conning station.** SOURCE: COAST GUARD.

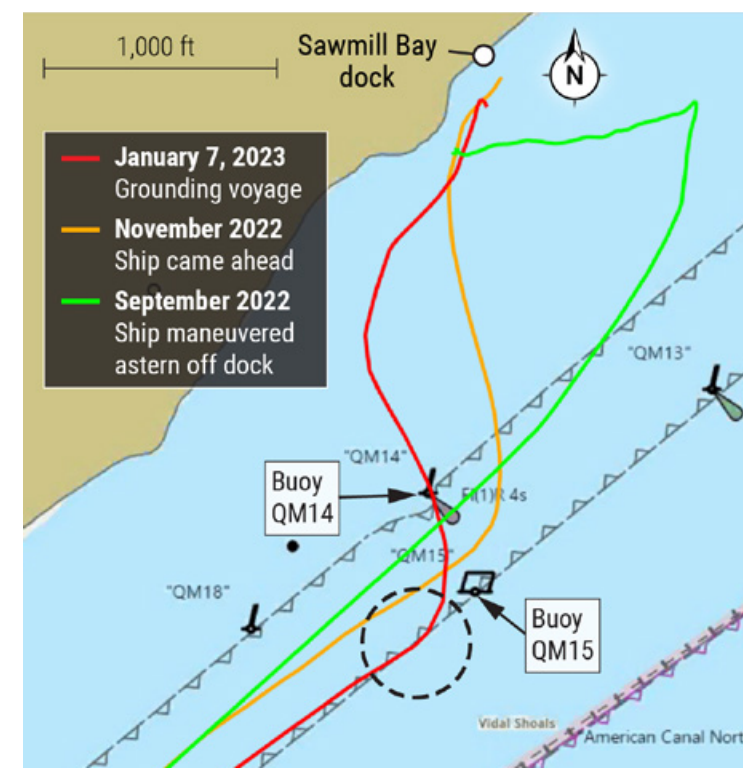
AIS tracklines of the *American Mariner* navigating into the channel from the facility. The area where the vessel's course took it near the edge of the channel is circled with dashes. BACKGROUND SOURCE: NOAA ENC US4MI2QU AS VIEWED ON MADE SMART AIS.

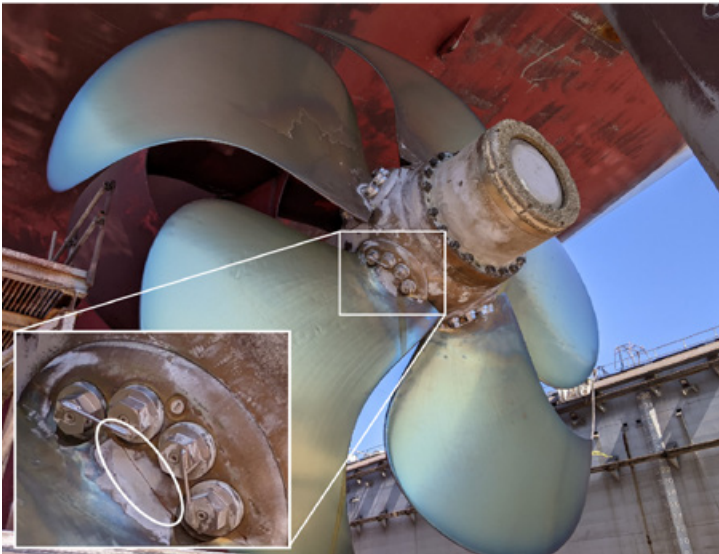
The CPP had five blades, each secured to the hub by seven bolts at the blade's base. At the shipyard, a diver conducted an underwater survey and found fractures and cracks on two of the propeller blades (nos. 2 and 4). The free surface cracks found on the no. 2 blade did not extend to the base of the hub and therefore would not have allowed hydraulic oil to leak. The fracture on the no. 4 blade was larger, extending from the hub near the leading edge, through the bolts, and approaching the trailing edge. Additionally, postcasualty examination and testing found that the potable water used to supplement the hydraulic oil during the casualty transit drained from the no. 4 blade, but not the no. 2 blade. Therefore, the fracture in the no. 4 blade base of the CPP system allowed hub hydraulic oil to exit the CPP system, diminishing the fluid reservoir to a level that the crew felt was unsafe to continue to operate the system.

The CPP on the *Maunalei* after the casualty, showing a fracture (inset) at the base of the no. 4 blade.

Postcasualty testing completed by a third-party company found that the cracks and fractures on the no. 4 blade base initiated at the bolt hole counterbore radius and were consistent with progressive cracking due to high cycle fatigue. The company also found that the bolt hole counterbore radius did not meet manufacturer machining requirements (the radius was about 0.2 millimeters smaller than the required 0.8 millimeters). Additionally, the no. 4 blade did not meet other manufacturer design specifications, such as material specifications for Charpy impact toughness—which measures the material's tendency to resist breaking when subjected to a sudden shock—tensile strength, yield strength, or percent elongation. Lastly, the chemical composition of the blade did not meet compositional requirements (the silicon content exceeded the specified minimum). Propeller blades require adherence to specified engineering design, material selection, and manufacturing requirements to maintain optimum performance and extend fatigue life. Because the no. 4 blade did not meet manufacturer design specifications, it was more susceptible to high cycle fatigue, which resulted in the development of cracks and fractures in the blade base. As a result of the *Maunalei*'s loss of propulsion, the CPP blade manufacturer revised the internal radius requirement—enlarging it—for all seven bolt hole counterbores to improve fatigue fracture resistance.

Based on the *Maunalei*'s no. 4 blade not meeting specifications and the manufacturer's postcasualty finite element analysis of other five-bladed CPP systems on similar vessels (which did not identify any other instances of cracks), the crack and fracture that developed on the no. 4 blade of the *Maunalei* CPP system was likely an isolated occurrence.

THE PROBABLE CAUSE of the loss of propulsion on the containership *Maunalei* was a crack developing in a controllable pitch propeller blade base and progressing into a fracture due to high cycle fatigue as a result of the blade not meeting manufacturer design specifications.

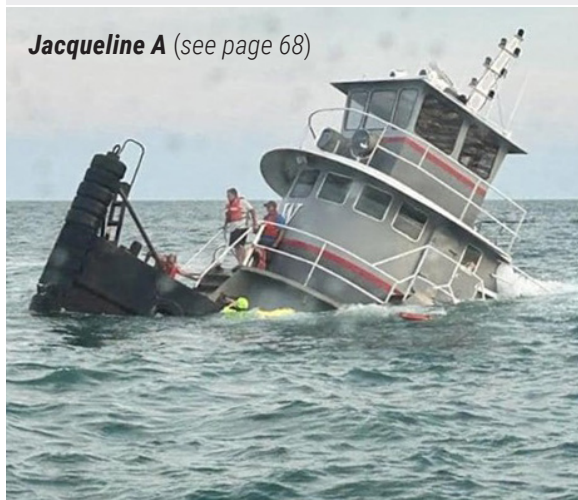
Jacqueline A (see page 68)

In the **Jacqueline A** casualty, flooding was caused by water ingress through wastage holes caused by corrosion that developed in inaccessible voids. The deterioration of hull plating may have caused flooding in the **Hotspur** casualty.

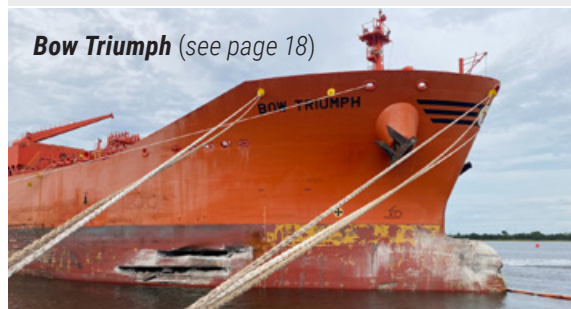
Bow Triumph (see page 18)

In the **Bow Triumph** casualty, the pilot's maneuvering of the vessel left it exposed to bank effect on its port side, overcoming his ability to safely navigate the vessel and leading to the vessel striking a pier. In the **Mark E Kuebler/Nisalah** collision, hydrodynamic forces drew the tugboat in toward the tanker, causing the two vessels to collide.

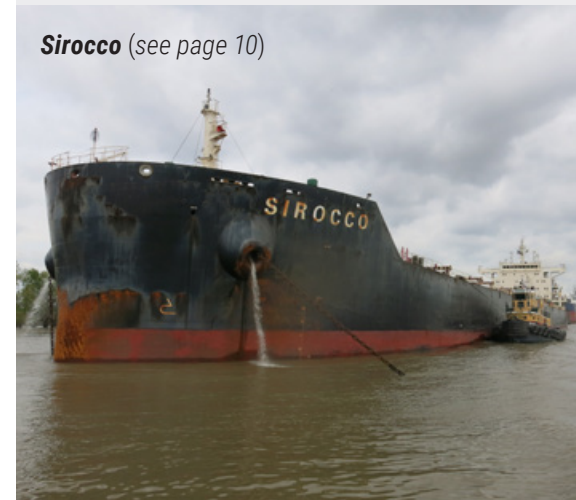
Sirocco (see page 10)

A strong current overcame the **Sirocco's** mooring winches' brake-holding capacities, causing the vessel to break away from the dock during loading. The **Queen City** contacted a dike when the pilot did not effectively compensate for strong outdraft while navigating a tow near a dam.
