2025 Summer Safety Meeting

Groundings – What can we Learn?

August 14th, 2025

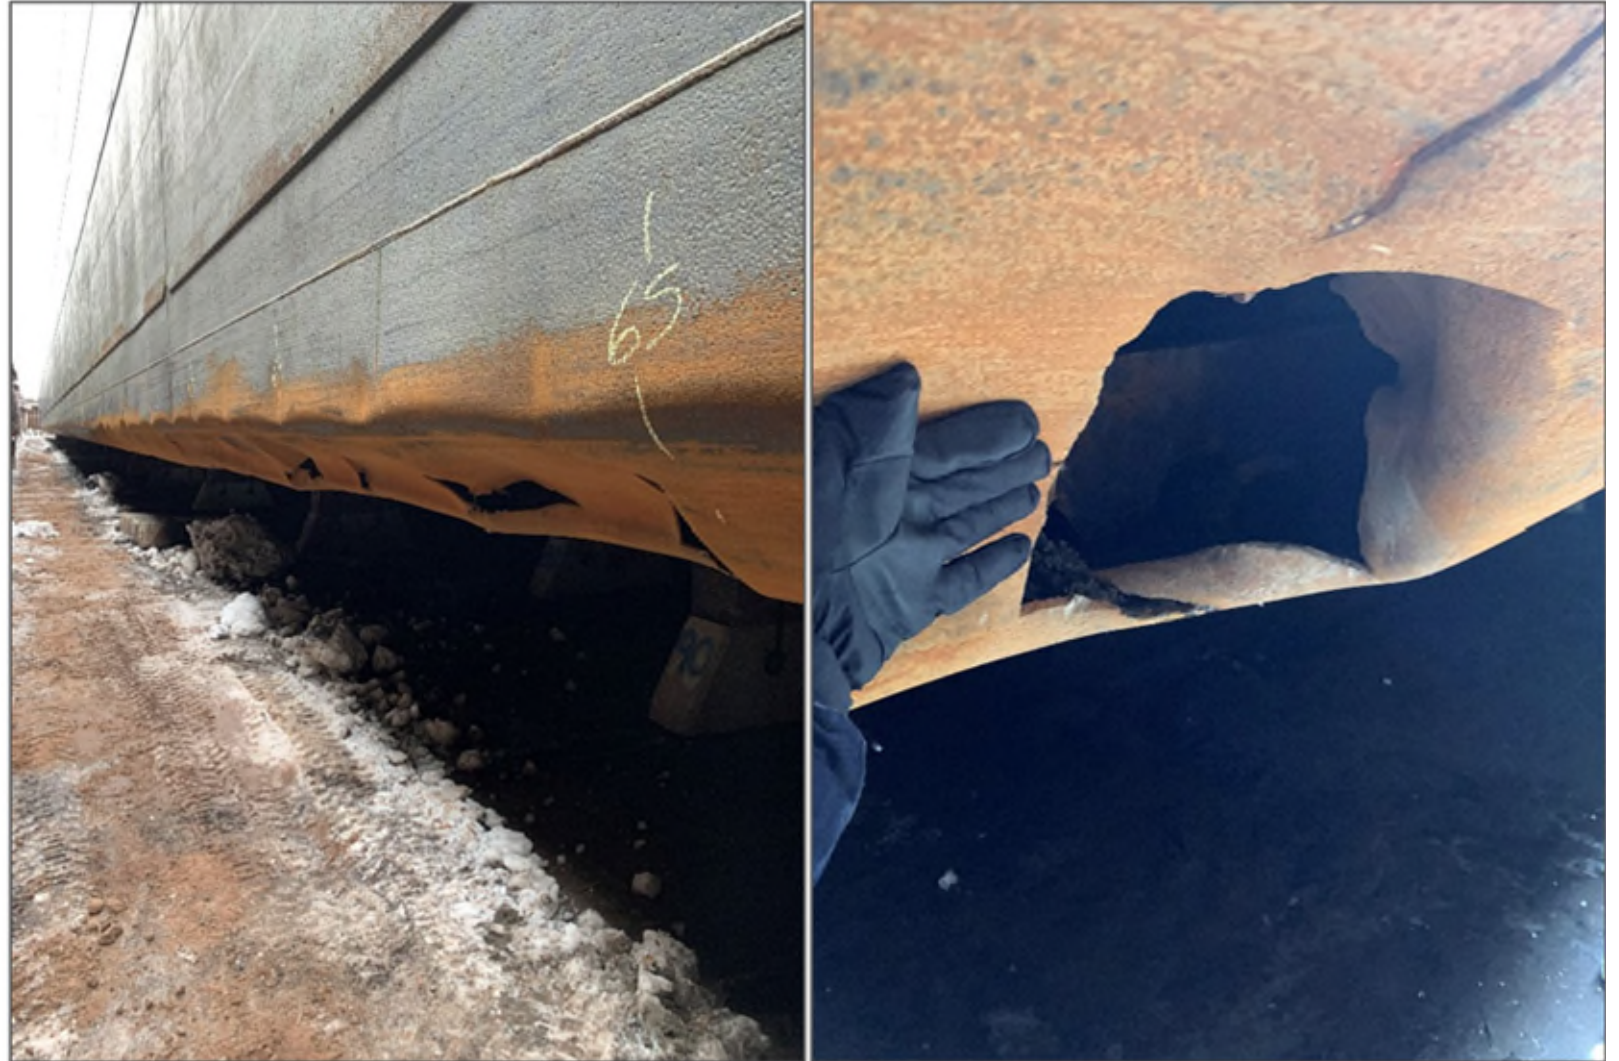
Grounding of the American Mariner

- January 7th, 2023, near Sault Ste Marie, Ontario
- Hit submerged rock
- No pollution or injuries
- \$600,000 in damage
- What may have led to this incident?

- The Master maneuvering the vessel away from the dock and into the channel while alone on the bridge, which required him to multitask (navigation, steering, and lookout duties) and resulted in the vessel overshooting the turn into the channel and running aground on the shoals on the opposite side of the channel.
- Do you see any Contributing causes?

- Owners, operators, and vessel masters are responsible for ensuring that bridge teams are staffed with enough certified mariners who are familiar with all bridge navigation equipment and able to independently take immediate action.
- Effective use of all available resources by a bridge team, including visual scanning, radars, electronic charts, and an automatic identification system, increases collective situational awareness and contributes to a safe navigation watch.
- [DCA23FM013.aspx](https://www.ntsb.gov/publications/industry/2013/01/20130101.asp)

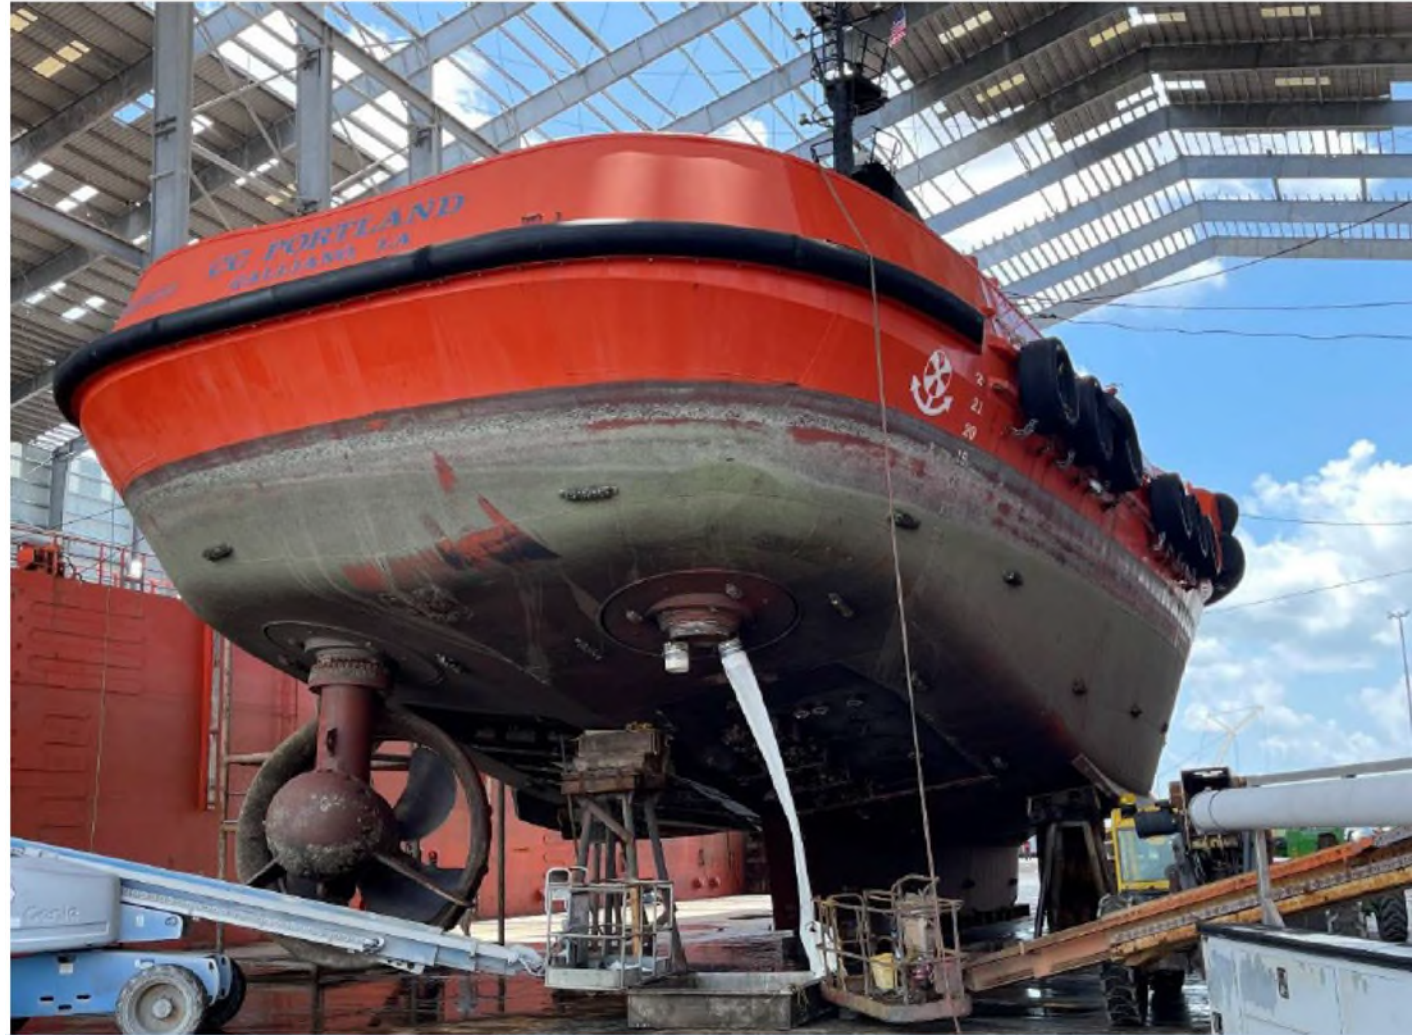
Tug Grounding during ship-assist

- August 7th, 2022,
Corpus Christi
Channel
- Oil Spill, but no
injuries
- \$1.3 million damage

- Tug is tethered at ship's bow, the tanker is moving in excess of 8 knots.
- To maintain position, the Tug operating at nearly 80% of its maximum speed—far greater than the 60% recommended
- Riskiest position for a tug

- The Mate's attempt to make up bow to bow with the LNG carrier while the tugboat and liquefied natural gas carrier were transiting at an excessive speed for the advanced harbor-assist maneuver.
- Contributing cause: The lack of a Company policy regarding maximum allowable speed for bow assist maneuvers.

- Owners and operators of ASD tugboats that perform bow-to-bow harbor-assist operations should set speed limits for these maneuvers. These limits may vary for different classes of tugboats based on design.
- Tugboat operators should communicate these pre-determined speed limits to pilots and ship masters in command of the vessels that they are assisting before engaging in these maneuvers.
- [NTSB: Accident Brief: The Grounding of Tugboat CC Portland - Marine Construction Magazine](#)

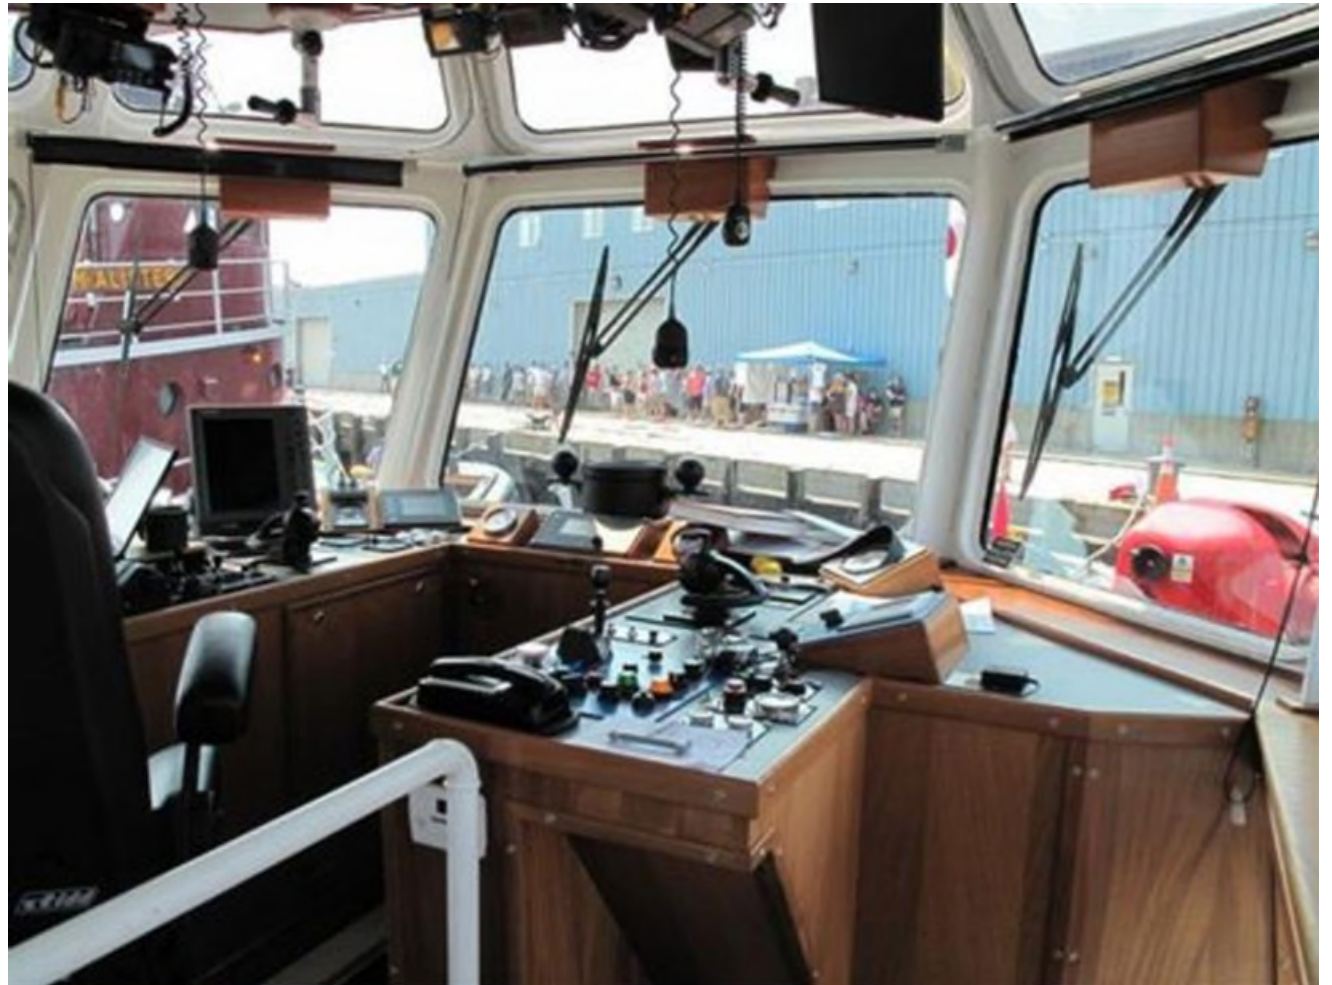
Tug Grounding on the C& D Canal

- May 2nd, 2025, west of the C& D Canal Bridge
- No pollution or injuries
- No damages
- What contributed to this incident?

- It is nighttime, Mate and deckhand (steering) on watch
- Mate inadvertently trips 24V circuit breaker with knee, causing multiple alarms
- Ultimately required turning on houselights to find breaker
- Boat veered left in the process; Mate reacted, slowed and redirected vessel , but grounded on northern bank

- Physical proximity –
 - Distractions?
 - Availability of a flashlight?
 - Engineering Controls?
