Reducing Downstreaming Incidents Report of the Quality Action Team

Reducing Downstreaming Incidents

Report of the Quality Action Team

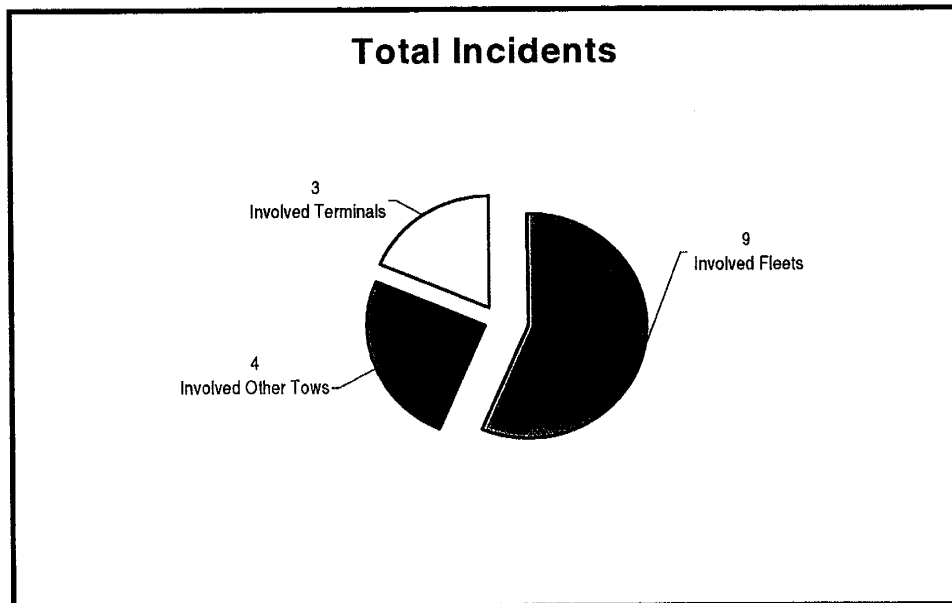
Nine of the incidents occurred in fleets, four of the incidents occurred as a towboat was attempting to remove barges from a tow in the control of another towboat and three of the incidents occurred at terminal facilities.
