REPORT OF THE COAST GUARD-AWO QUALITY ACTION
TEAM ON TOWING VESSEL CREW FATALITIES

JULY 26, 1996

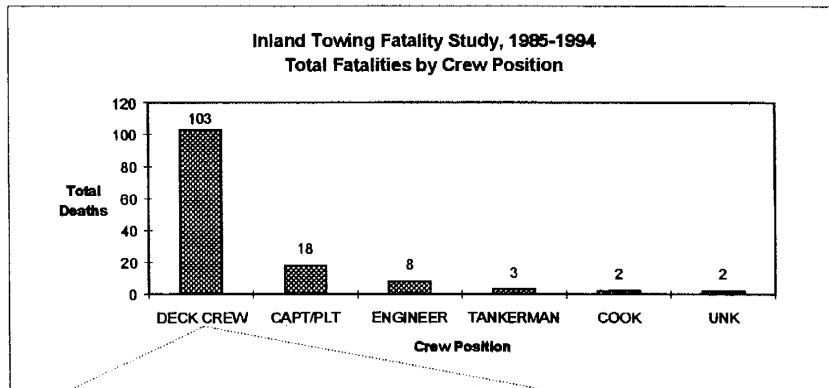
Fatalities by Position, Cause, & Activity

Figure 3 on the following page illustrates the point made earlier that crew position and crew activity were the most critical predictors of fatality.

Each graph in the series follows from the one preceding it. The first depicts total fatalities by crew position. The second focuses on the causes of fatalities for just the 103 deck crew deaths. The third highlights the activities of the deck crew members who died subsequent to a fall into the water.

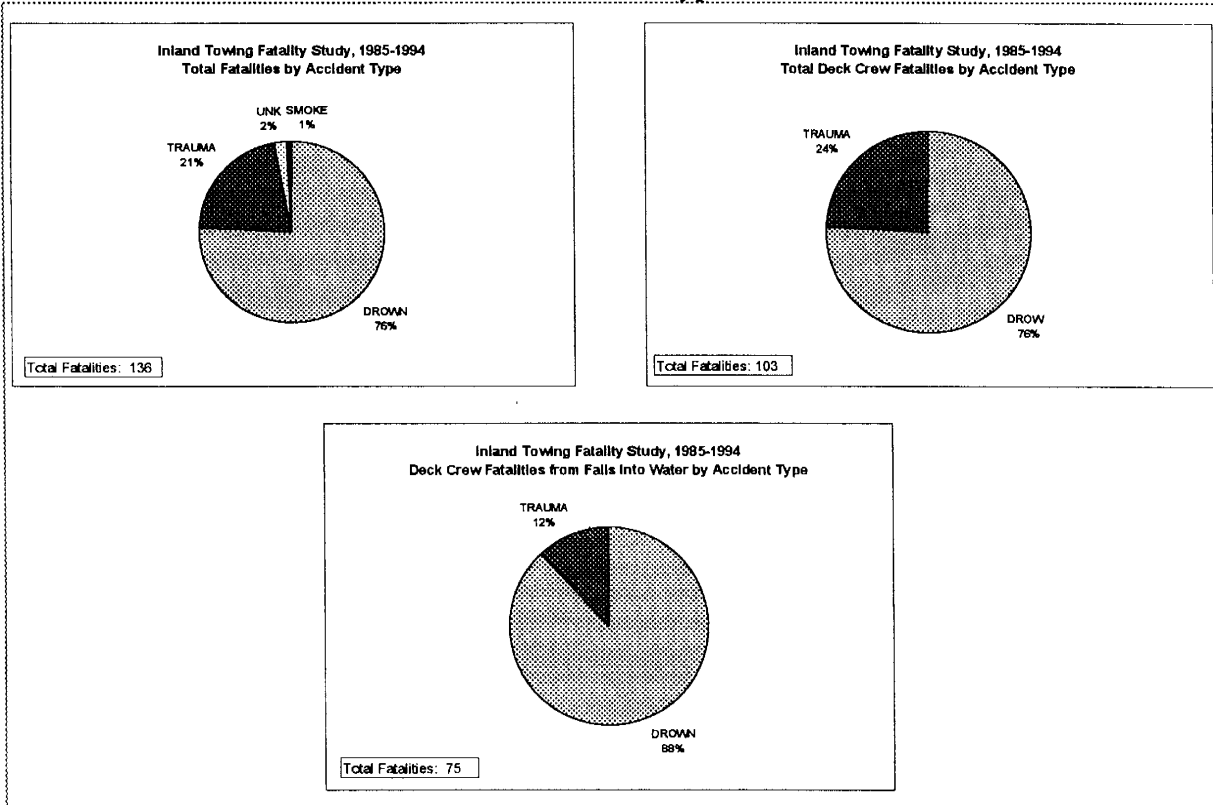
Figure 6

Accident Type

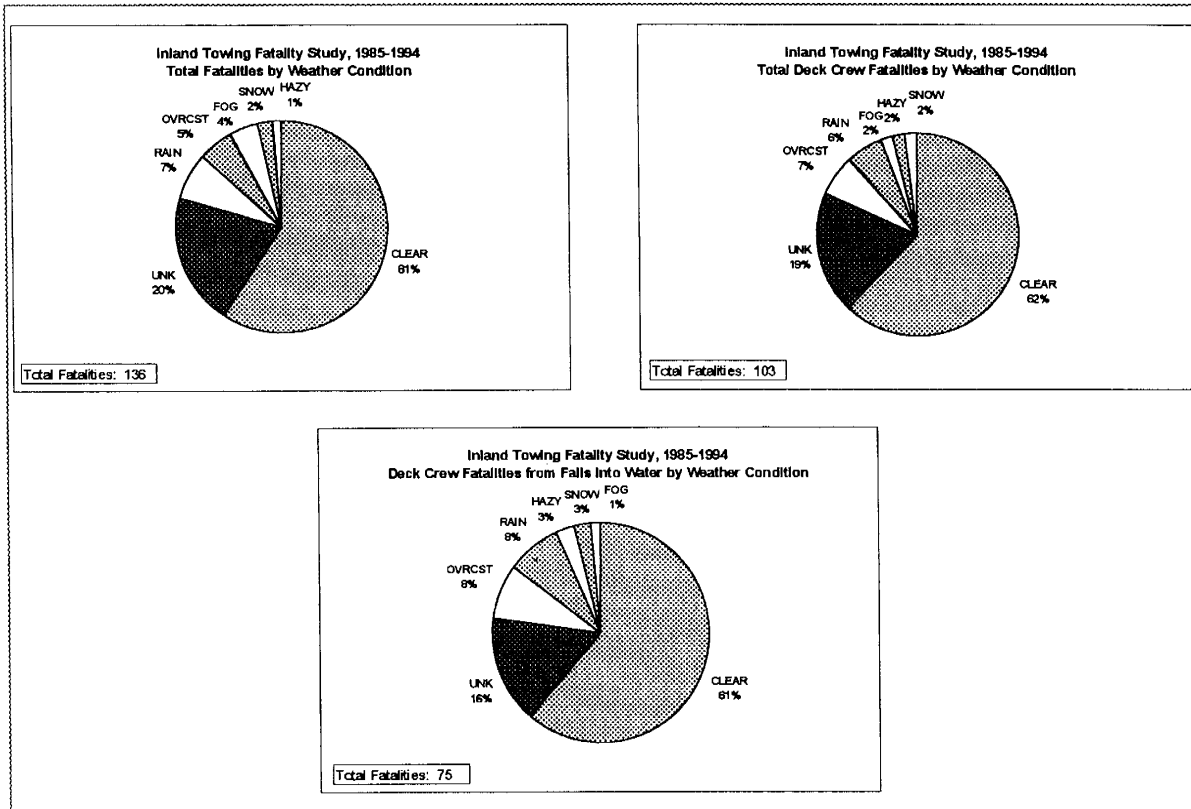
Figure 7

Weather Condition

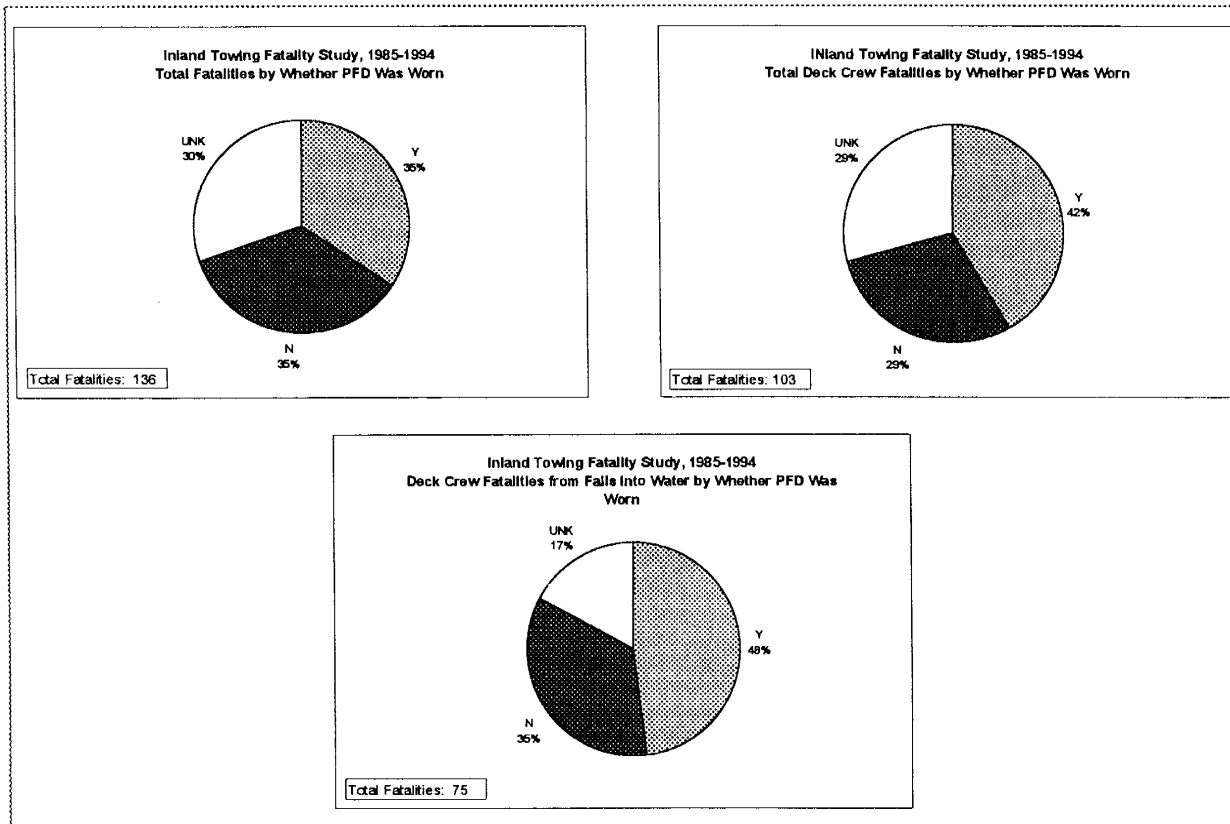
Figure 10

PFD Use
